Notification No.: 208

- Seawall construction works at Zones 2 and 3A were carried out within silt curtain as recommended in the EIA Report.
- The ranges of suspended solid at station IS8 during the baseline monitoring are shown as below:

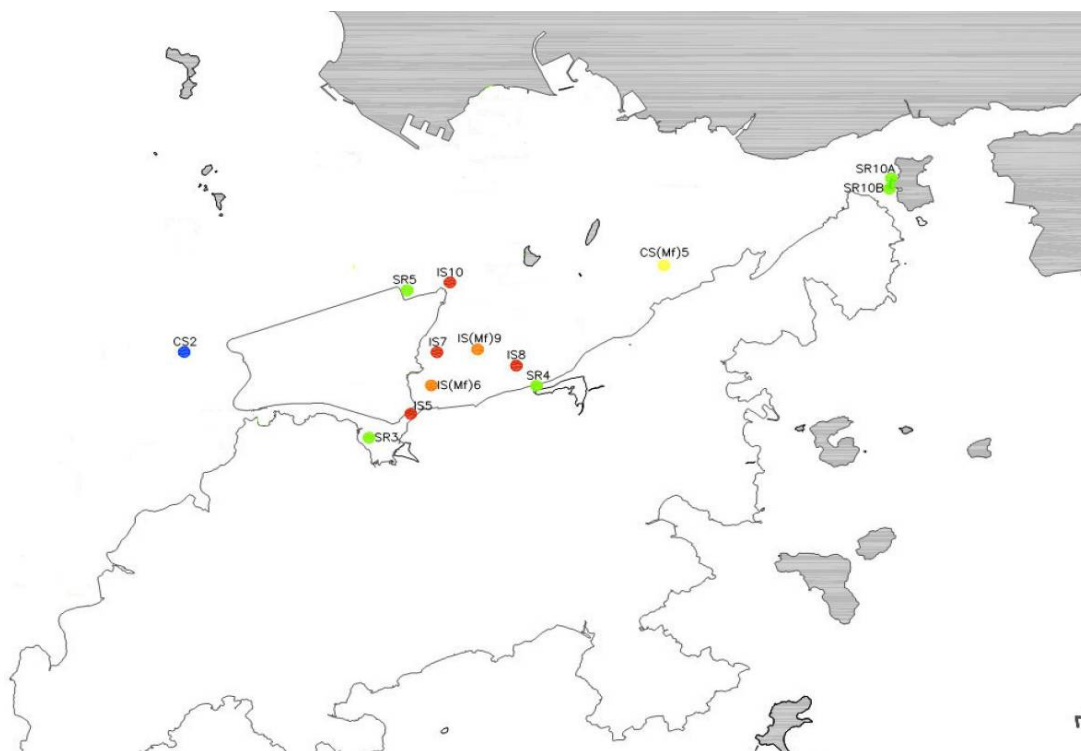
Location Plan:

The measured value at the station IS8 was within the range of suspended solid during baseline monitoring for the mid-flood tide. In addition, there were no specific activities recorded during the monitoring period that would cause any significant impacts on the monitoring results.
