**Contract No. HY/2013/04 Hong Kong-Zhuhai-Macao Bridge (HZMB)  
Hong Kong Boundary Crossing Facilities – Infrastructure Works Stage II  
(Southern Portion)**

**Monthly EM&A Report for October 2018**

**Contract No. HY/2013/04 – HZMB HKBCF – Infrastructure Works Stage II  
(Southern Portion)  
Monthly Environmental Monitoring & Audit Report for October 2018**

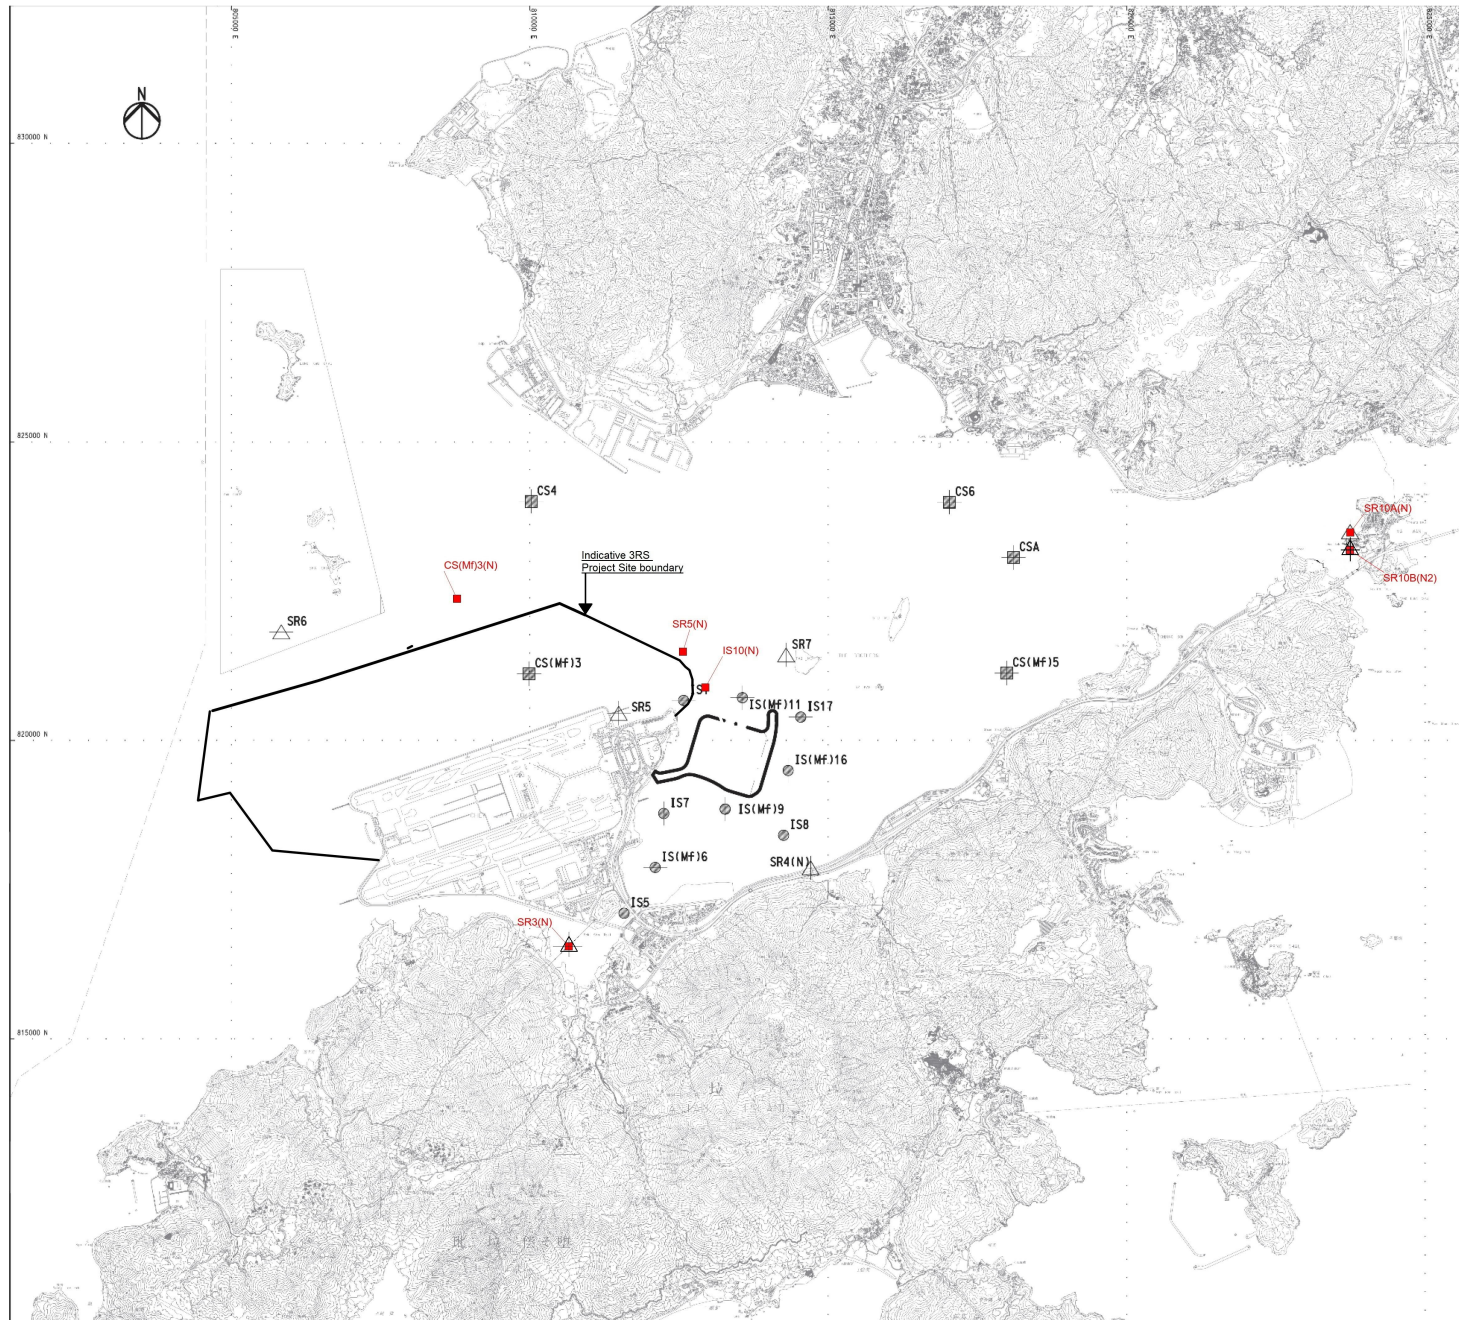
FIGURE 4.1— LOCATION OF WATER QUALITY MONITORING STATIONS

Station	East	North
IS5	811579	817106
IS(Mf)6	812101	817873
IS7	812244	818777
IS8	814251	818412
IS(Mf)9	813273	818850
IS10(N)	812942	820881
IS(Mf)11	813562	820716
IS(Mf)16	814328	819497
IS17	814539	820391
SR3(N)	810689	816591
SR4(N)	814705	817859
SR5(N)	812569	821475
SR6	805837	821818
SR7	814293	821431
SR10A(N)	823644	823484
SR10B(N2)	823689	823159
CS(Mf)3(N)	808814	822355
CS(Mf)5	817990	821129
CS4	810025	824004
CS6	817028	823992
CSA	818103	823064

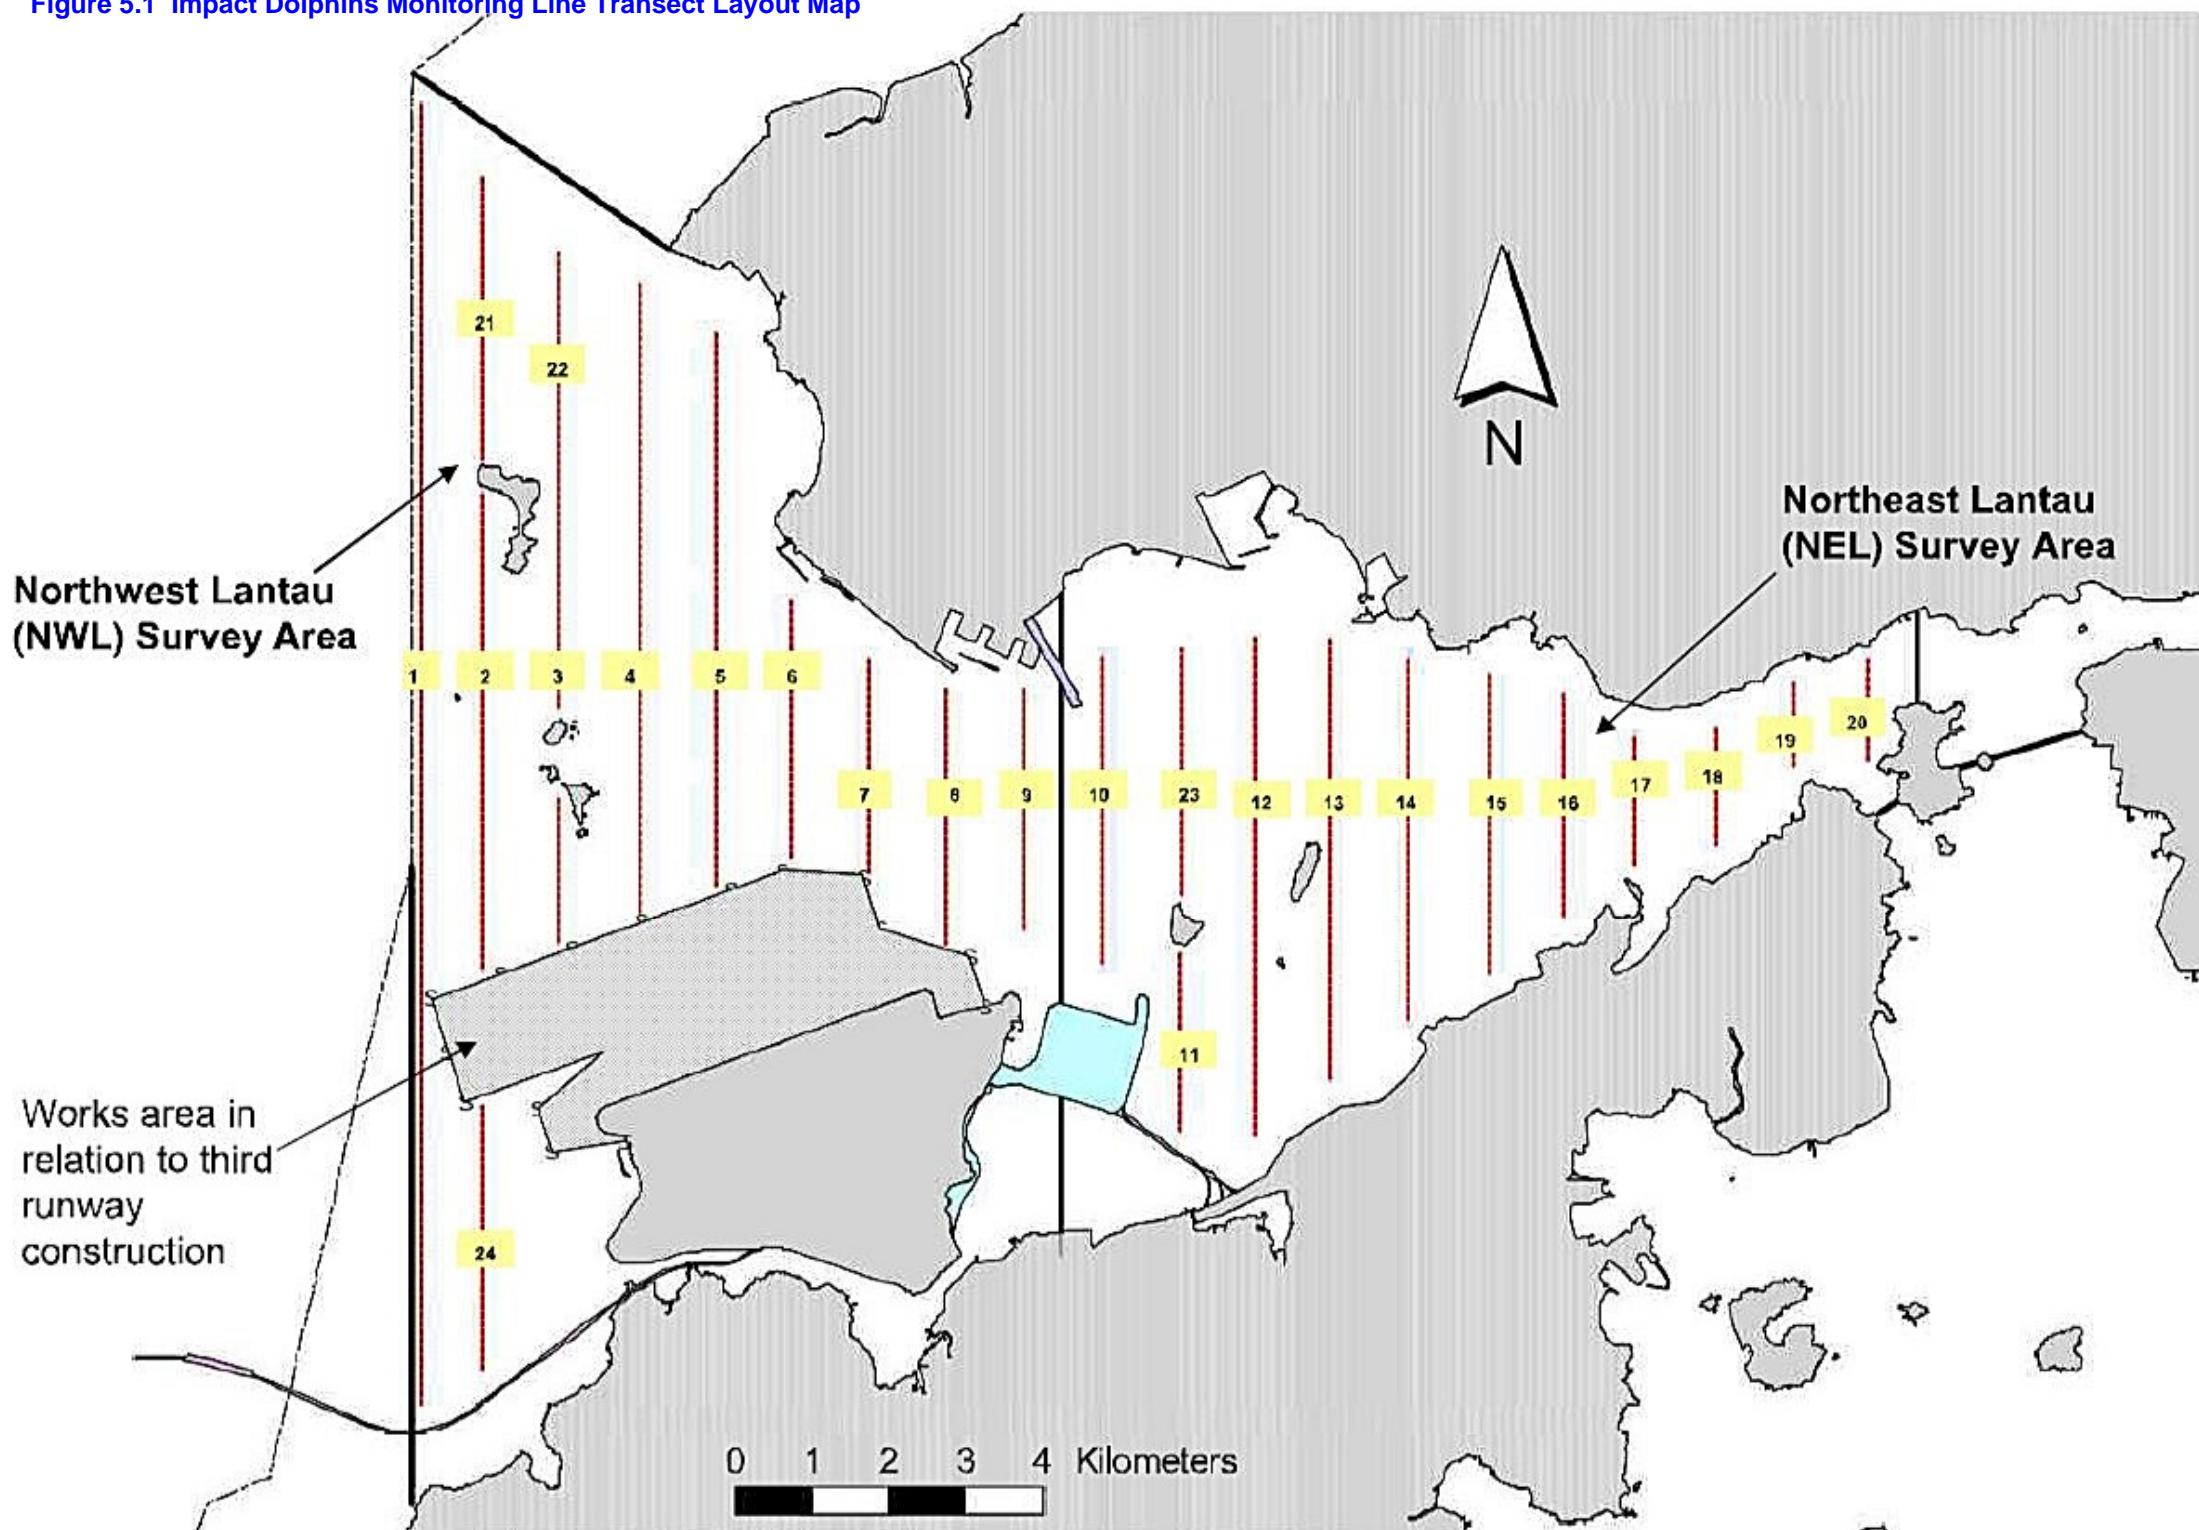
Figure 5.1 Impact Dolphins Monitoring Line Transect Layout Map

**Table 5.1** shows the co-ordinates for the transect lines and layout map. The layout map showing the transect lines have been provided by AFCD and are shown in **Figure 5.1**.

- (a) \* Due to the presence of deployed silt curtain systems at the site boundaries of the Contract, some of the transect lines shown in Figure 5.1 could not be fully surveyed during the regular survey. Transect 10 is reduced from 6.4km to approximately 3.6km in length due to the HKBCF construction site. Therefore the total transect length for both NEL and NWL combined is reduced to approximately 108km.

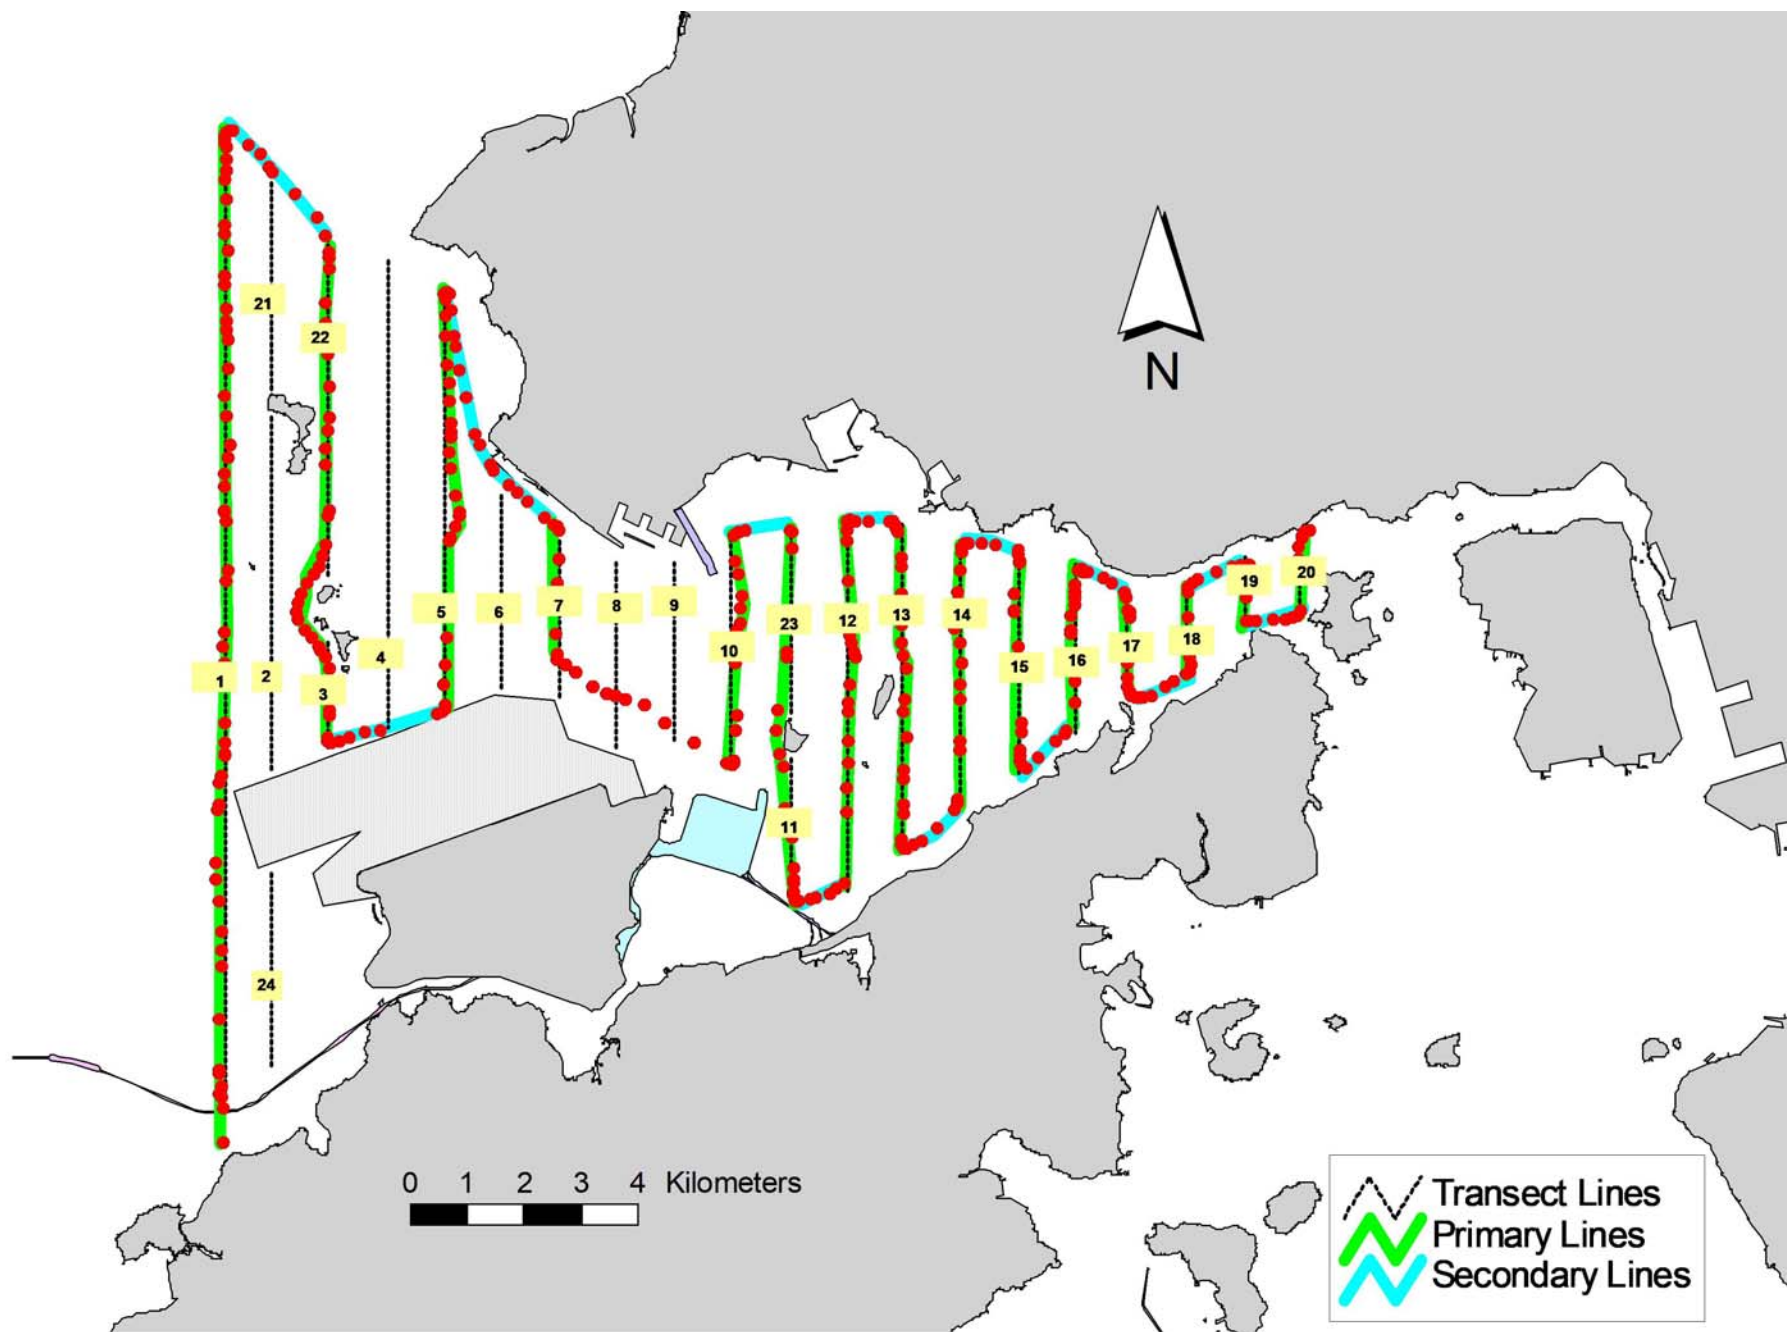
Figure 1. Transect Line Layout in Northwest and Northeast Lantau Survey Areas

- 2.1.1. According to the requirement of the updated EM&A manual, the dolphin monitoring programme should cover all transect lines in NEL and NWL survey areas (see Figure 1) twice per month throughout the entire construction period. The co-ordinates of all transect lines are shown in Table 1.

- 2.1.7. Survey effort being conducted along the parallel transect lines that were perpendicular to the coastlines (as indicated in Figure 1) was labeled as “primary” survey effort, while the survey effort conducted along the connecting lines between parallel lines was labeled as “secondary” survey effort. According to HKCRP long-term dolphin monitoring data, encounter rates of Chinese White Dolphins deduced from effort and sighting data collected along primary and secondary lines were similar in NEL and NWL survey areas. Therefore, both primary and secondary survey effort were presented as on-effort survey effort in this report.

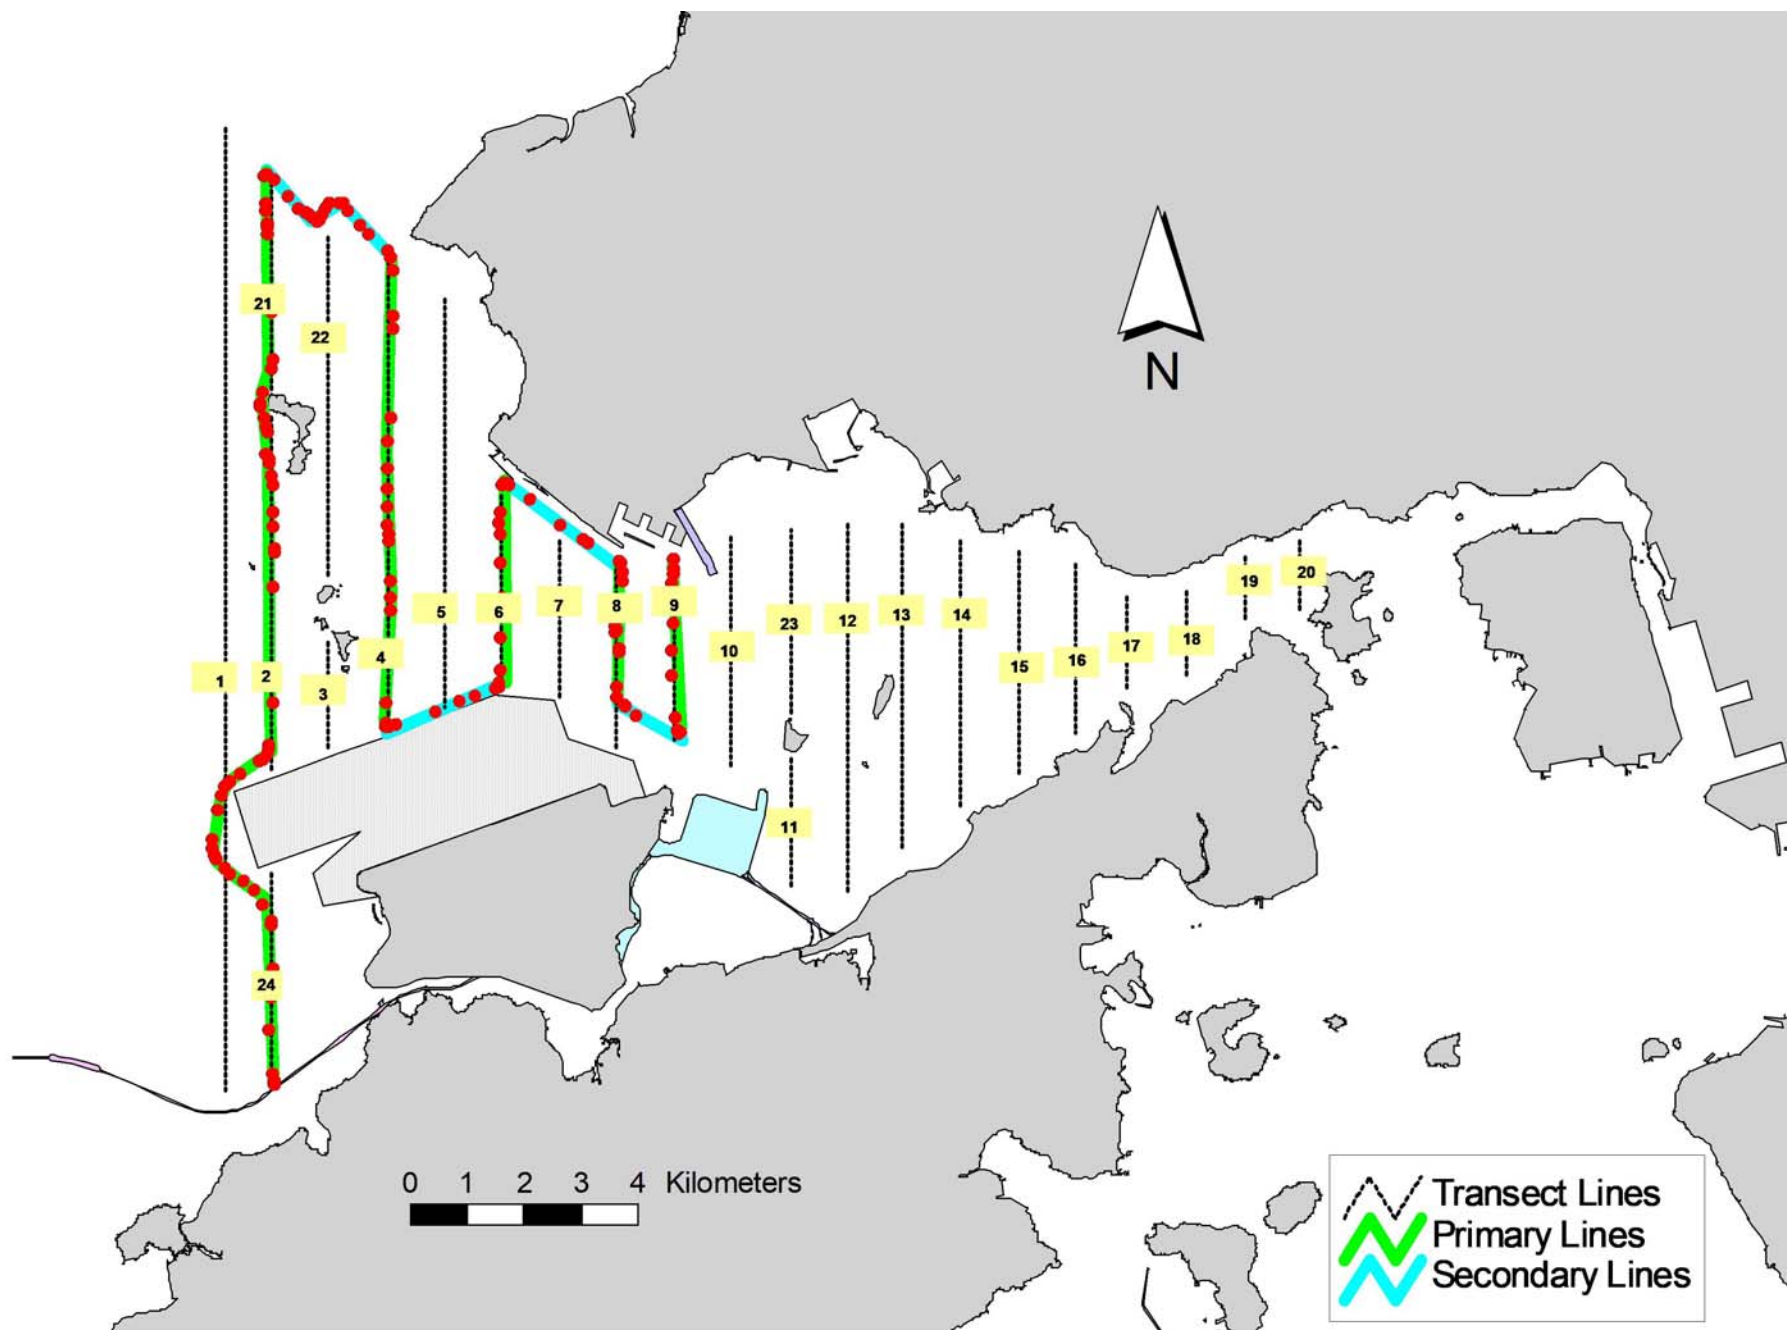
Figure 2. Survey Route on October 4<sup>th</sup>, 2018 (from HKLR03 project)

Two sets of systematic line-transect vessel surveys were conducted under the HKBCF dolphin monitoring programme on 4, 11, 16 and 18 October 2018, to cover all transect lines in NWL and NEL survey areas twice. The survey routes of each survey day are presented in **Figures 2 to 5 of Appendix L**.

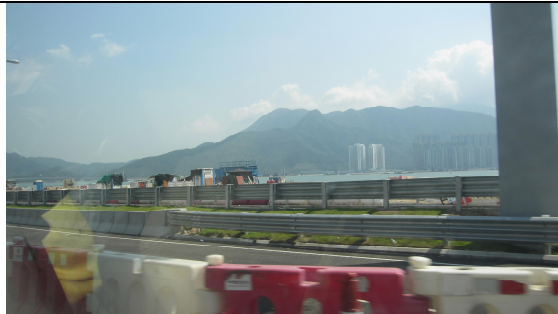
3(a)

3. The vehicular entrance of HY/2013/04 site boundary was also inspected and found to be operating normally with no fugitive dust observed.

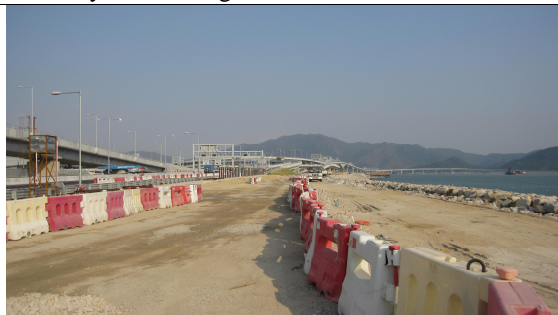
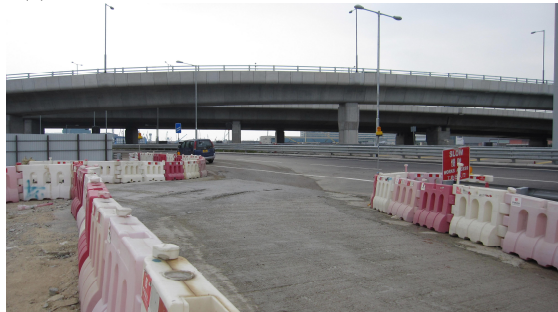
4. The wheel wash facility at the vehicular exit of HY/2013/04 site boundary was also inspected and found to be operating normally with no fugitive dust observed.
