**Contract No. HY/2013/04 Hong Kong-Zhuhai-Macao Bridge (HZMB)
Hong Kong Boundary Crossing Facilities – Infrastructure Works Stage II
(Southern Portion)**

Monthly EM&A Report for November 2018

This is the 41st Monthly EM&A Report summarising the findings of EM&A activities conducted under the Contract from 1 to 30 November 2018 (the “reporting period”) and is submitted to fulfil Condition 5.4 of the EP.

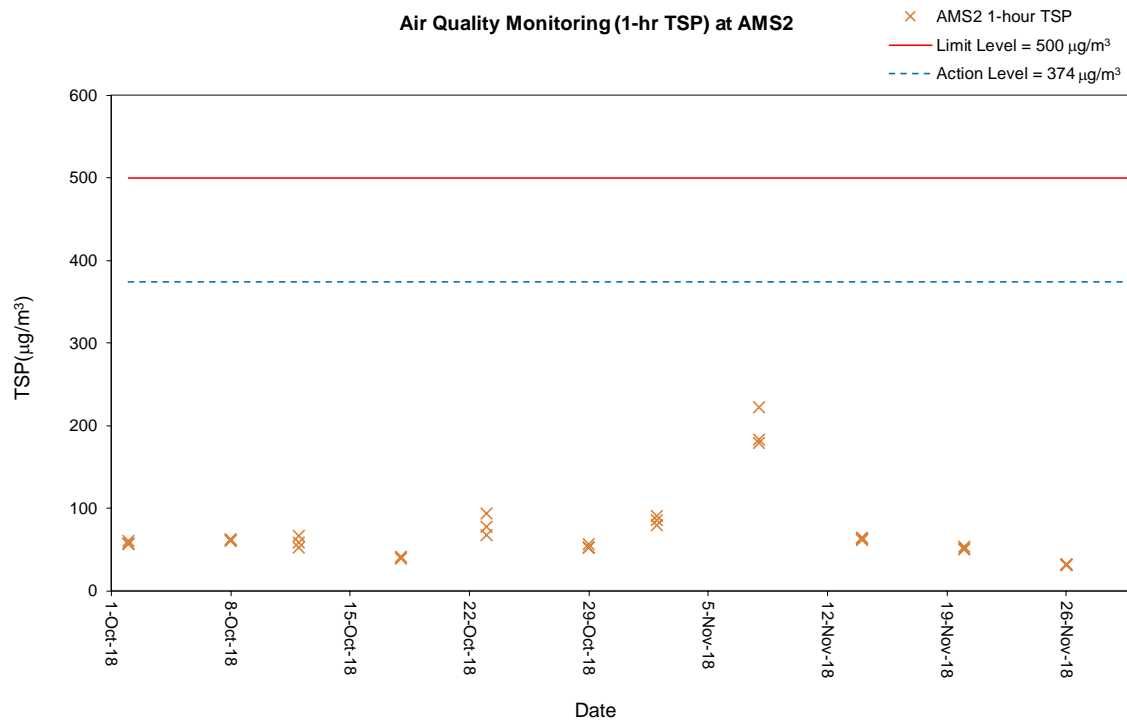
HKBCF	HY/2013/04	AMS2 Tung Chung Development Pier	20-Nov-18	24-hr TSP	16:53	58	µg/m ³
HKBCF	HY/2013/04	AMS2 Tung Chung Development Pier	23-Nov-18	24-hr TSP	14:10	86	µg/m ³
HKBCF	HY/2013/04	AMS2 Tung Chung Development Pier	29-Nov-18	24-hr TSP	10:27	63	µg/m ³
HKBCF	HY/2013/04	AMS3C Ying Tung Estate Market Rooftop	01-Nov-18	24-hr TSP	07:55	102	µg/m ³
HKBCF	HY/2013/04	AMS3C Ying Tung Estate Market Rooftop	07-Nov-18	24-hr TSP	08:03	86	µg/m ³
HKBCF	HY/2013/04	AMS3C Ying Tung Estate Market Rooftop	13-Nov-18	24-hr TSP	08:15	70	µg/m ³
HKBCF	HY/2013/04	AMS3C Ying Tung Estate Market Rooftop	19-Nov-18	24-hr TSP	08:10	99	µg/m ³
HKBCF	HY/2013/04	AMS3C Ying Tung Estate Market Rooftop	23-Nov-18	24-hr TSP	08:04	104	µg/m ³
HKBCF	HY/2013/04	AMS3C Ying Tung Estate Market Rooftop	29-Nov-18	24-hr TSP	07:56	51	µg/m ³
HKBCF	HY/2013/04	AMS7B 3RS Site Office	01-Nov-18	24-hr TSP	09:53	125	µg/m ³
HKBCF	HY/2013/04	AMS7B 3RS Site Office	07-Nov-18	24-hr TSP	10:04	98	µg/m ³

HKBCF	HY/2013/04	AMS7B 3RS Site Office	13-Nov-18	24-hr TSP	10:15	132	µg/m ³
HKBCF	HY/2013/04	AMS7B 3RS Site Office	19-Nov-18	24-hr TSP	09:57	128	µg/m ³
HKBCF	HY/2013/04	AMS7B 3RS Site Office	23-Nov-18	24-hr TSP	09:14	128	µg/m ³
HKBCF	HY/2013/04	AMS7B 3RS Site Office	29-Nov-18	24-hr TSP	09:55	73	µg/m ³

Remark: The air quality monitoring before 1 October 2018 are conducted by Contract No. HY/2013/01 Hong Kong-Zhuhai-Macao Bridge HKBCF – Passenger Clearance Building. Please refer the monitoring results from August 2018 to September 2018 in the published Monthly EM&A Report for Contract No. HY/2013/01.
