T +852 2828 5757 F +852 2827 1823 mottmac.hk Contract No. HY/2013/04 Hong Kong-Zhuhai-Macao Bridge (HZMB) Hong Kong Boundary Crossing Facilities – Infrastructure Works Stage II (Southern Portion)

Monthly EM&A Report for March 2019 (Revision 1)

This is the 45<sup>th</sup> Monthly EM&A Report summarising the findings of EM&A activities conducted under the Contract from 1 to 31 March 2019 (the "reporting period") and is submitted to fulfil Condition 5.4 of the EP.

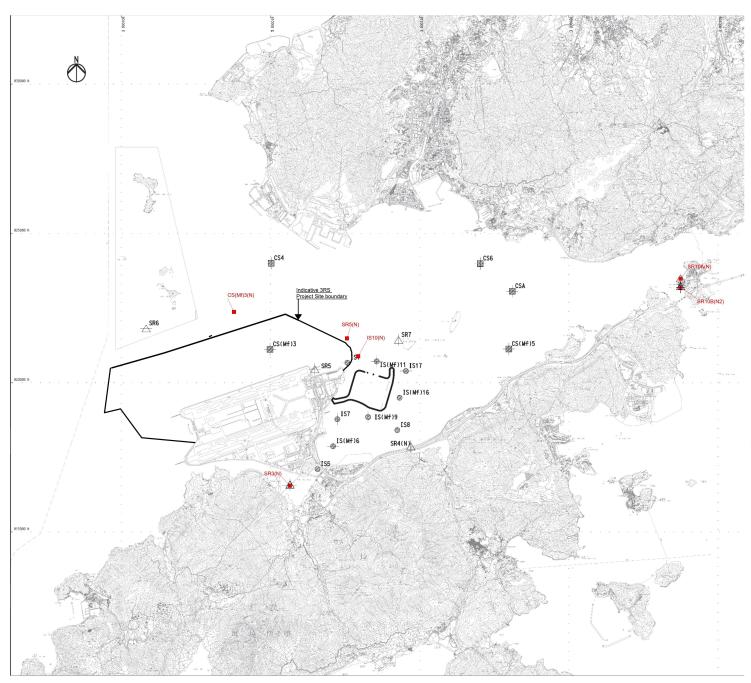
#### FIGURE 4.1— LOCATION OF WATER QUALITY MONITORING STATIONS

The nine Impact Stations (IS) were chosen on the basis of their proximity to the reclamation and thus the greatest potential for water quality impacts, the seven Sensitive Receiver Stations (SR) were chosen as they are close to the key sensitive receives and the five Control/ Far Field Stations (CS) were chosen to facilitate comparison of the water quality of the IS stations with less influence by the Project/ ambient water quality conditions.

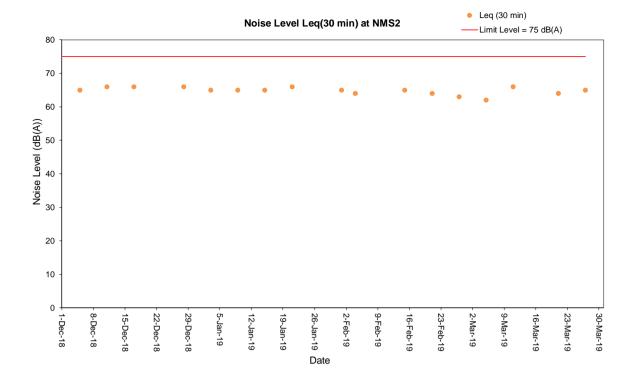
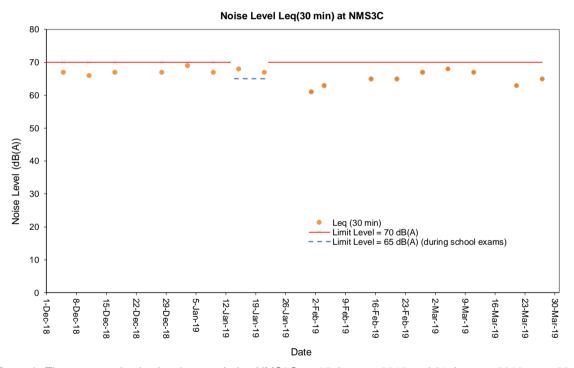
Remark: The measured noise levels recorded at NMS3C on 15 January 2019 and 21 January 2019 were 68.4 dB(A) and 66.7 dB(A) respectively, which exceeded the noise level of 65dB(A) during examination period and were higher than the baseline level of 66.3 dB(A). Therefore, baseline correction was carried out and the corrected noise levels which solely represent the noise level of construction works were 64.2 dB(A) and 56.1 dB(A) respectively, therefore there was no exceedance after correction. As such the Event and Action Plan was not triggered.

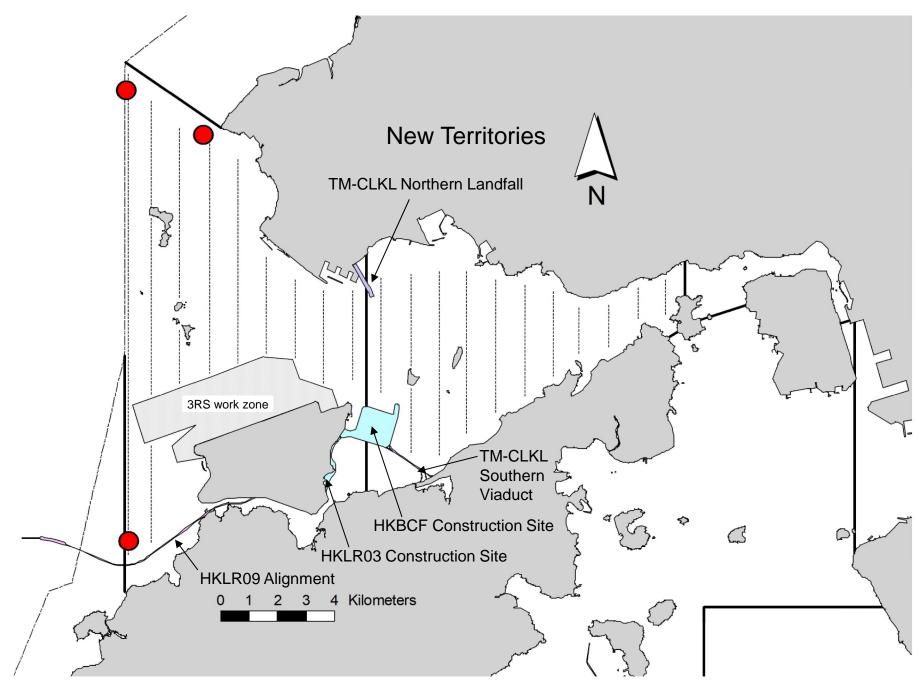
Figure 6. Distribution of Chinese White Dolphin Sightings during March 2019 HKLR03 Monitoring Surveys

For dolphin monitoring, dolphin surveys were conducted on 4, 11, 13 and 18 March 2019. A total of 259.07 km of survey effort was collected, with 95.6% of the total survey effort being conducted under favourable weather conditions. Only three groups of six Chinese White Dolphins were sighted. All three dolphin groups were sighted in NWL, while no dolphin was sighted at all in NEL.
