T +852 2828 5757 F +852 2827 1823 mottmac.hk Contract No. HY/2013/04 Hong Kong-Zhuhai-Macao Bridge (HZMB) Hong Kong Boundary Crossing Facilities – Infrastructure Works Stage II (Southern Portion)

Quarterly EM&A Report for June to August 2019 (Revision 0)

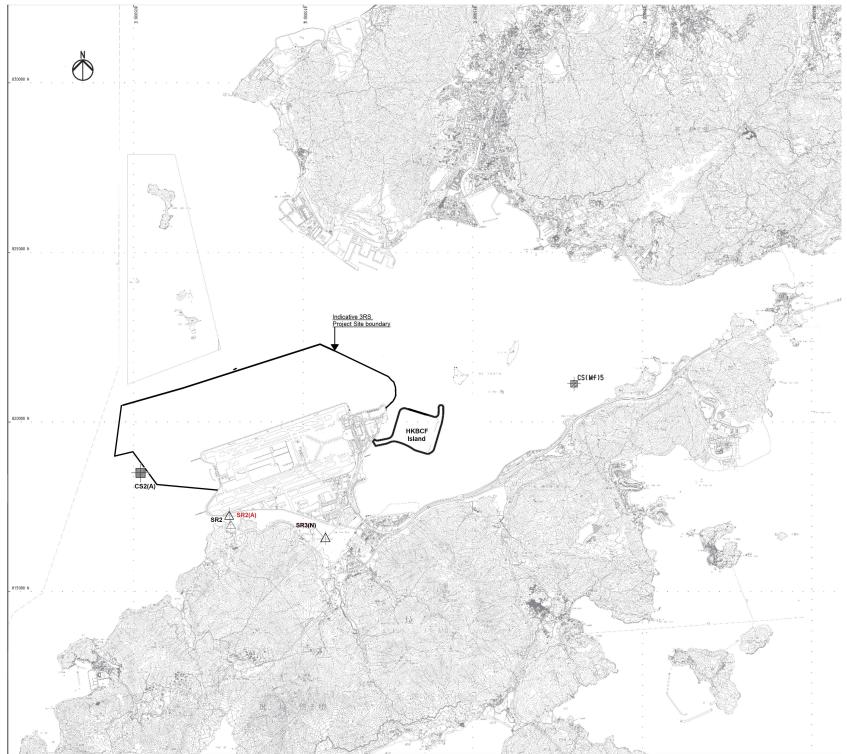
## FIGURE 2.3 — LOCATION OF WATER QUALITY MONITORING STATIONS

Station	East	North
SR2	807856	816953
SR2(A)	807810	817189
SR3(N)	810689	816591
CS2(A)	805232	818606
CS(Mf)5	817990	821129

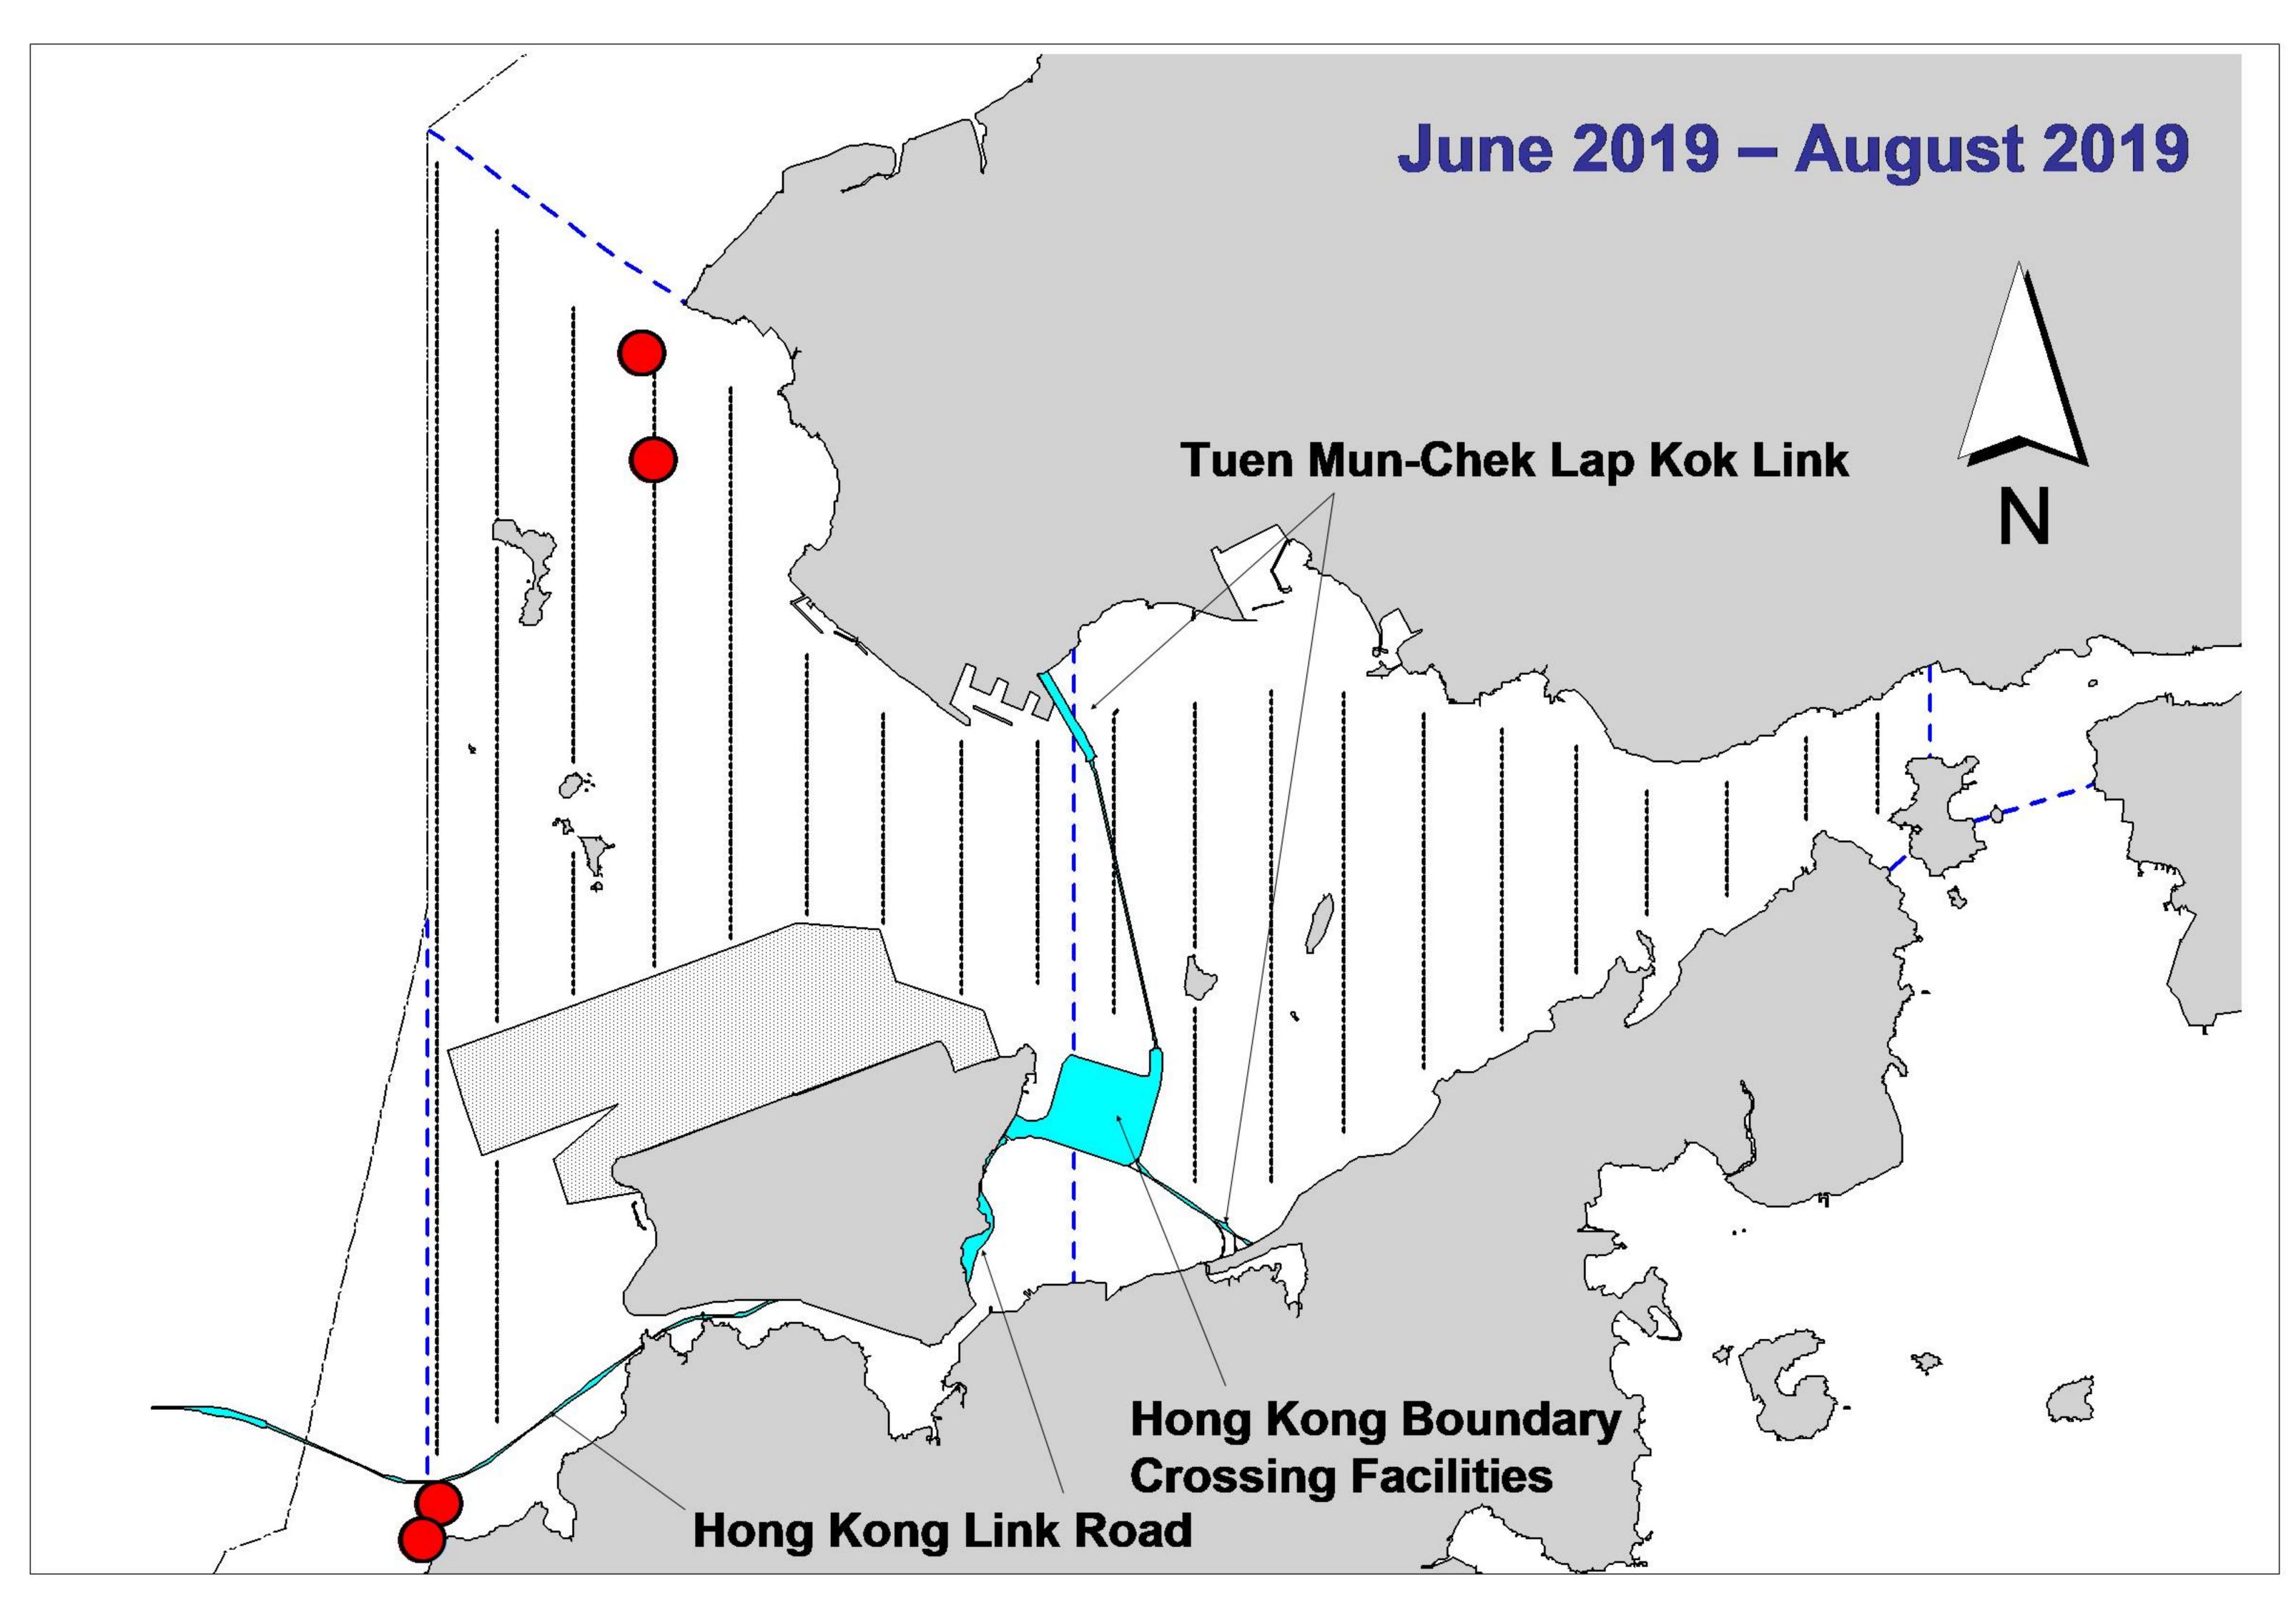
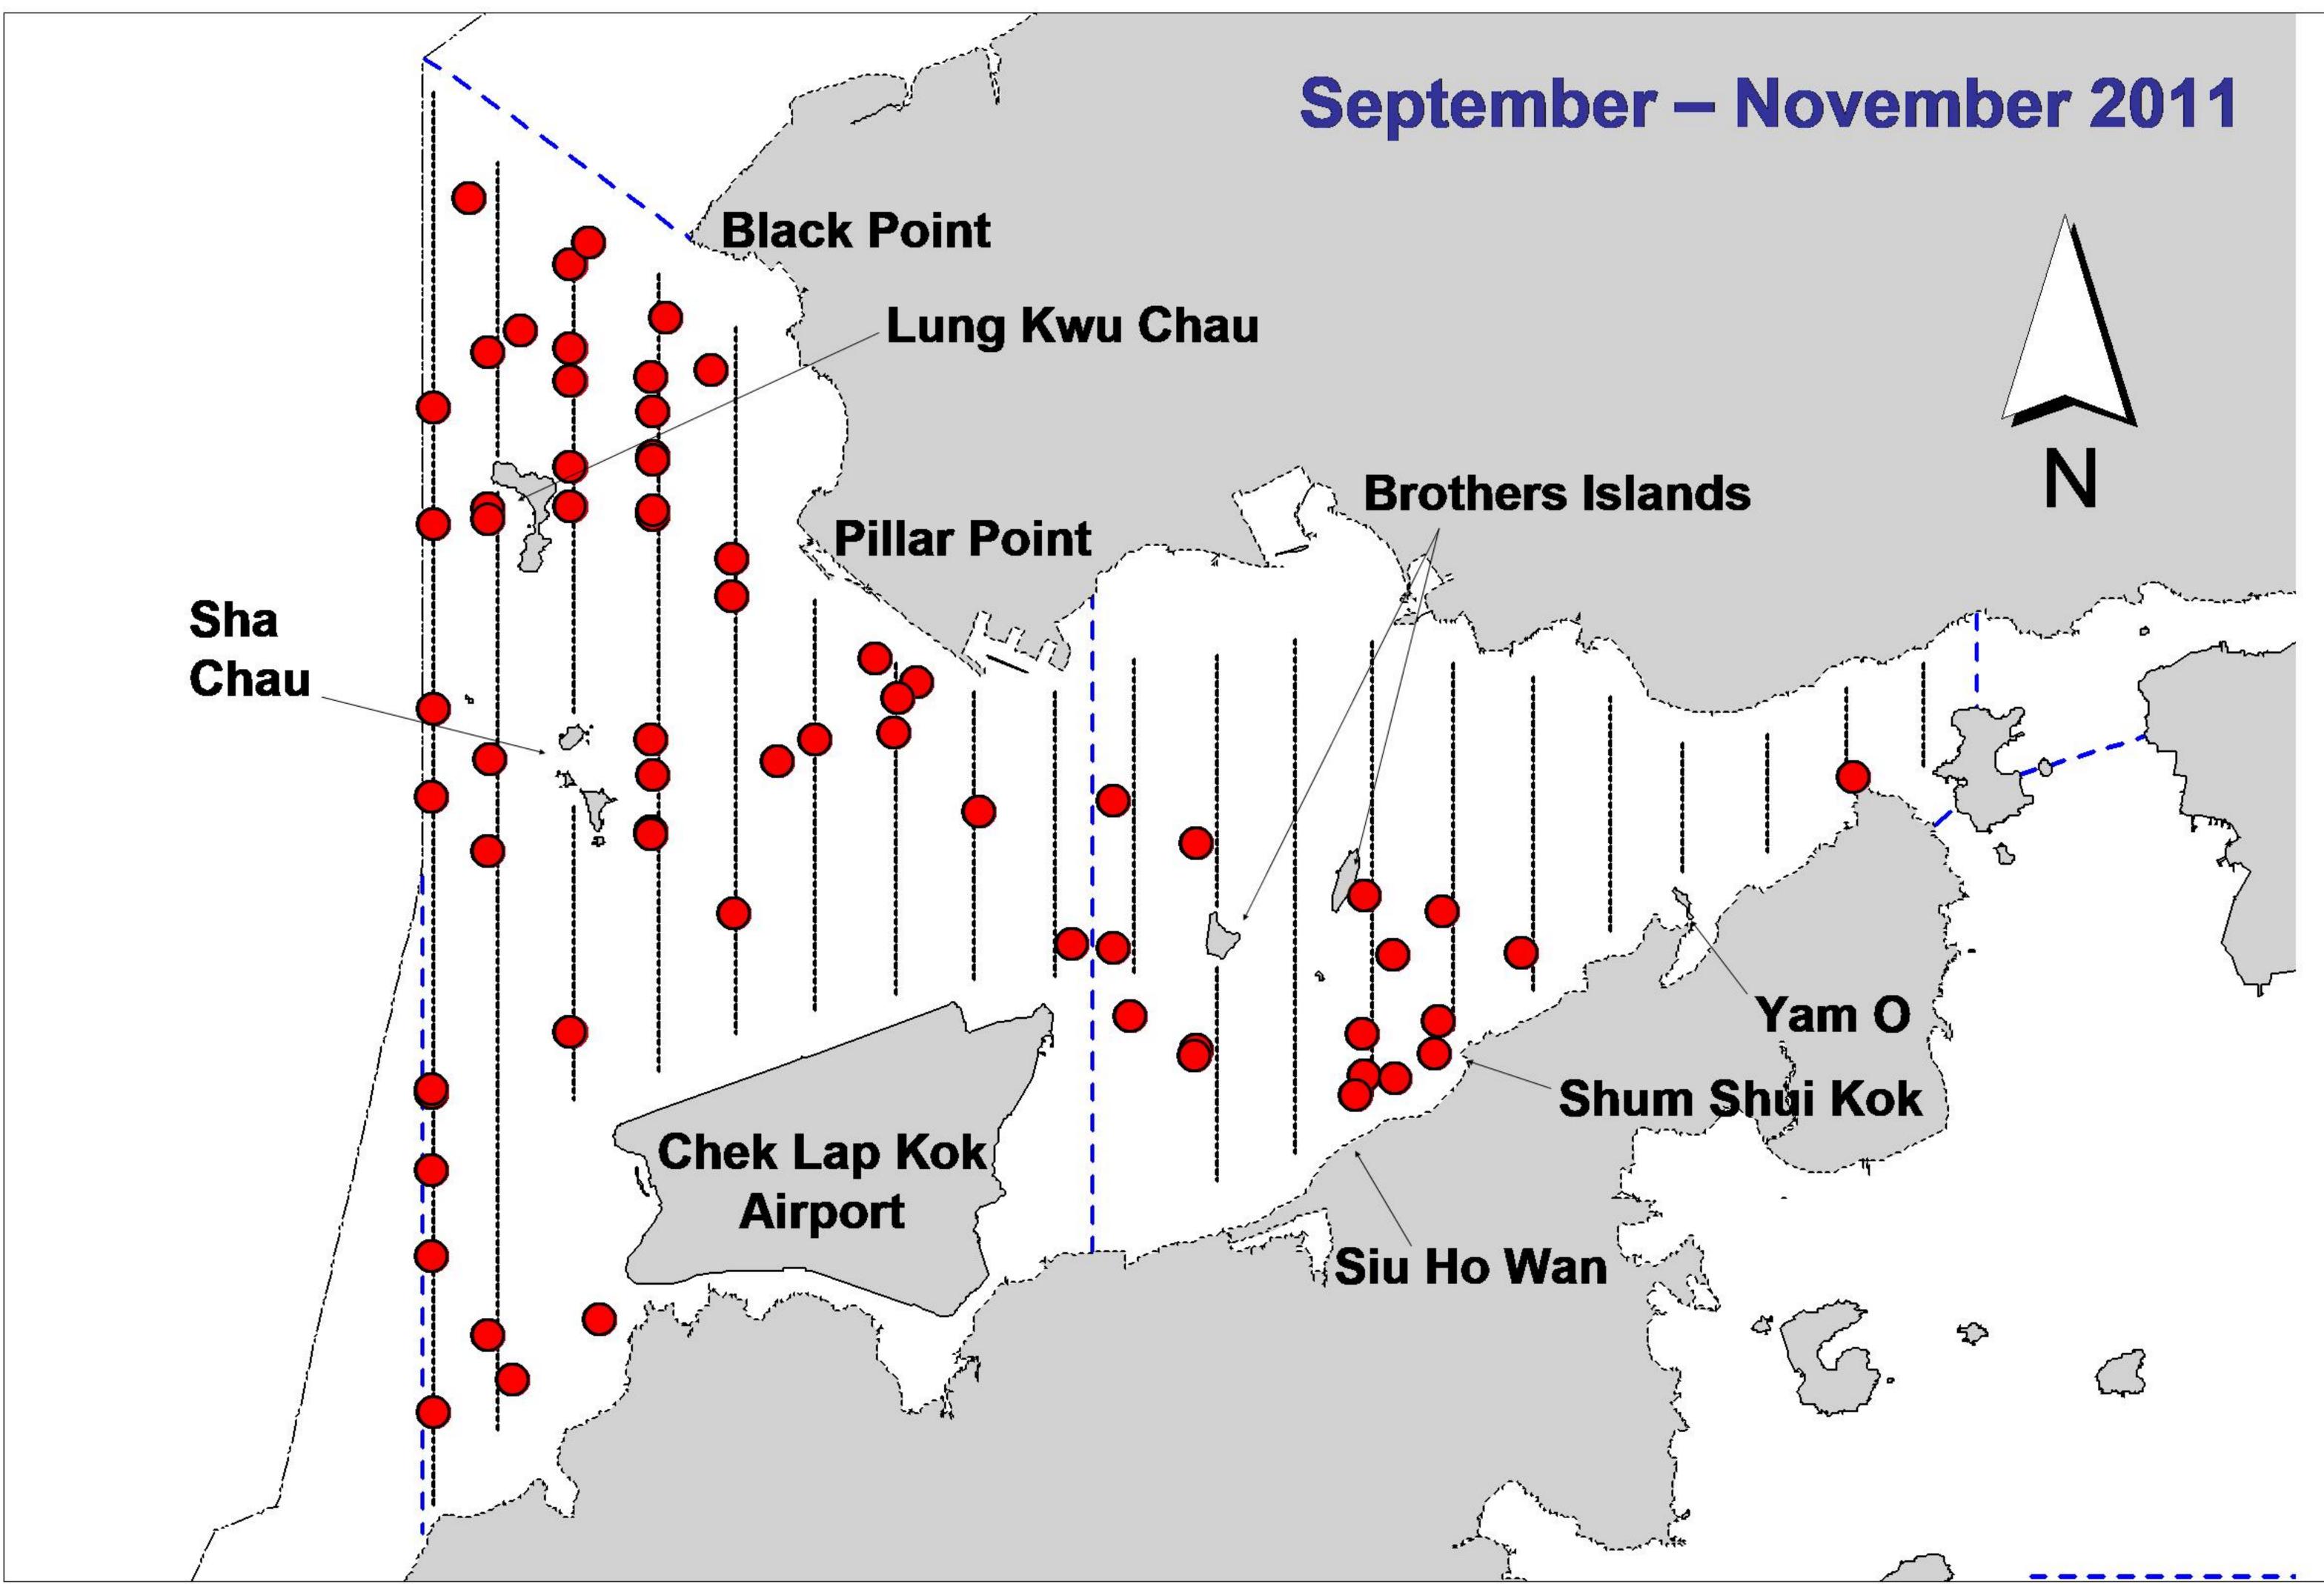
Figure 1. Distribution of Chinese white dolphin sightings in Northwest and Northeast Lantau during HKLR03 monitoring surveys (top) and baseline monitoring surveys (bottom)

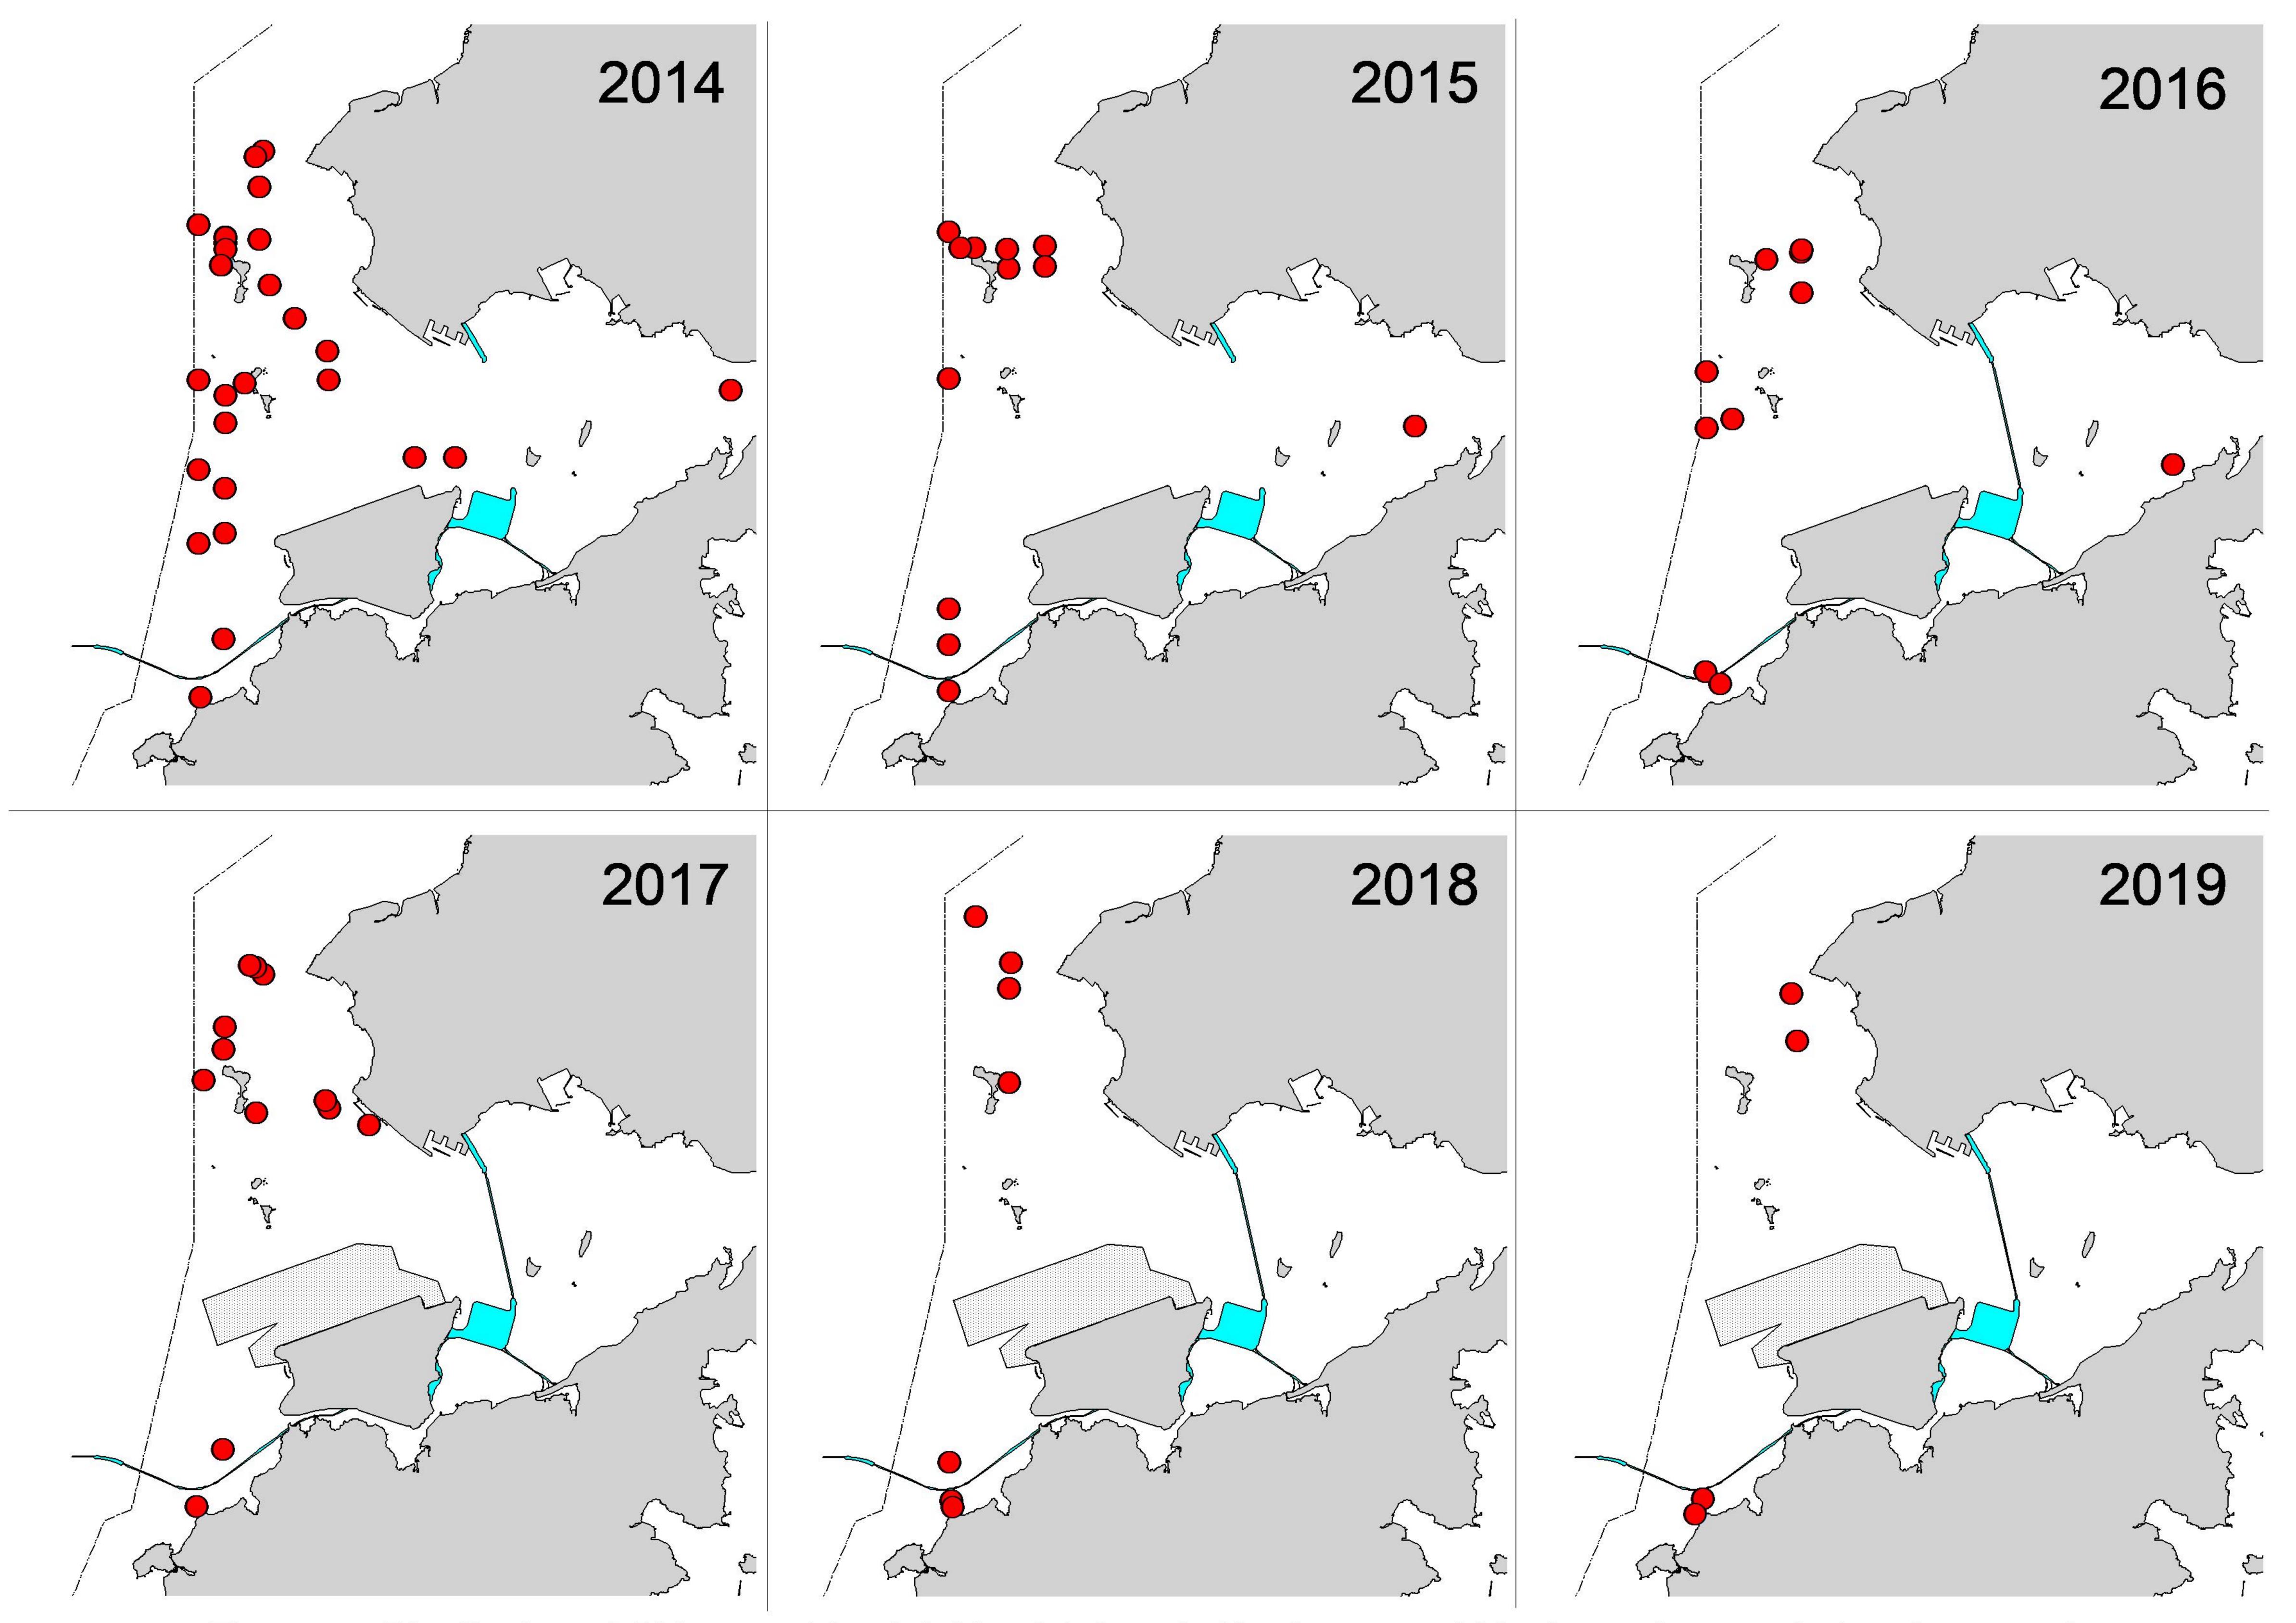
Figure 2. Distribution of Chinese white dolphin sightings in Northwest and Northeast Lantau during the past six summer quarters (June-August) of HKLR03 monitoring period in 2014-19

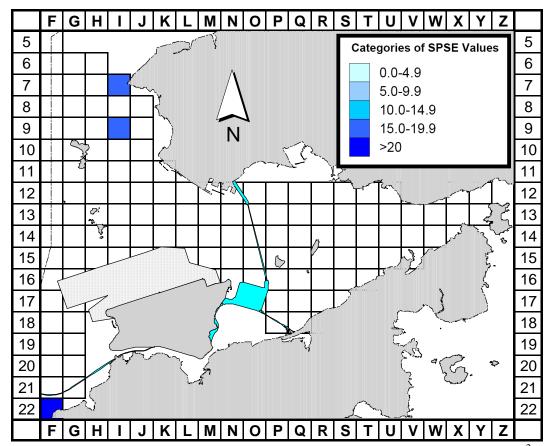
Figure 3a. Sighting density of Chinese white dolphins with corrected survey effort per km<sup>2</sup> in Northeast and Northwest Lantau survey areas, using data collected during HKLR03 impact monitoring period monitoring period (June-August 19) (SPSE = no. of on-effort sightings per 100 units of survey effort)

- 3.5.1. During the present quarter, the quantitative grid analysis revealed that only three grids recorded dolphin occurrences, and the only grid with moderately high dolphin density was located near Black Point (Figures 3a and 3b). On the contrary, the other two grids only recorded moderately low dolphin densities. However, it should be emphasized that the amount of survey effort collected in each grid during the three-month period was fairly low (6-12 units of survey effort for most grids), and therefore the habitat use pattern derived from the three-month dataset should be treated with caution. A more complete picture of dolphin habitat use pattern should be examined when more survey effort for each grid will be collected throughout the post-construction monitoring programme.

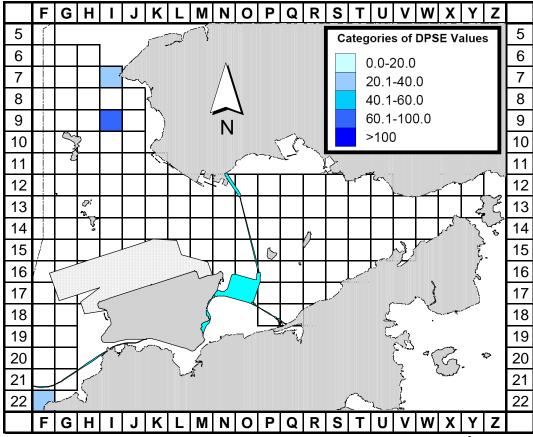
Figure 3b. Density of Chinese white dolphins with corrected survey effort per km<sup>2</sup> in Northeast and Northwest Lantau survey areas, using data collected during HKLR03 impact monitoring period (June-August 19) (DPSE = no. of dolphins per 100 units of survey effort)

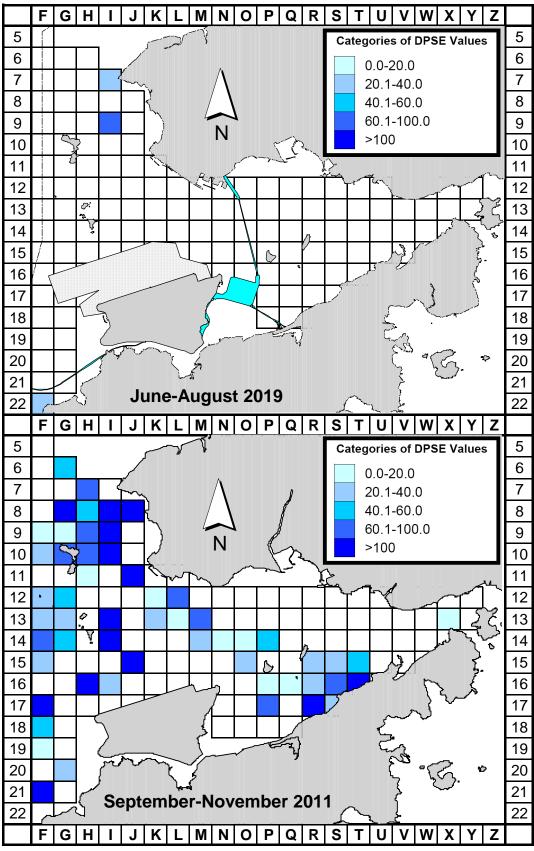
Figure 4. Comparison of density of Chinese white dolphins with corrected survey effort per km<sup>2</sup> in Northwest and Northeast Lantau survey area between the impact monitoring period (June - August 2019) and baseline monitoring period (September-November 2011) (DPSE = no. of dolphins per 100 units of survey effort)

- 3.5.2. When compared with the habitat use patterns during the baseline period, dolphin usage in NEL and NWL has drastically diminished in both areas during the present monitoring period (Figure 4). During the baseline period, many grids between Siu Mo To and Shum Shui Kok in NEL recorded moderately high to high dolphin densities, but the dolphins have completely disappeared from this area during the present quarterly period (Figure 4).

- 3.5.3. Moreover, the dolphin density patterns were also very different in NWL between the baseline and present post-construction monitoring periods, with high usage throughout the area during the baseline period, while only one grid with moderately high dolphin density was located near Black Point during the present quarterly period in the post-construction phase (Figure 4).

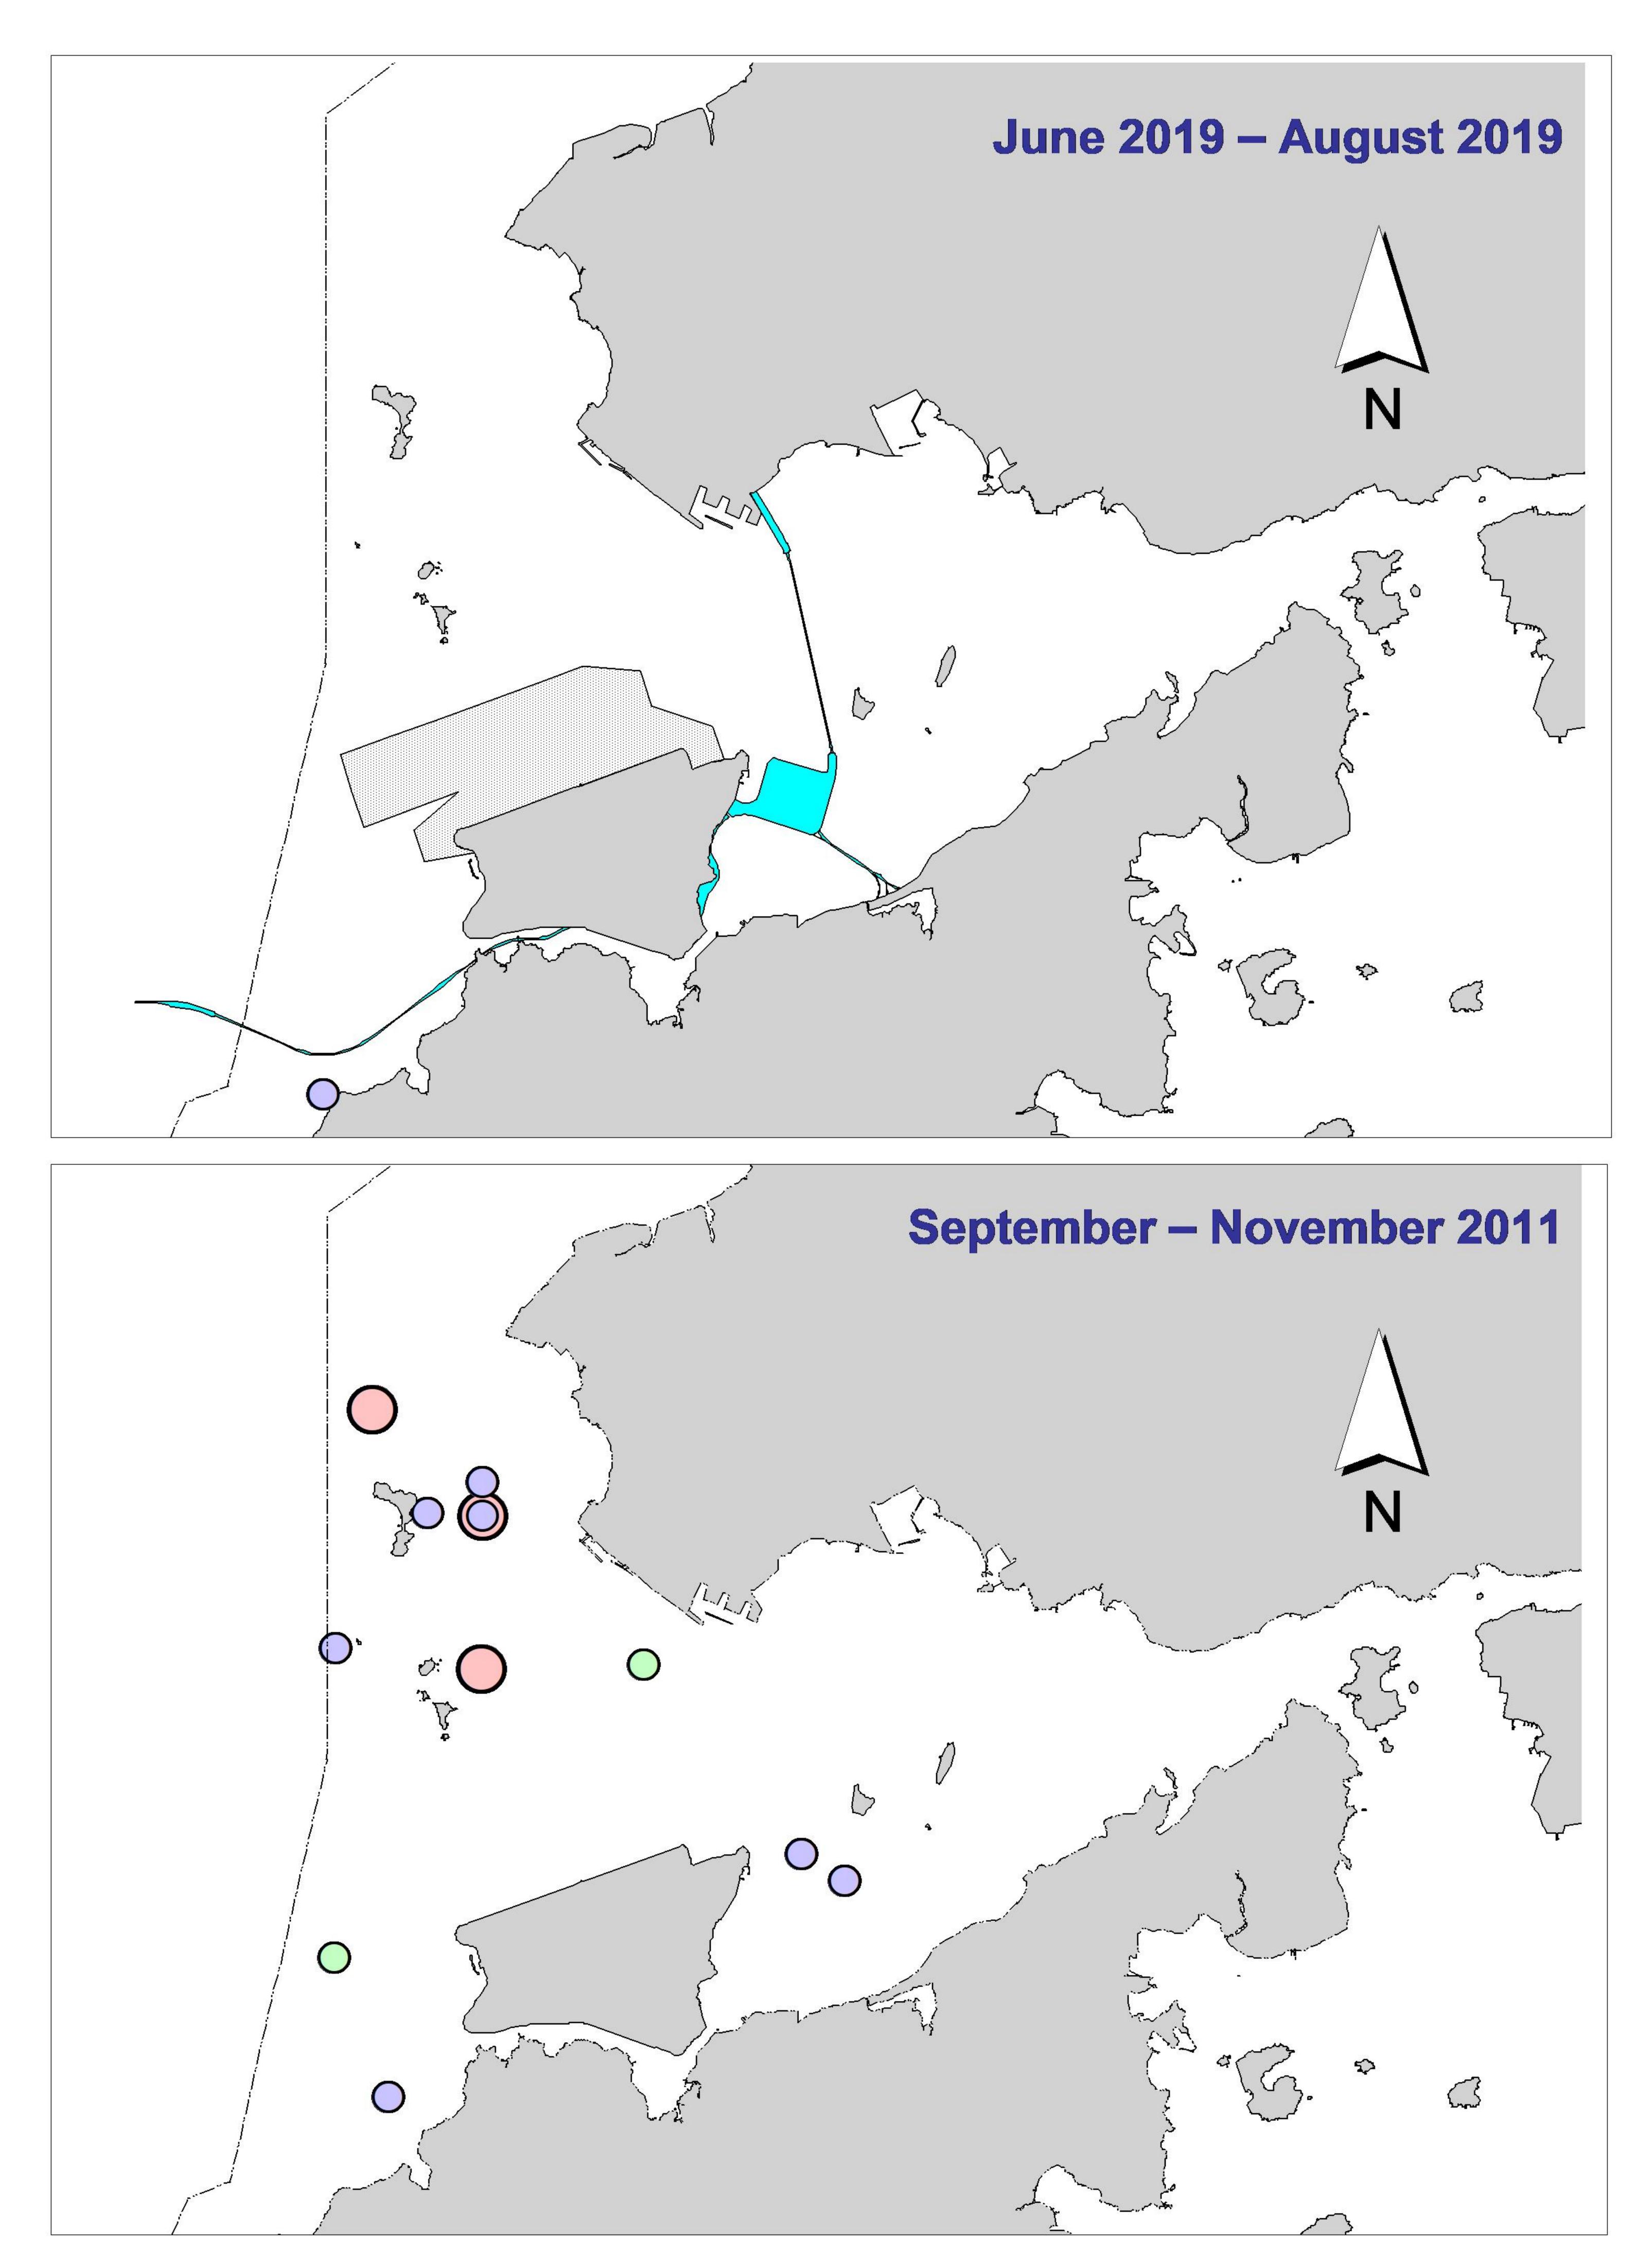
Figure 5. Distribution of Chinese white dolphins engaged in feeding (purple dots), socializing (pink dots) and traveling (green dots) activities during HKLR03 monitoring surveys (top) and baseline monitoring surveys (bottom)

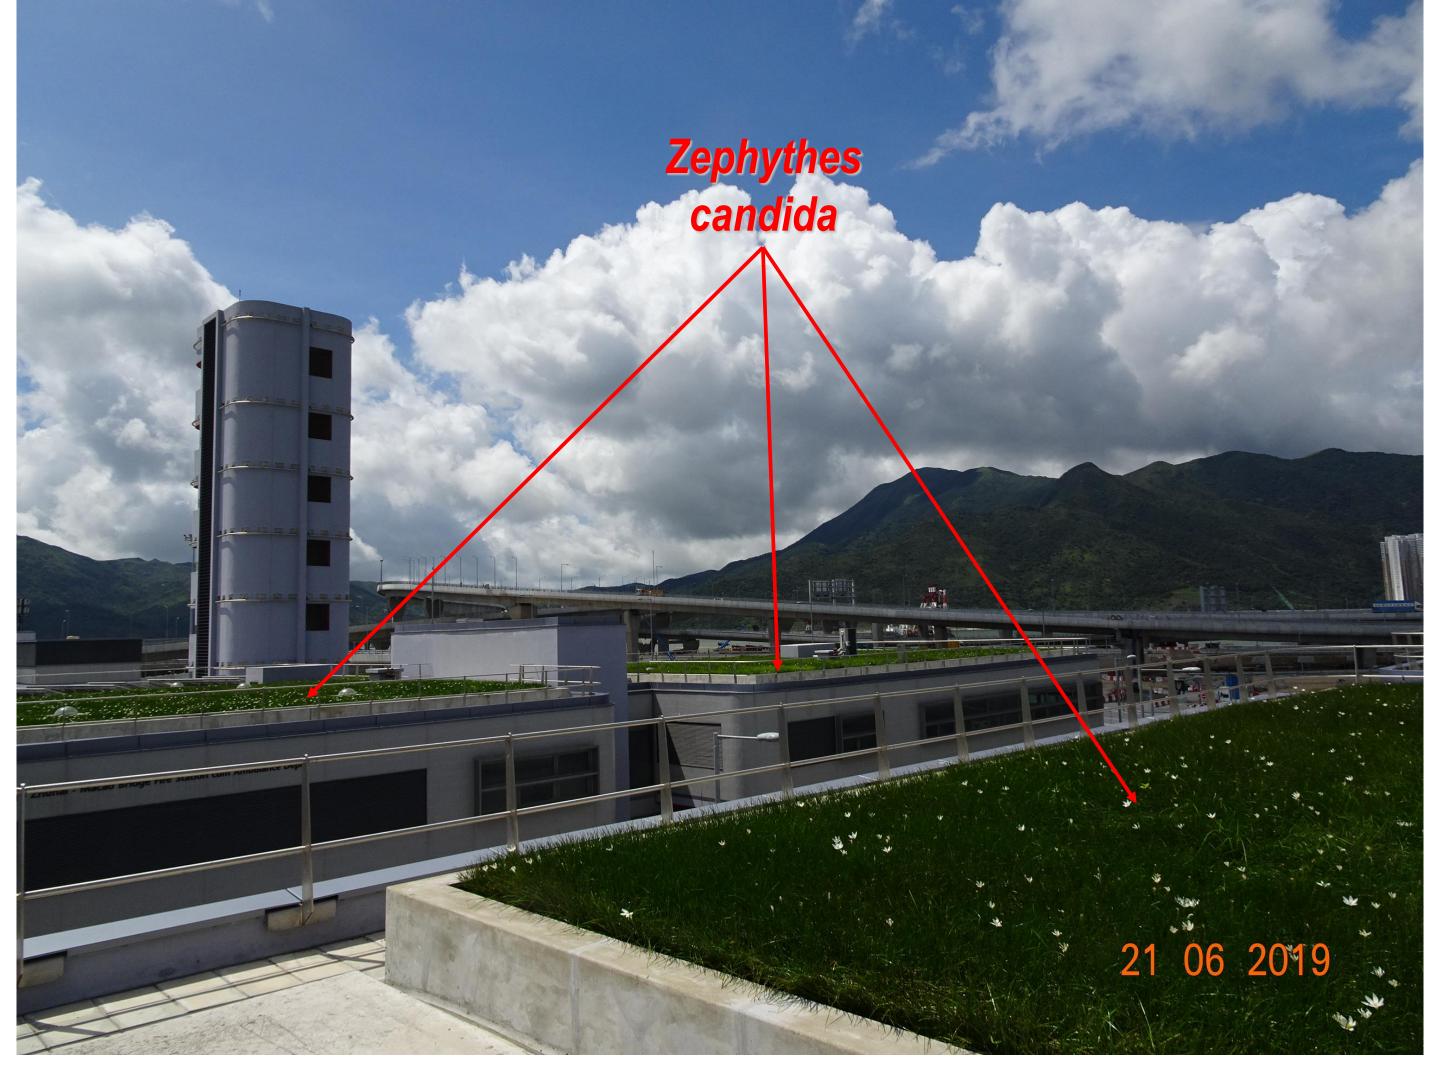
Photo 1: Portion A1+A2+Q (1)

Remarks / Recommendations for Contractor						
Date of Site Audit: 21 / 06 / 2019						
	Observation and/or Recommended Measures:					
No particular tinding						
Target Date of Completion:	N/A					
	/ - 1					
Signatures:						
	Name	Signature				
ET's Representative	Vincent Lu	th				
Contractor's Representative	Marko CHAM	R				
		C21
