Contract No. HY/2011/03

**Hong Kong-Zhuhai-Macao Bridge Hong Kong Link Road
Section between Scenic Hill and Hong Kong Boundary Crossing
Facilities**

Monthly EM&A Report No.152 (May 2025)

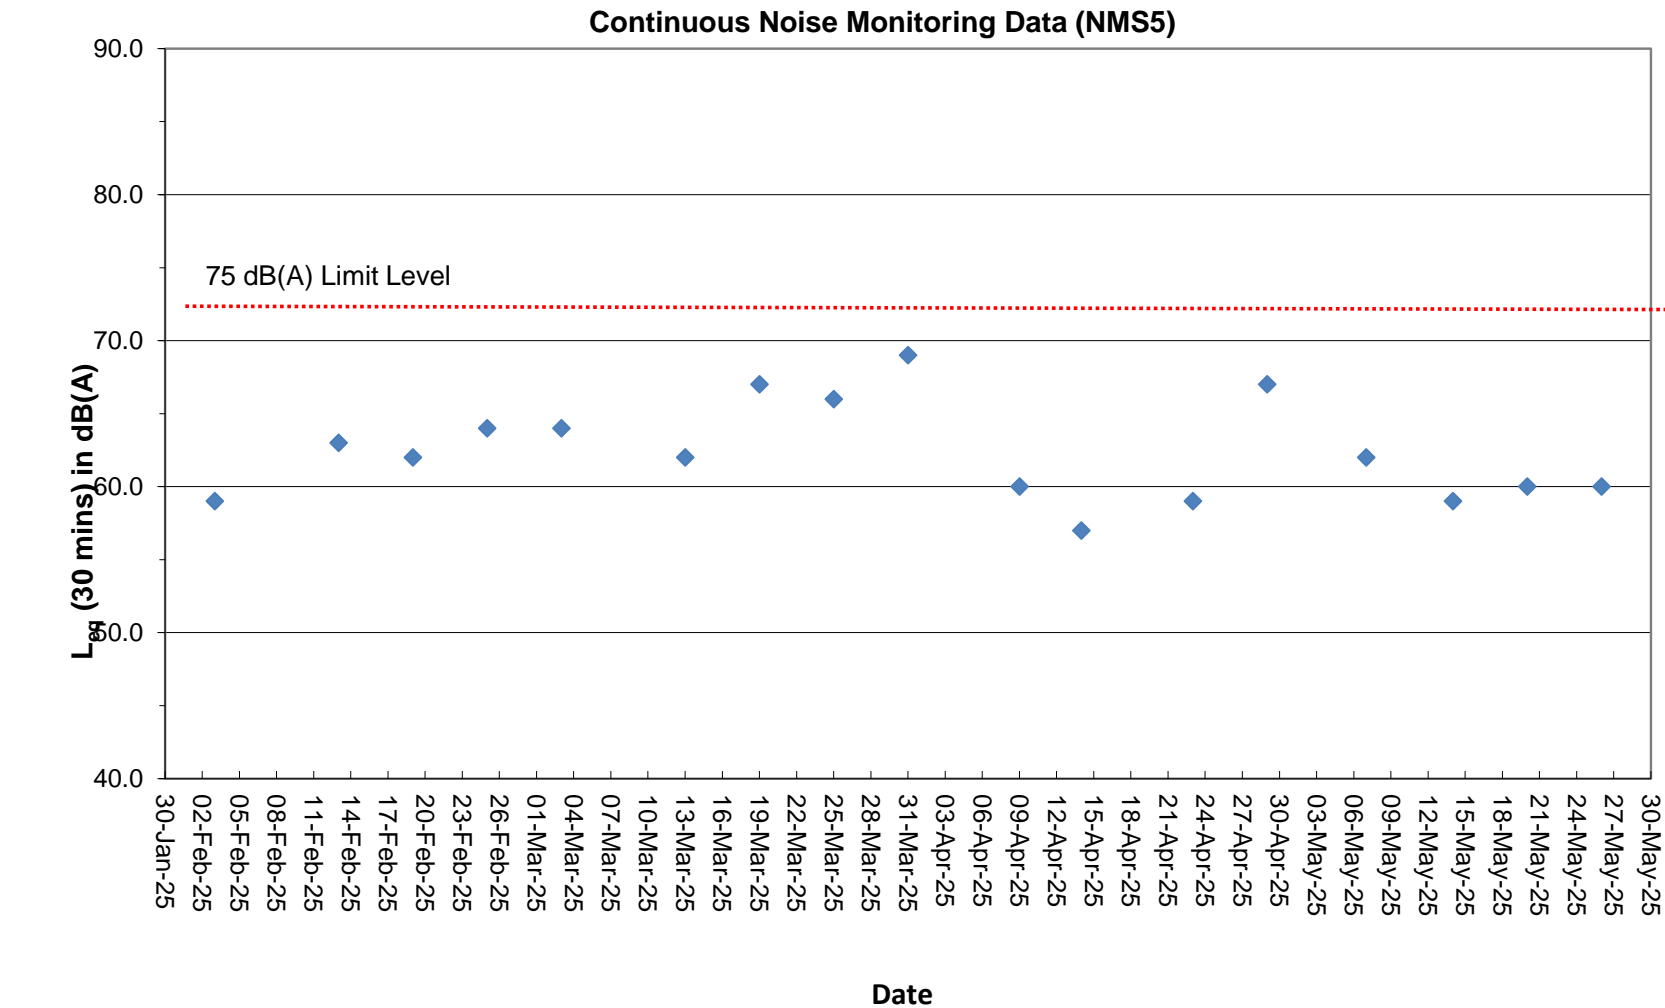
Graphical Plot of Noise Levels at NMS5

Remarks:
(1) A free field correction of +3 dB(A) was applied to the measured noise level.
