Contract No. HY/2011/03

Hong Kong-Zhuhai-Macao Bridge Hong Kong Link Road Section between Scenic Hill and Hong Kong Boundary Crossing Facilities

Monthly EM&A Report No.155 (August 2025)

10 September 2025

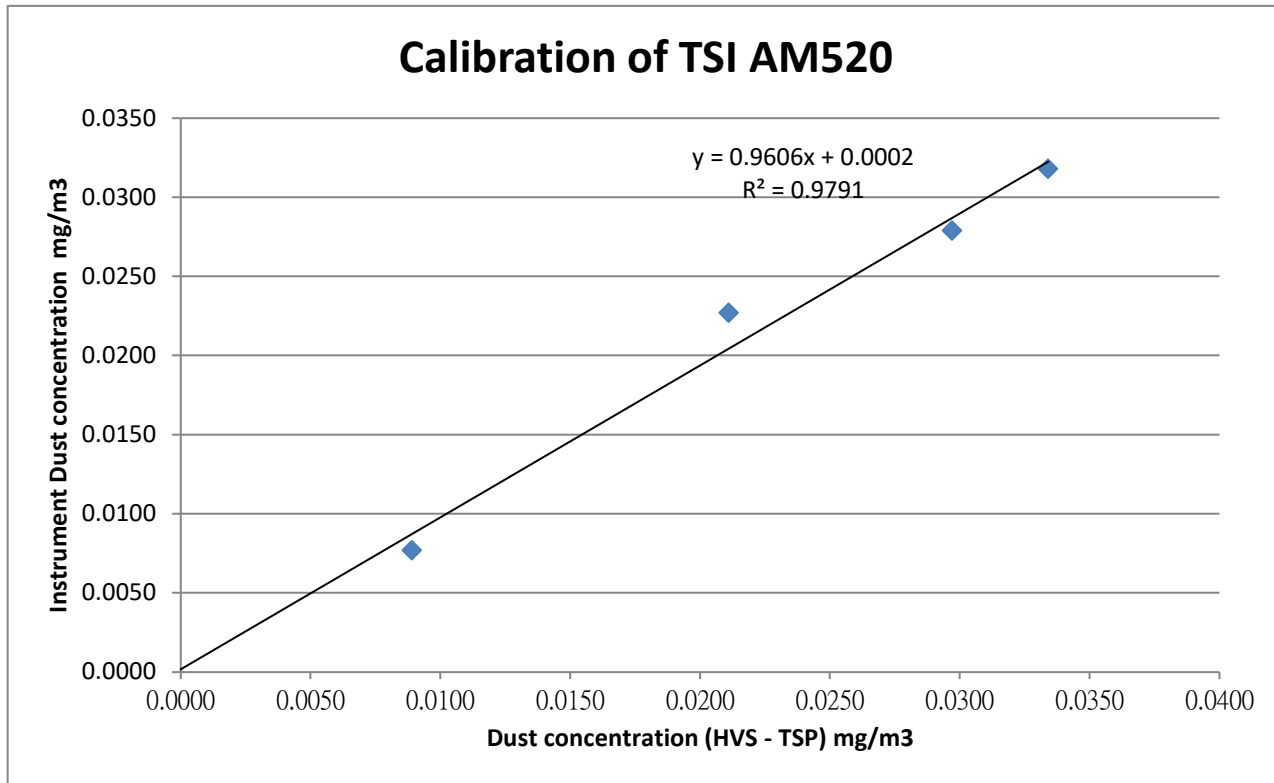
HVS - TSP (mg/m ³)	0.0334	0.0297	0.0089	0.0211
TSI AM520 (mg/m ³)	0.0318	0.0279	0.0077	0.0227

K Factor :	0.9606
Correlation Coefficient :	0.9791

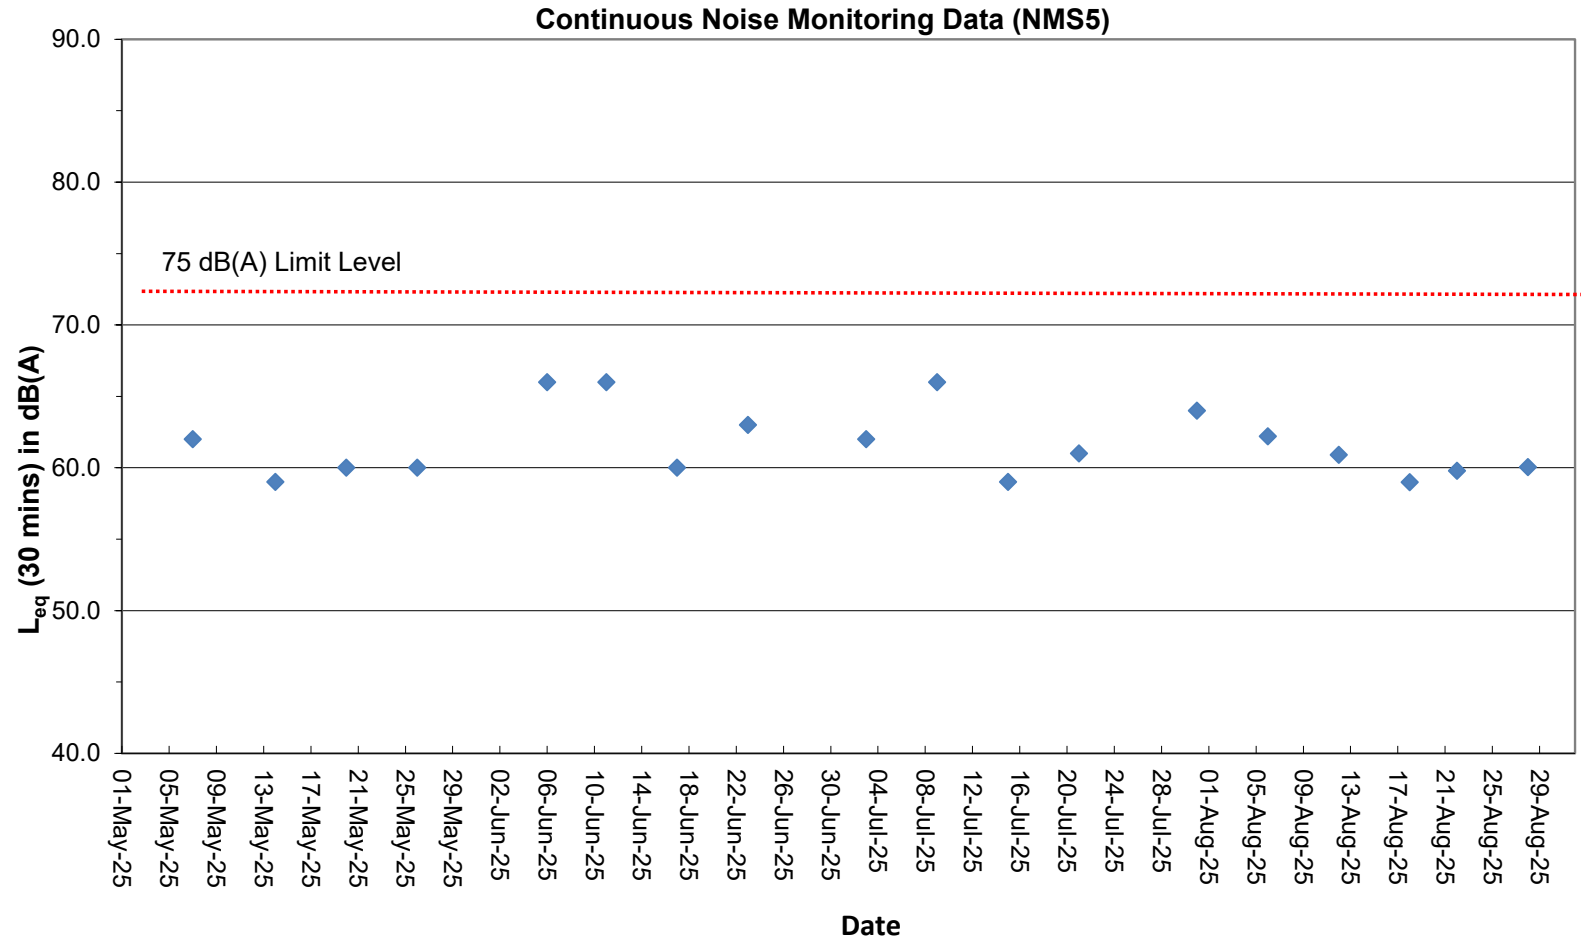
Graphical Plot of Noise Levels at NMS5

(1) A free field correction of +3 dB(A) was applied to the measured noise level.
