Dragages -China Harbour-VSL JV

Contract HY/2011/09
Hong Kong-Zhuhai-Macao Bridge
Hong Kong Link Road-Section between
HKSAR Boundary and Scenic Hill
Monthly EM&A Report
February 2014
(Version 1.0)

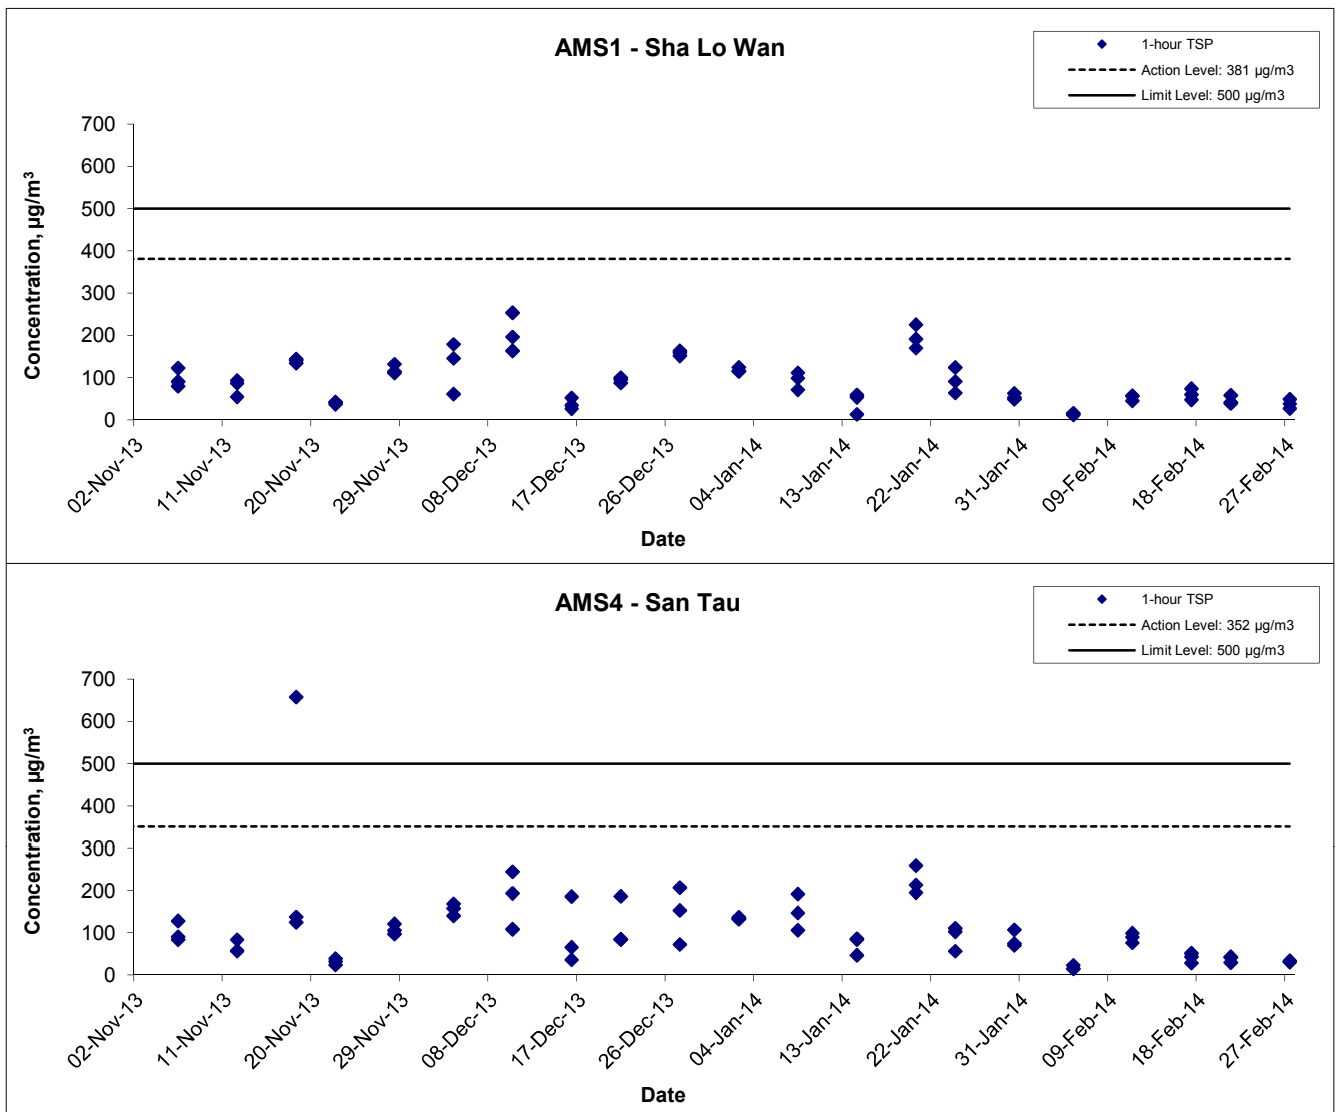
Title Contract No. HY/2011/09 Hong Kong-Zhuhai-Macao Bridge Hong Kong Link Road – Section between HKSAR Boundary and Scenic Hill Graphical Presentation of 1-hour TSP Monitoring Results	Scale N.T.S	Project No. MA12014

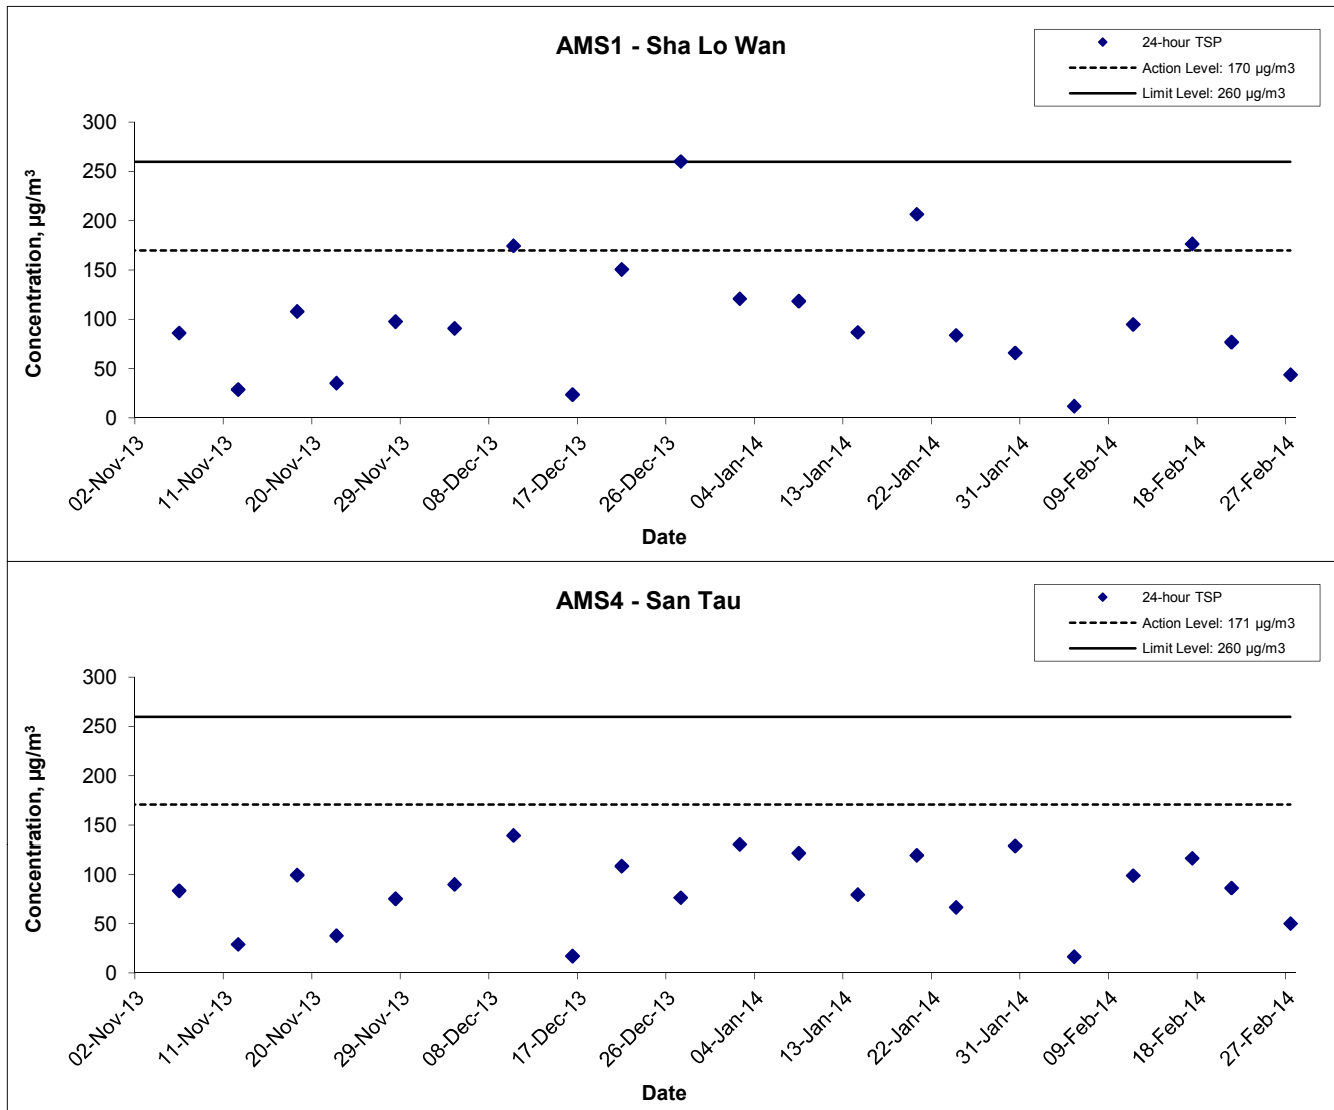
Title Contract No. HY/2011/09 Hong Kong-Zhuhai-Macao Bridge Hong Kong Link Road – Section between HKSAR Boundary and Scenic Hill Graphical Presentation of 24-hour TSP Monitoring Results	Scale N.T.S	Project No. MA12014	
	Date Feb 14	Appendix F

- 8.3 For 24-hour TSP monitoring, no Limit Level exceedance was recorded. One Action Level exceedance was recorded at AMS1 on 17 February 2014.
- 8.4 According to the investigation, no dust generation works was conducted at near the monitoring station during the monitoring and observable dust source from construction activity under Contract No. HY/2011/09. In addition, construction works from other site and stockpile of dusty materials without proper cover at near the monitoring station was observed. Therefore, the exceedance is considered not due to the Contract.

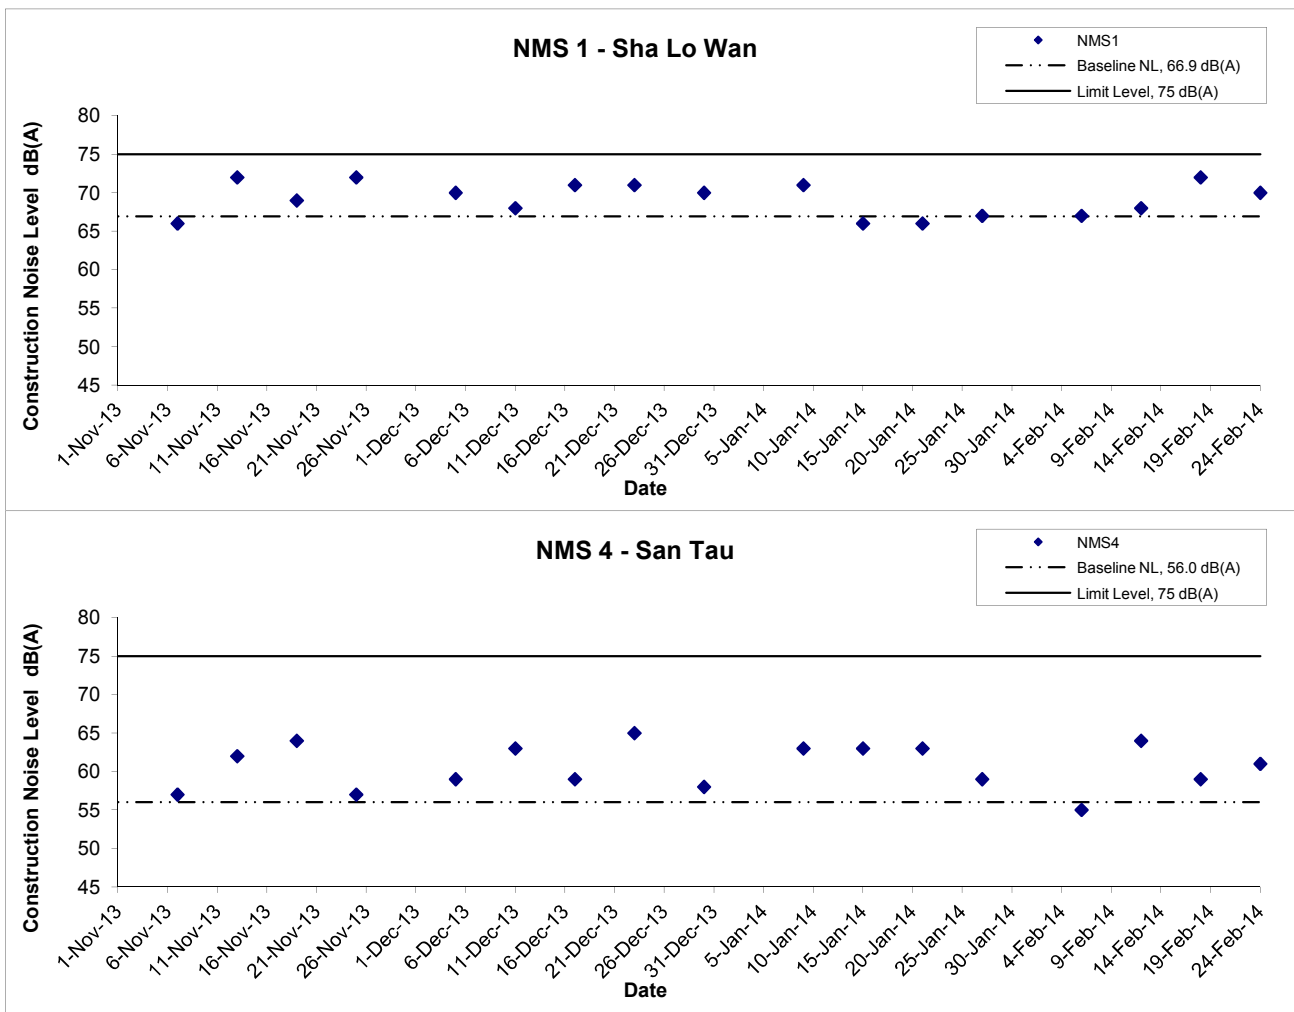
Title	Contract HY/2011/09 Hong Kong-Zhuhai-Macao Bridge Hong Kong Link Road-Section between HKSAR Boundary and Scenic Hill Graphical Presentation of Construction Noise Monitoring Results	Scale	Project No.	CINOTECH
		N.T.S	MA12014	
		Date	Appendix	
		Feb 14	G

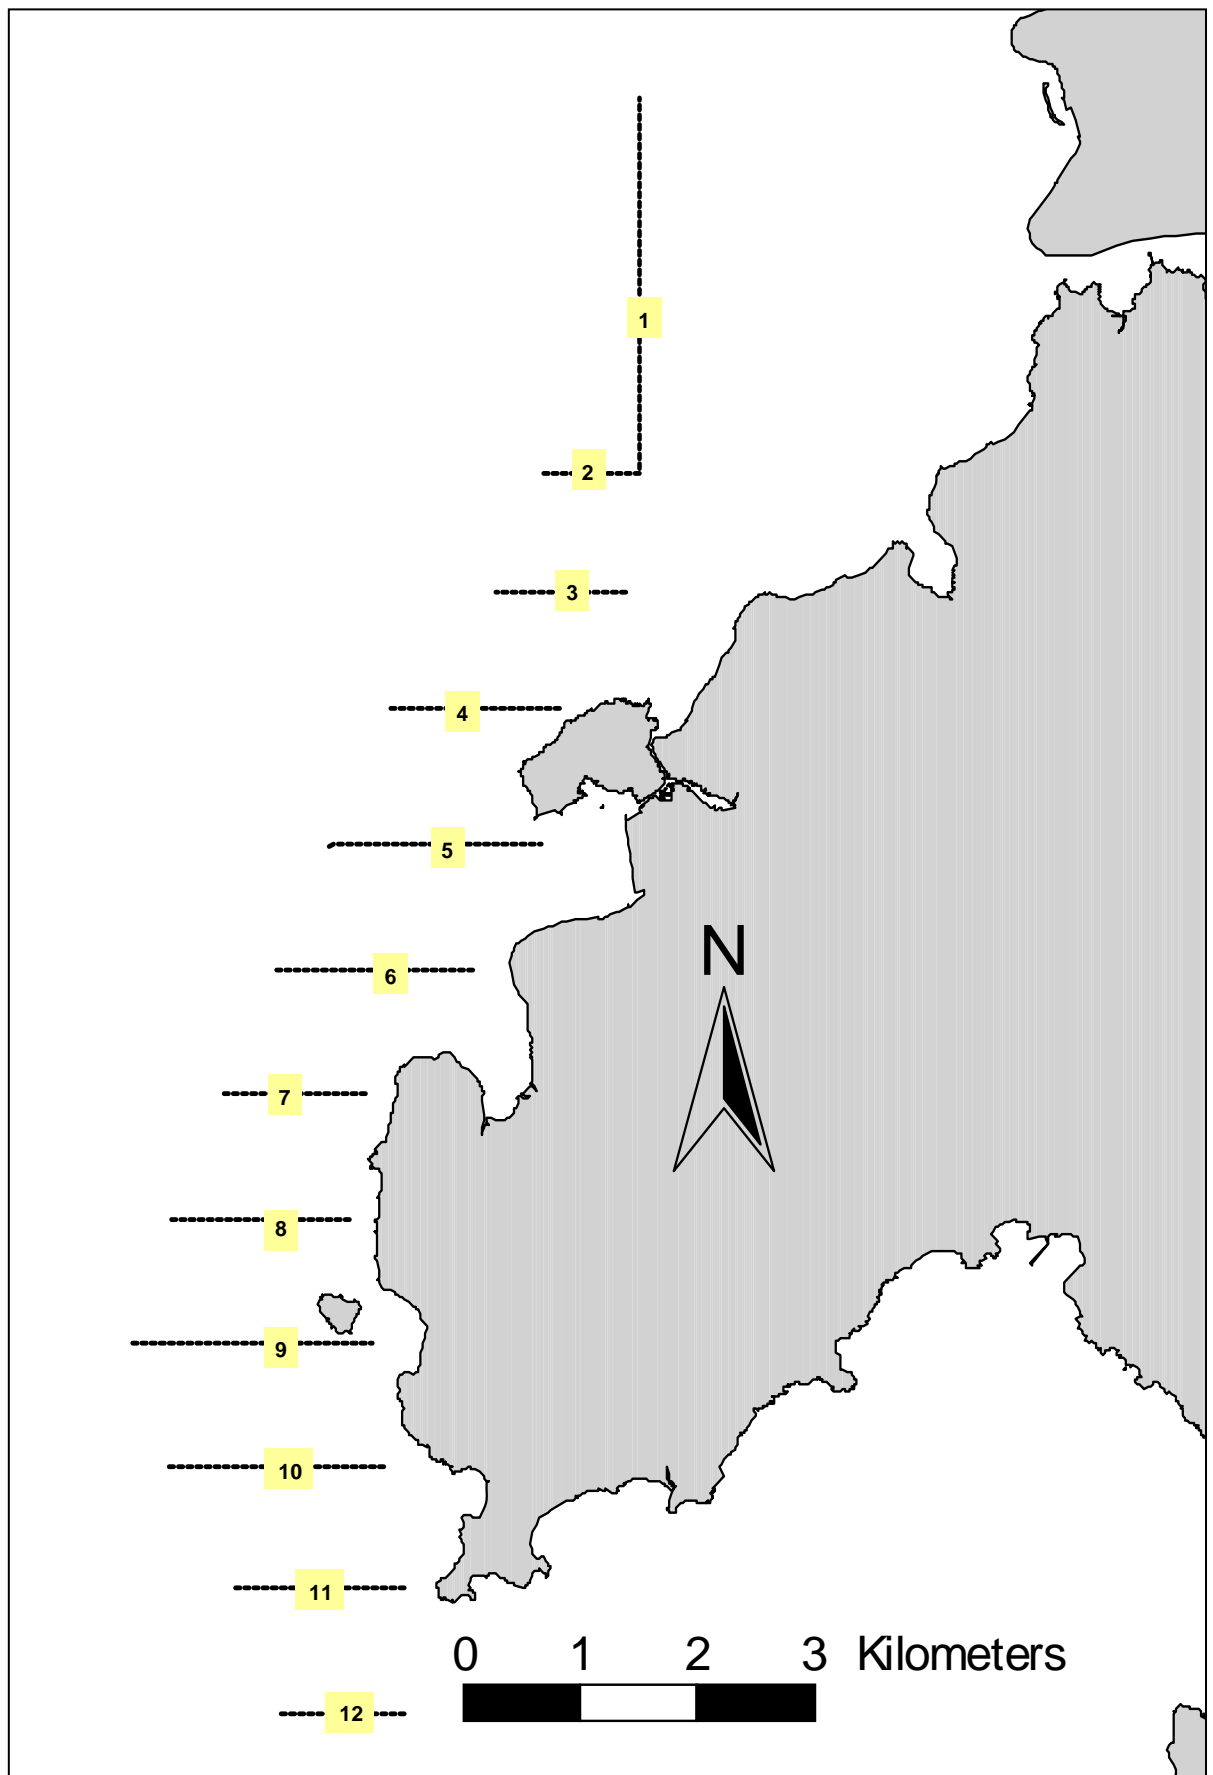
Figure 1. Transect Line Layout in West Lantau Survey Areas

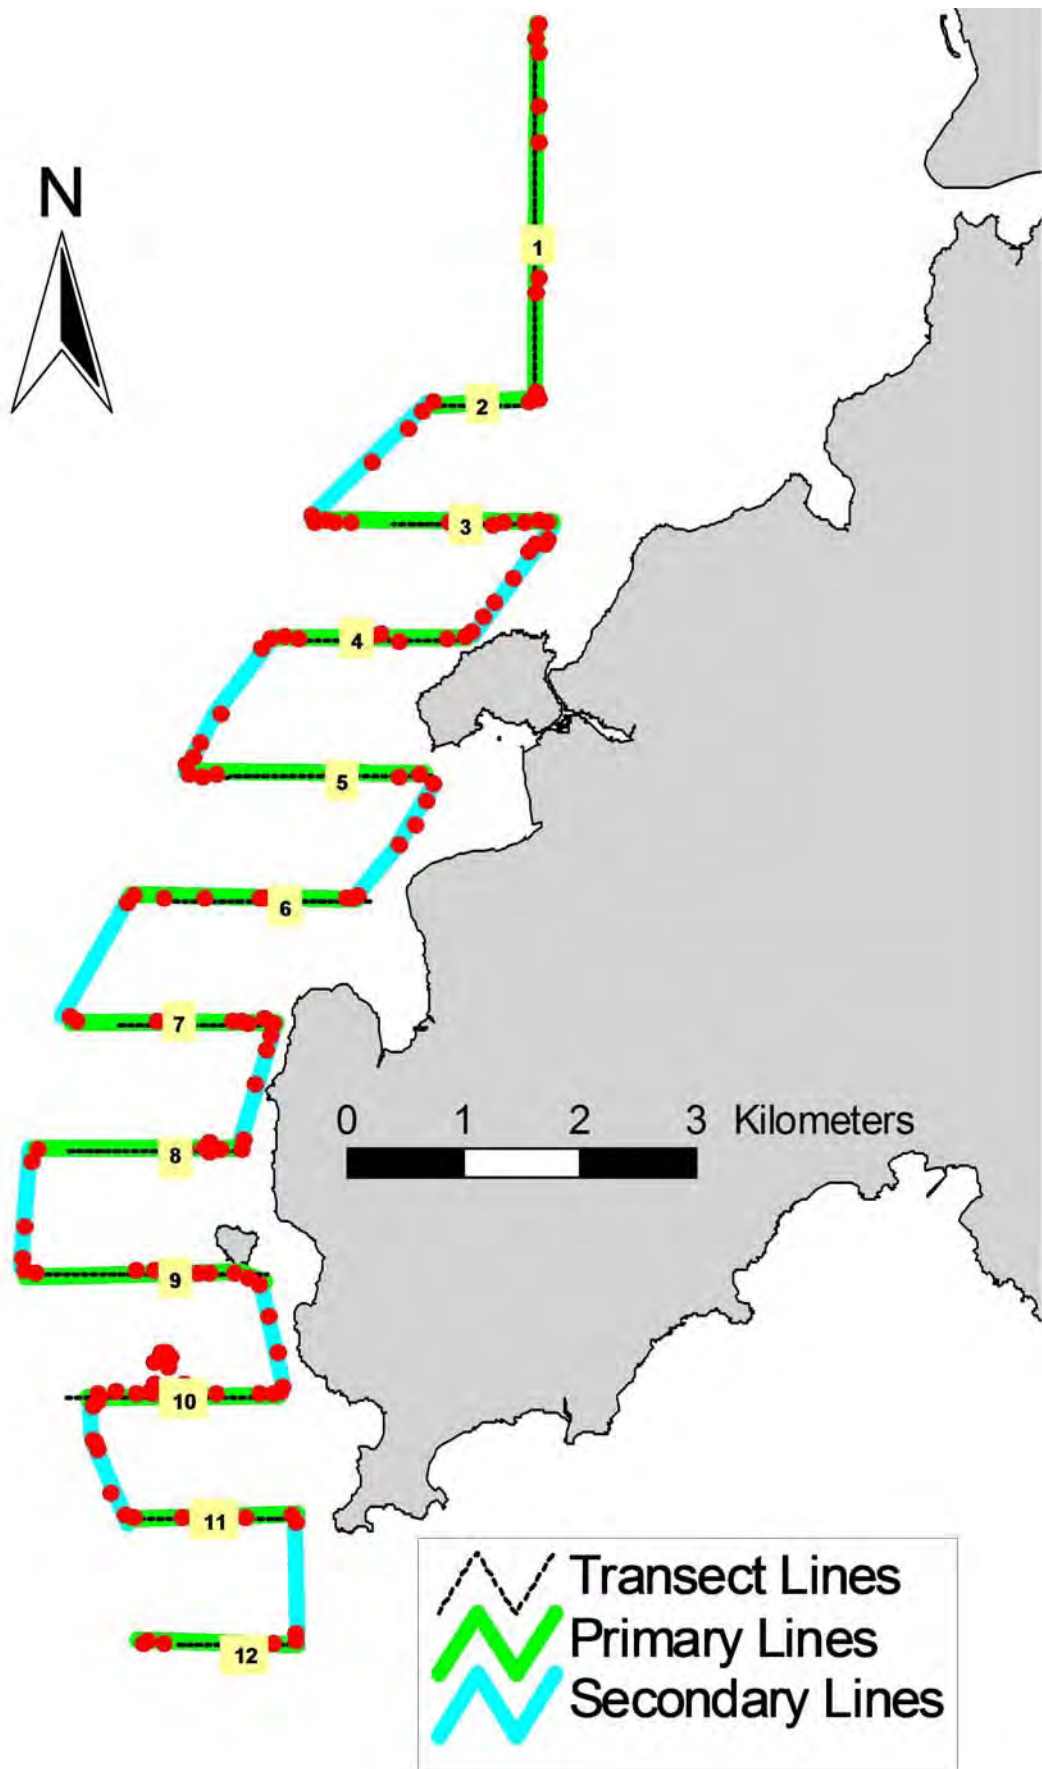
Figure 2. Survey Route on February 24th, 2014 (note: red dots represent the tracked positions of survey boat logged continuously by GPS throughout the course of the survey)

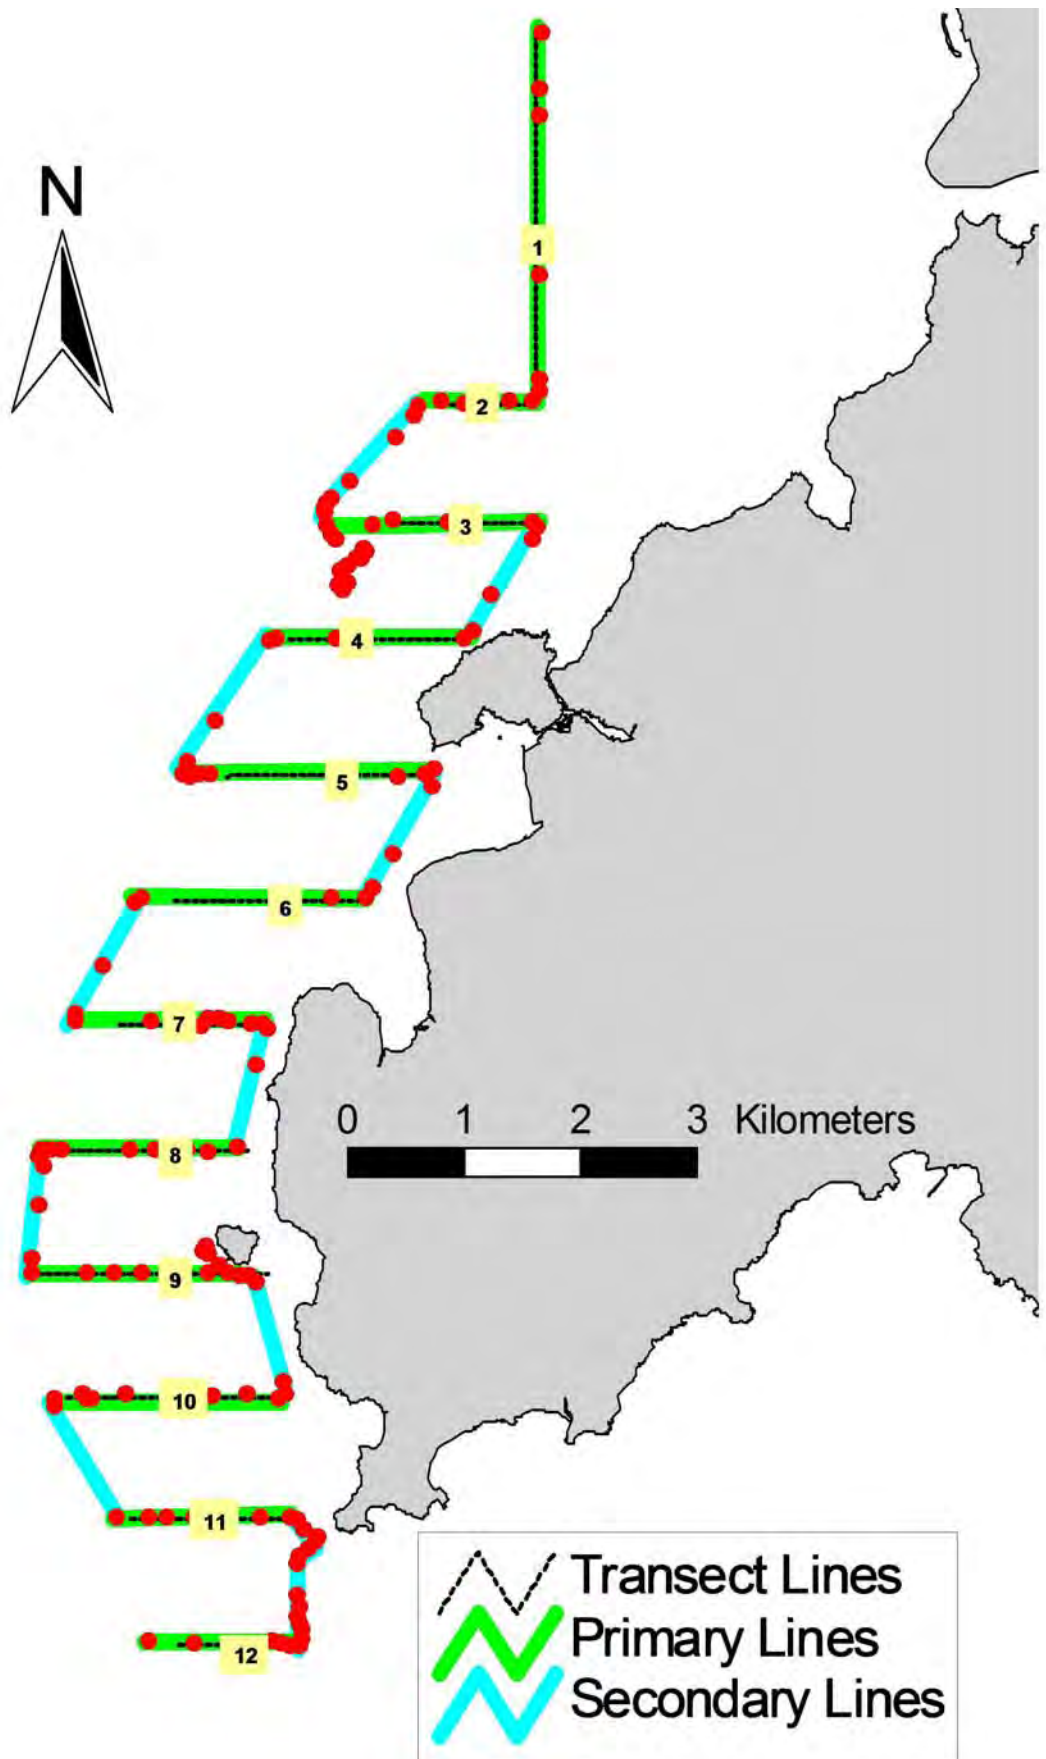
Figure 3. Survey Route on February 26th, 2014 (note: red dots represent the tracked positions of survey boat logged continuously by GPS throughout the course of the survey)

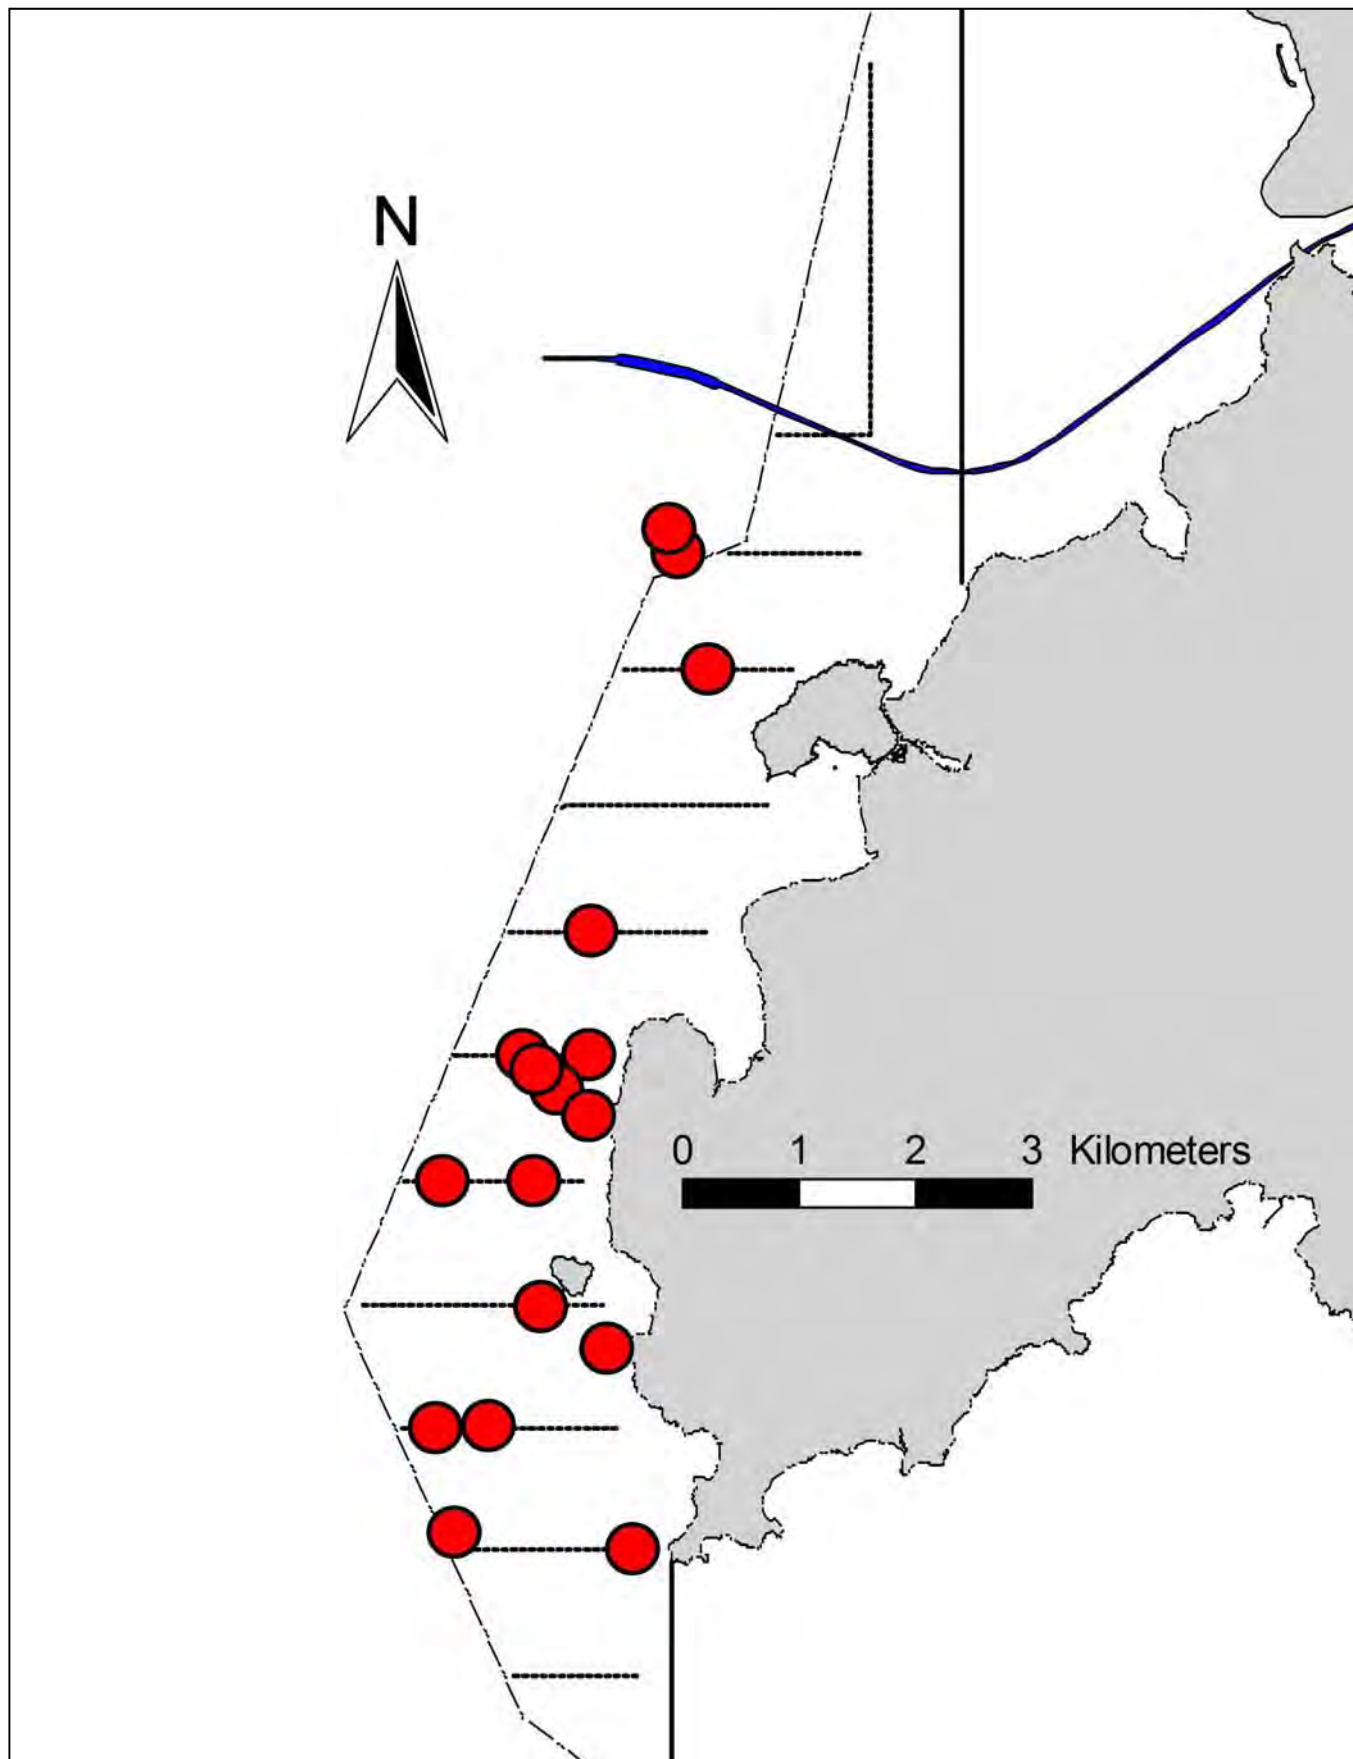
Figure 4. Distribution of Chinese White Dolphin Sighting during February 2014 HKLR09 Monitoring Surveys

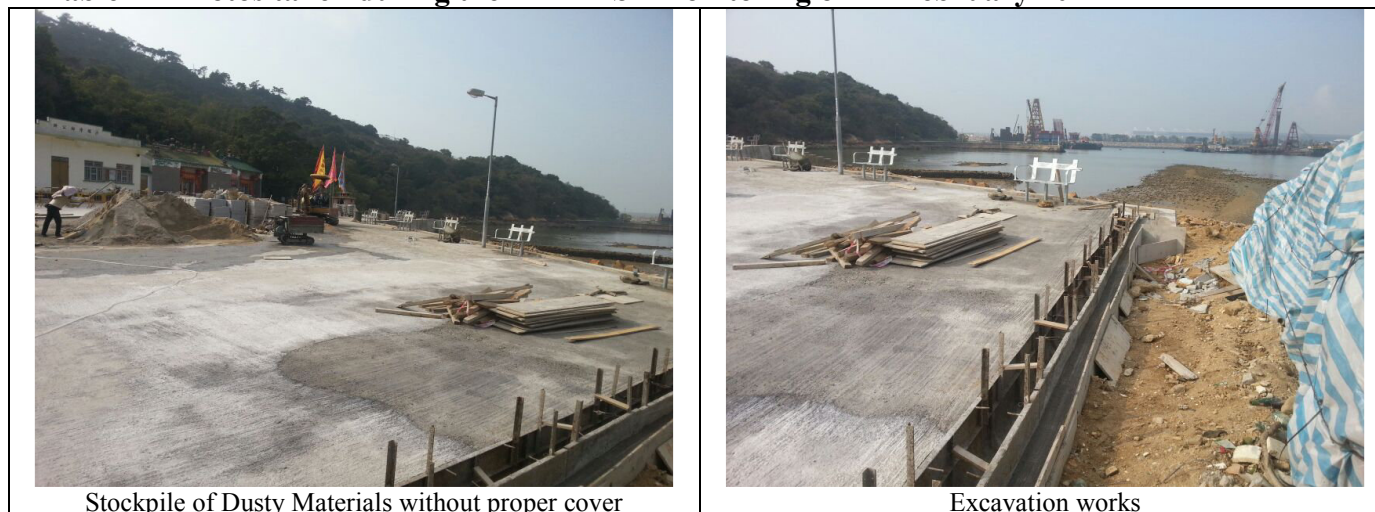
Stockpile of Dusty Materials without proper cover

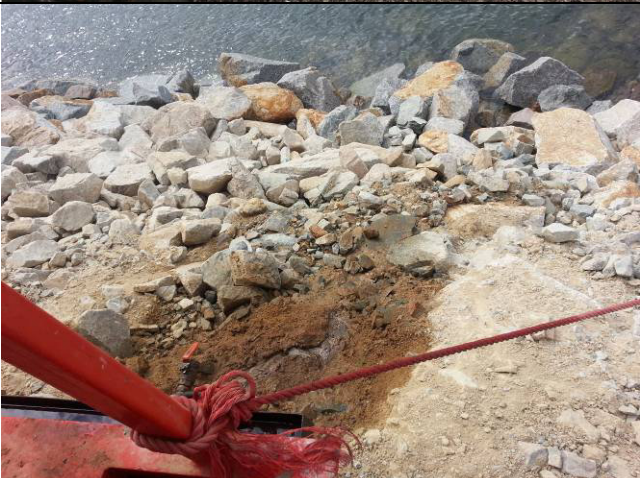
<p>Ref No: 140205-R03</p> <p>Impact: Waste / Chemical Management (F8)</p> <p>Details: Clear and avoid the oil leakage at P101.</p>

05/02/2014	Clear and avoid the oil leakage at P101.	Rectification/improvement was observed during the follow-up audit session on 11 February 2014.
Landscape & Visual Impact	N/A ⁽¹⁾	N/A ⁽¹⁾	N/A ⁽¹⁾
Permits/Licences	N/A ⁽¹⁾	N/A ⁽¹⁾	N/A ⁽¹⁾
Other	N/A ⁽¹⁾	N/A ⁽¹⁾	N/A ⁽¹⁾
Cultural Heritage (Sha Lo Wan (West) Archaeological Site)	N/A ⁽²⁾	N/A ⁽²⁾	N/A ⁽²⁾
