**Contract No. HY/2012/07
Tuen Mun – Chek Lap Kok Link –
Southern Connection Viaduct Section**

Fifty-first Monthly EM&A Report

13 February 2018

**Contract No. HY/2012/07 TM-CLKL Southern Connection Viaduct
Section
51st Monthly EM&A Report for January 2018 (EP-354/2009/D)**

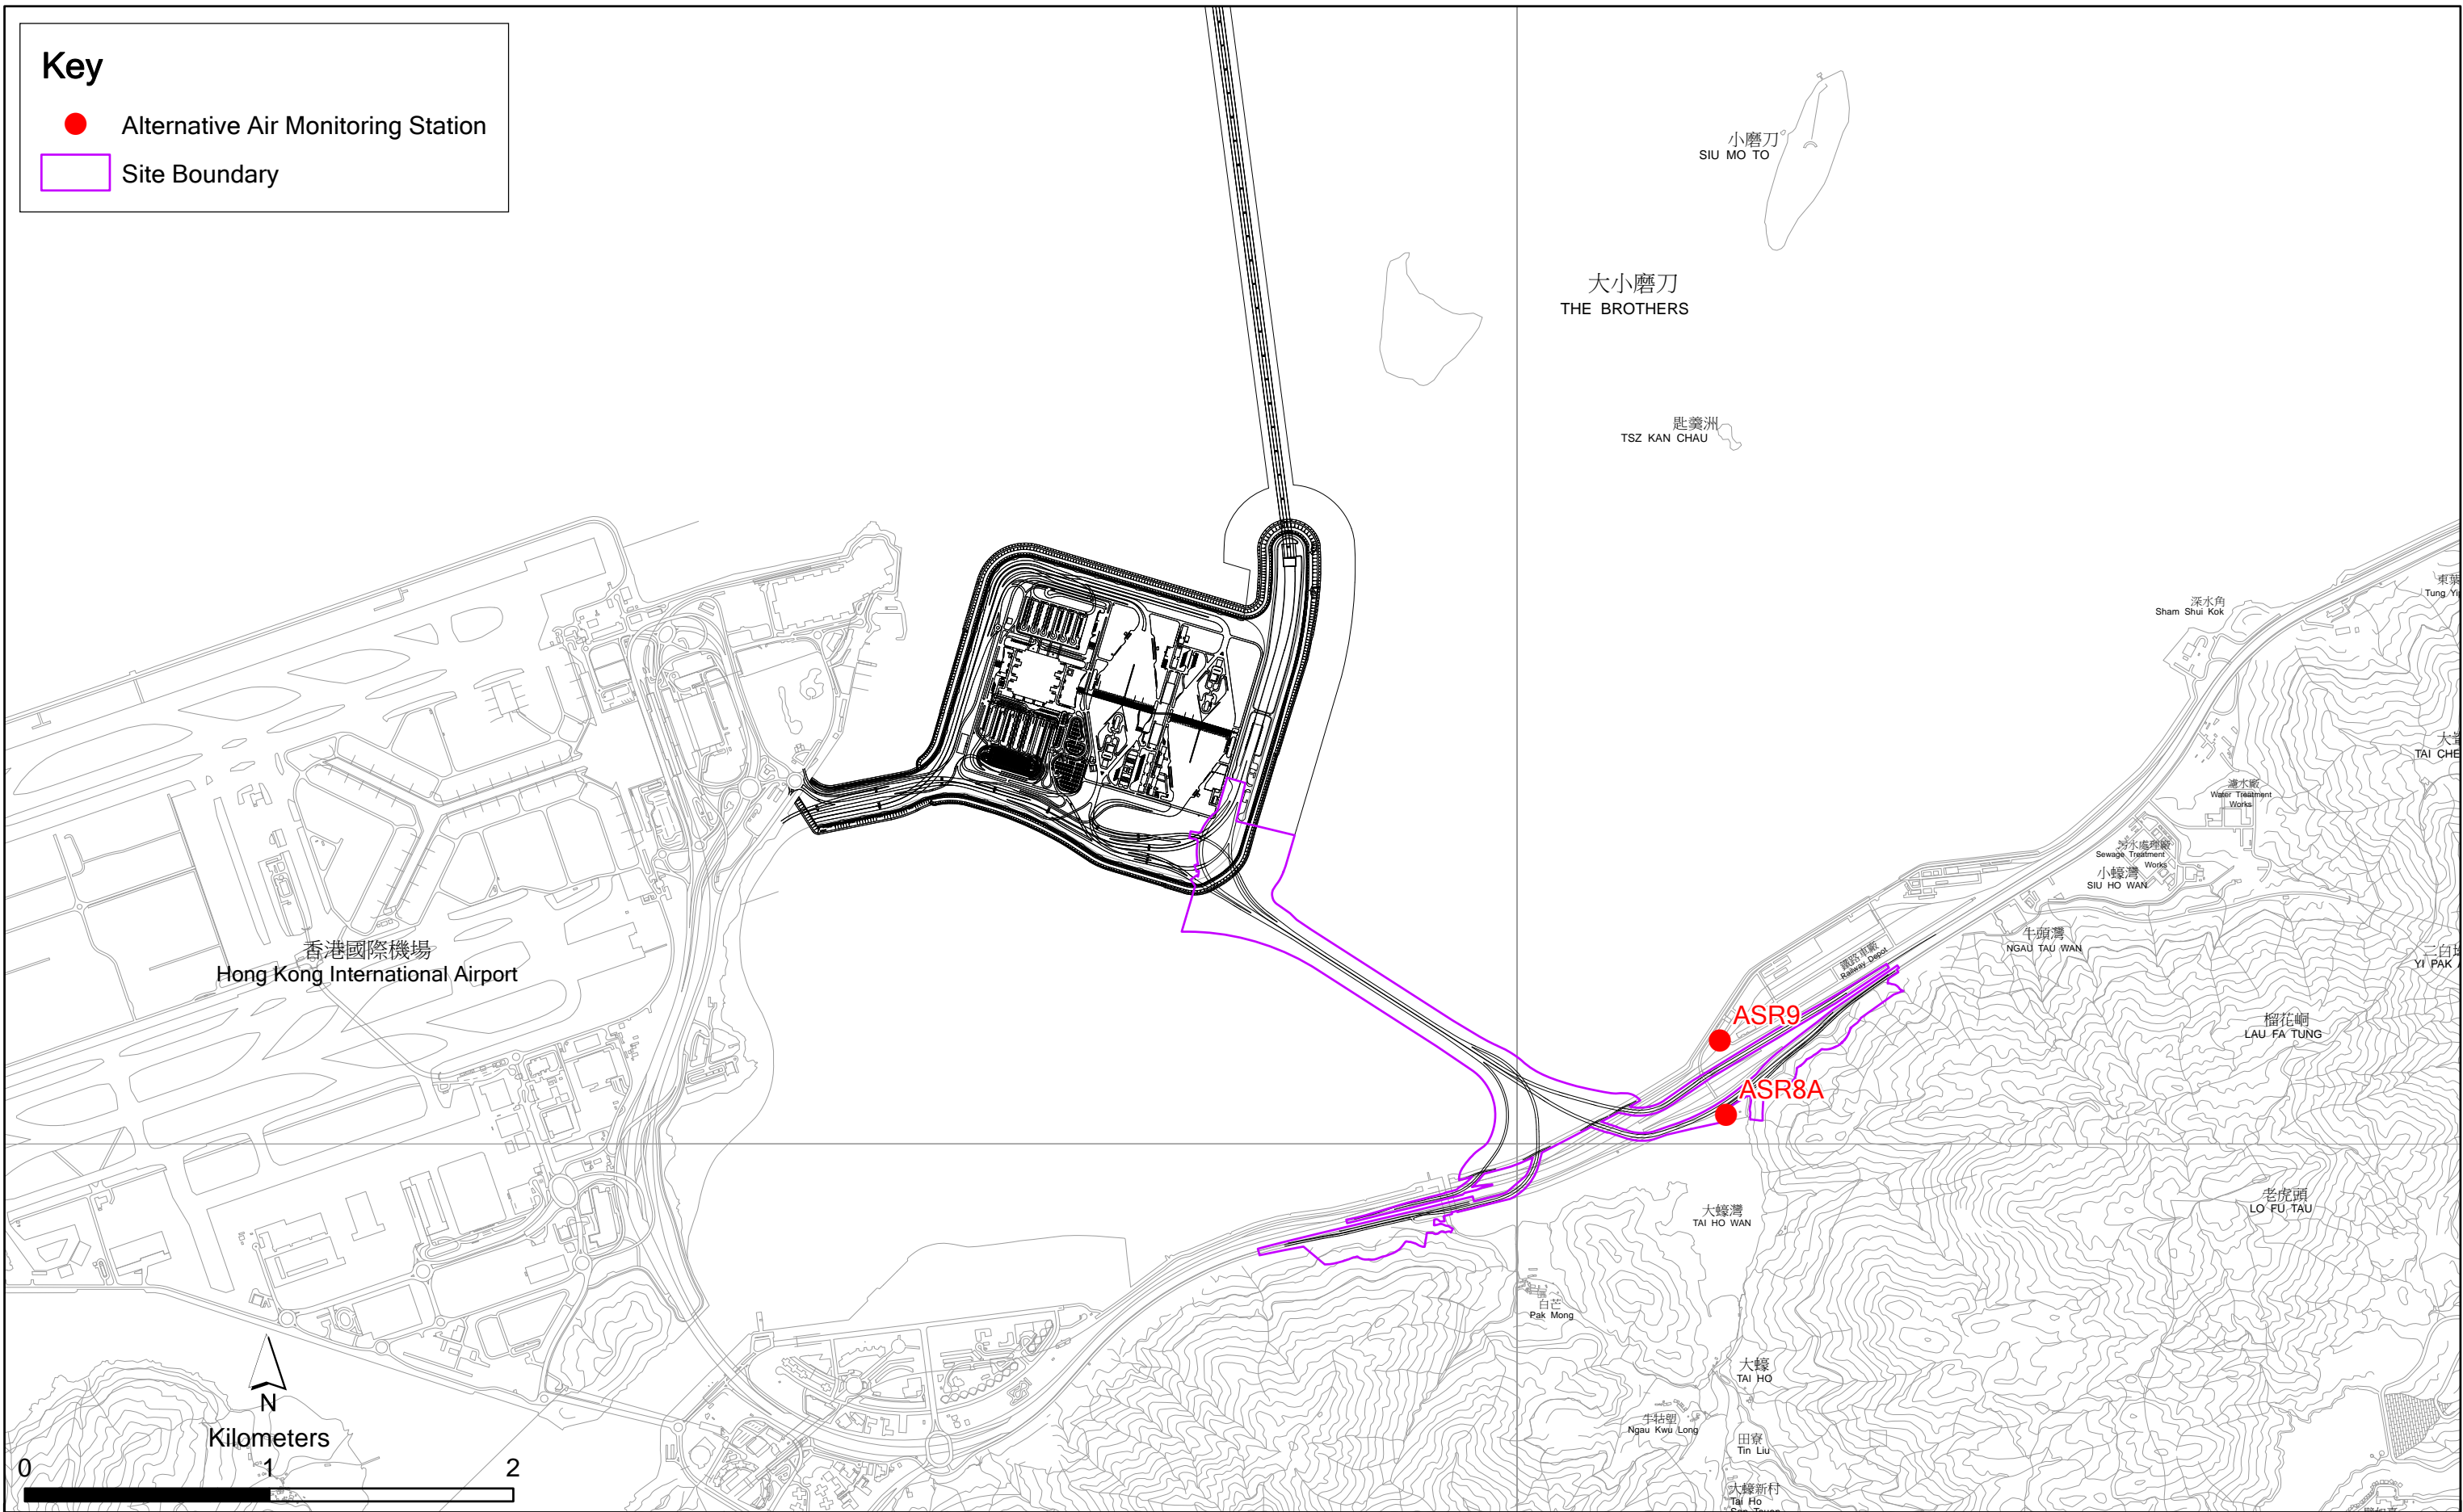
Figure 2.1
Locations of Air Quality Monitoring Stations

High Volume Samplers (HVSs) were used for 1-hour TSP and 24-hour TSP monitoring at ASR8A and ASR9 in accordance with the requirements of the Updated EM&A Manual. The TSP monitoring stations are illustrated in *Figure 2.1* and detailed in *Table 2.1*. Wind meter was deployed at Area 4 for logging wind speed and wind direction. Copies of the calibration certificates for the equipment are presented in *Appendix E*. Details of the deployed equipment are given in *Table 2.2*.
