**Contract No. HY/2012/08  
Tuen Mun – Chek Lap Kok Link –  
Northern Connection Sub-sea Tunnel  
Section**

***Sixty-sixth Monthly Environmental Monitoring &  
Audit (EM&A) Report***

14 May 2019

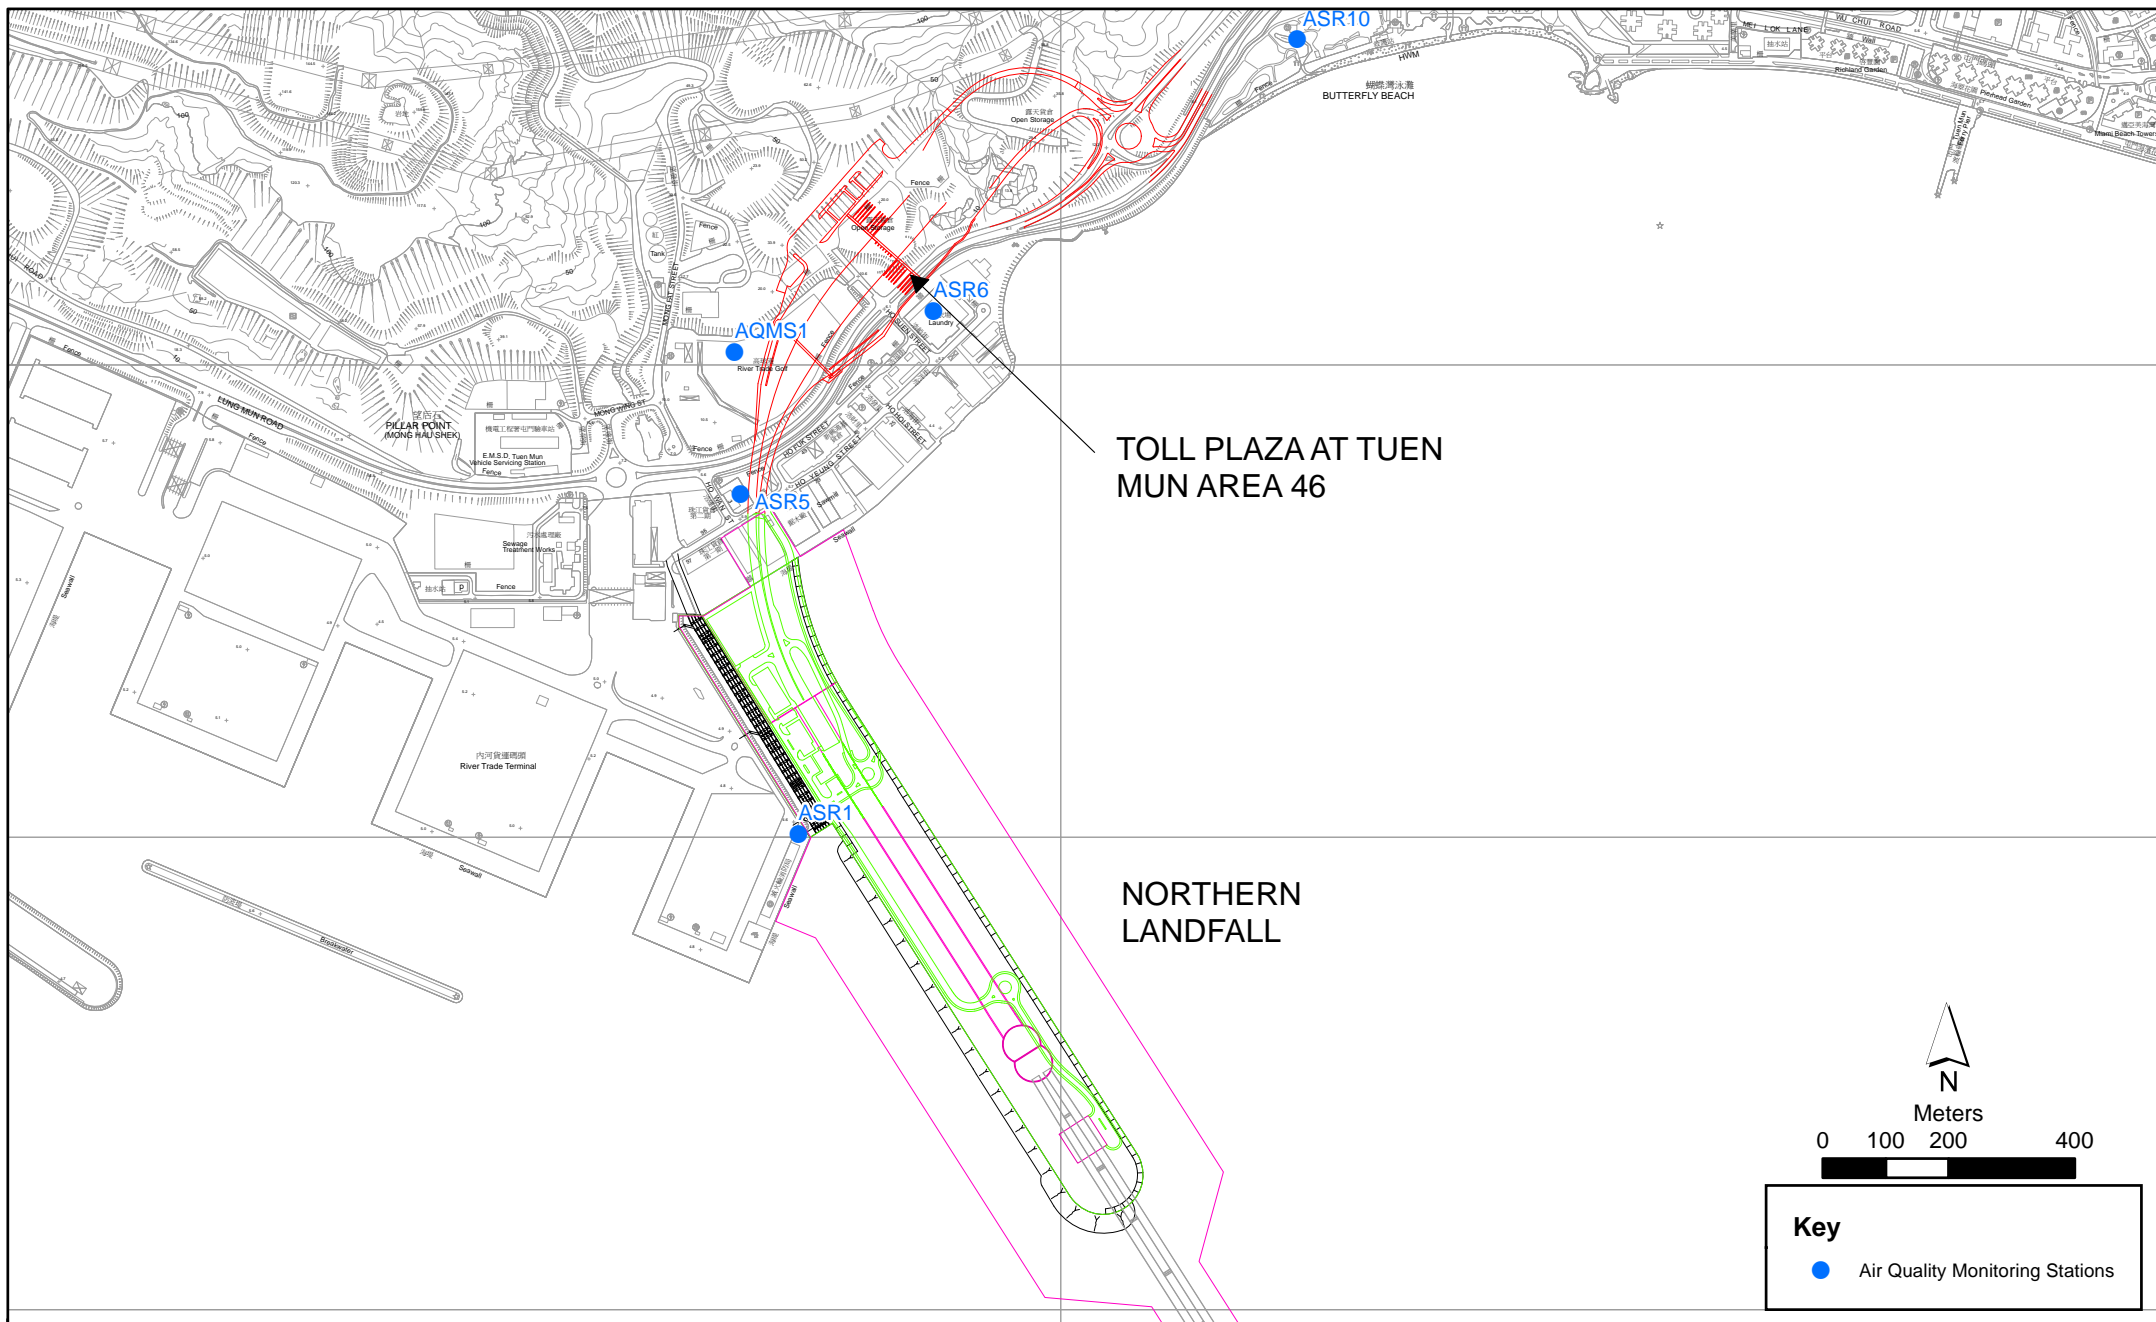
Figure 2.1

Air Quality Monitoring Stations for the Enhanced TSP Monitoring

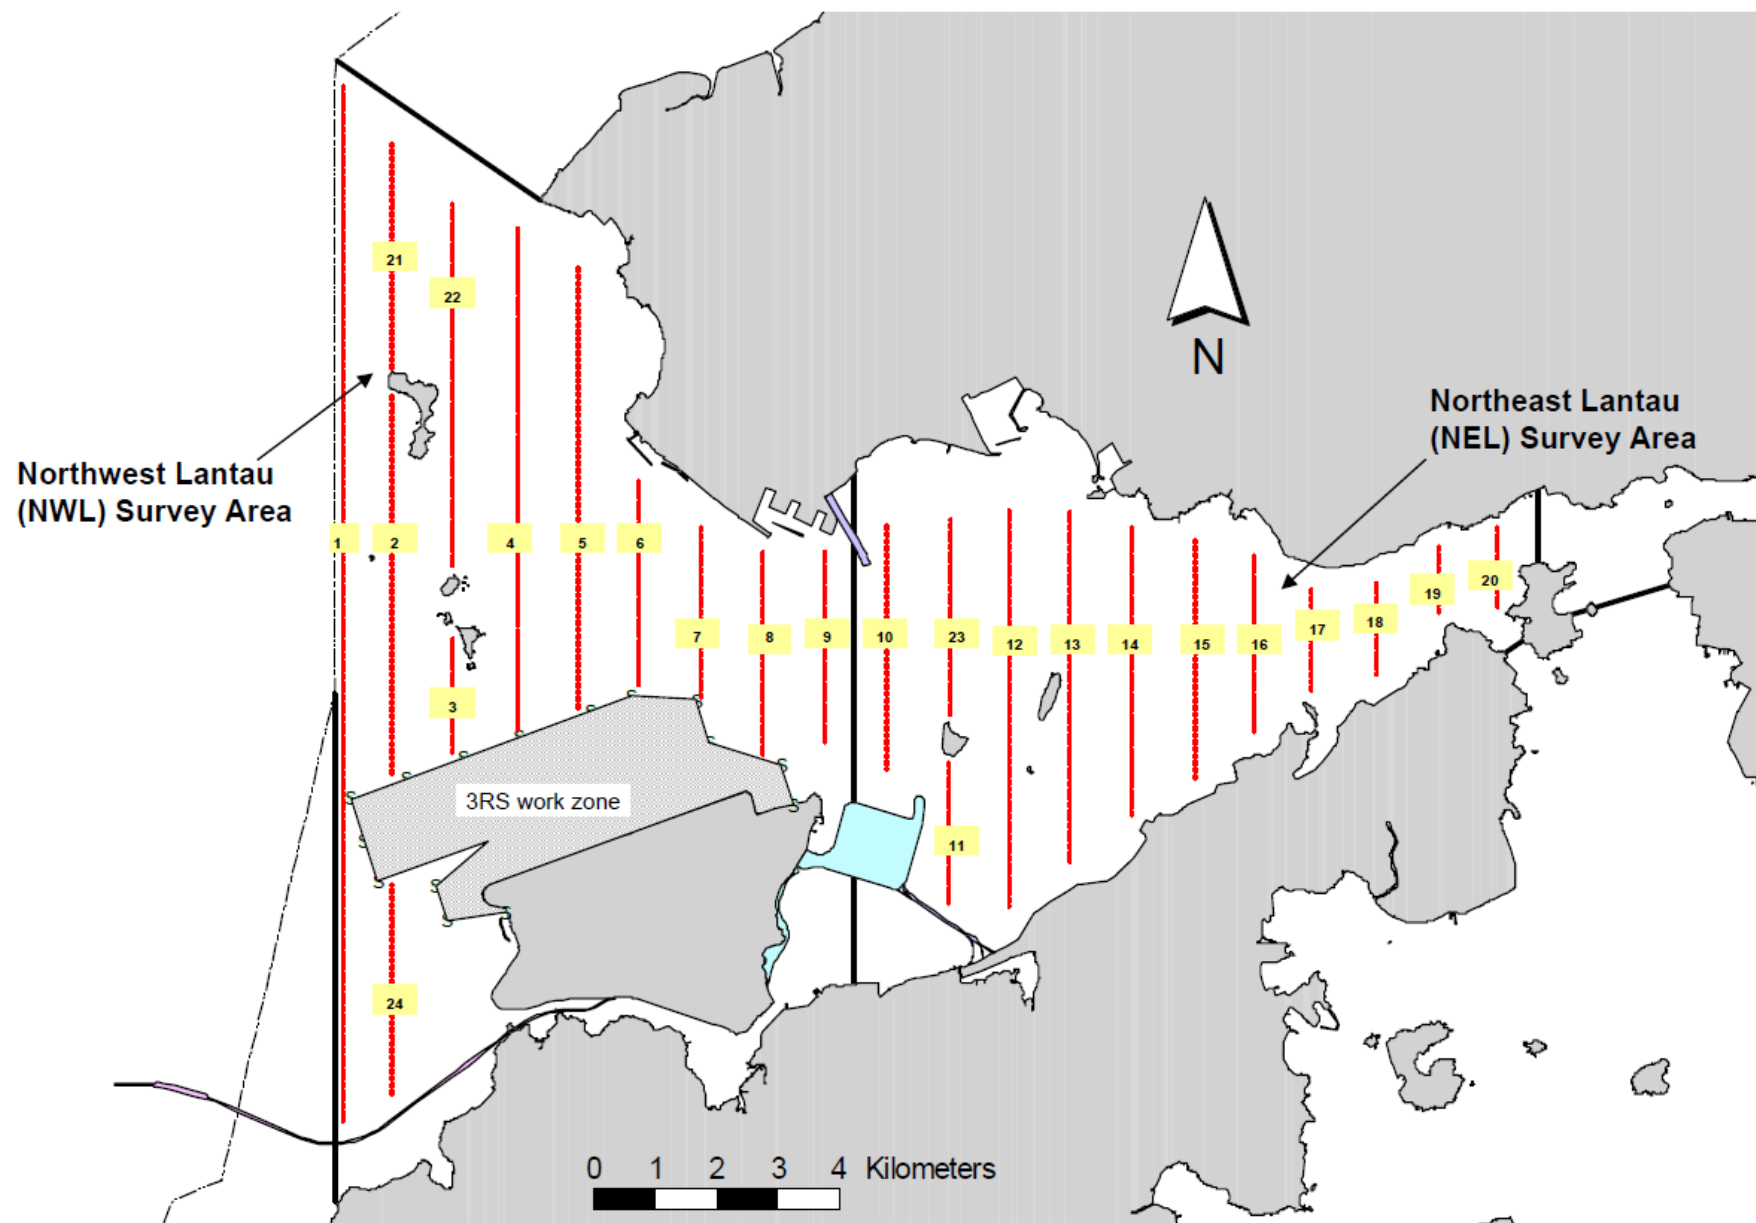
Figure 2.3

Layout of Transect Lines of Dolphin Monitoring in Northwest and Northeast Lantau Areas

The impact dolphin monitoring was carried out in the NEL and NWL along the line transect as depicted in *Figure 2.3*. The co-ordinates of all transect lines are shown in *Table 2.8* below.

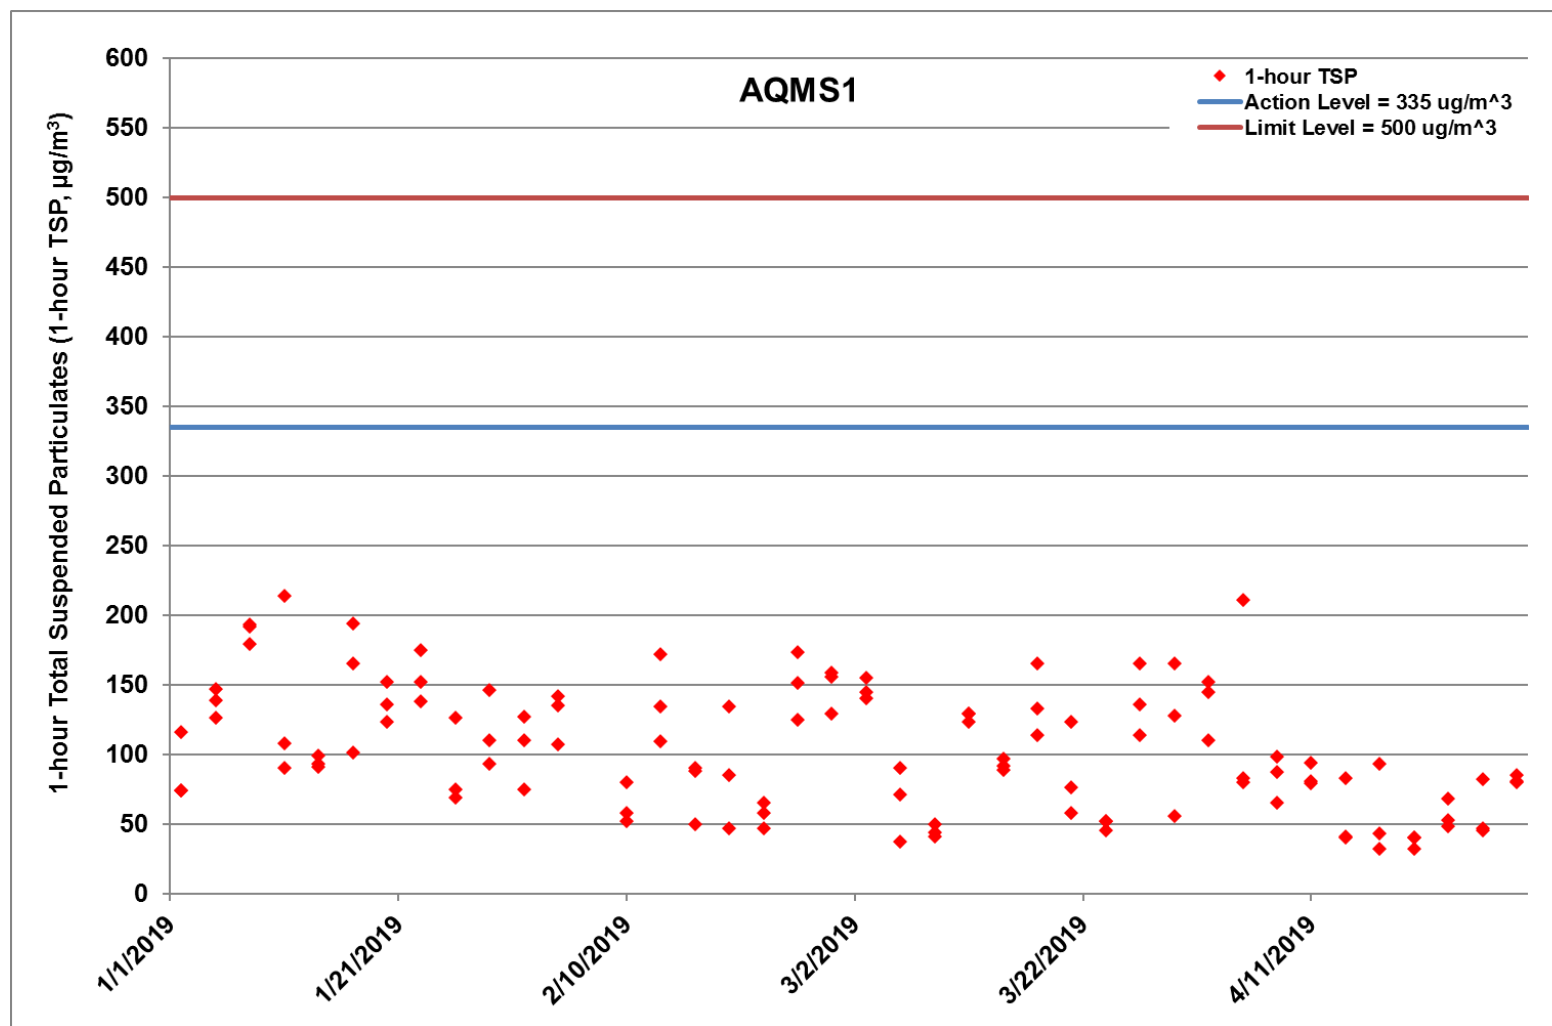
**Figure G.1 Impact Monitoring – 1-hour Total Suspended Particulates ( $\mu\text{g}/\text{m}^3$ ) at AQMS1 between 1 January 2019 and 30 April 2019 during impact monitoring period. The weather conditions during the monitoring period varied from sunny to cloudy. Major land-based construction activities included: RC structure, D-wall Construction, TBM Tunnel Works (1/1/2019 – 30/4/2019)**

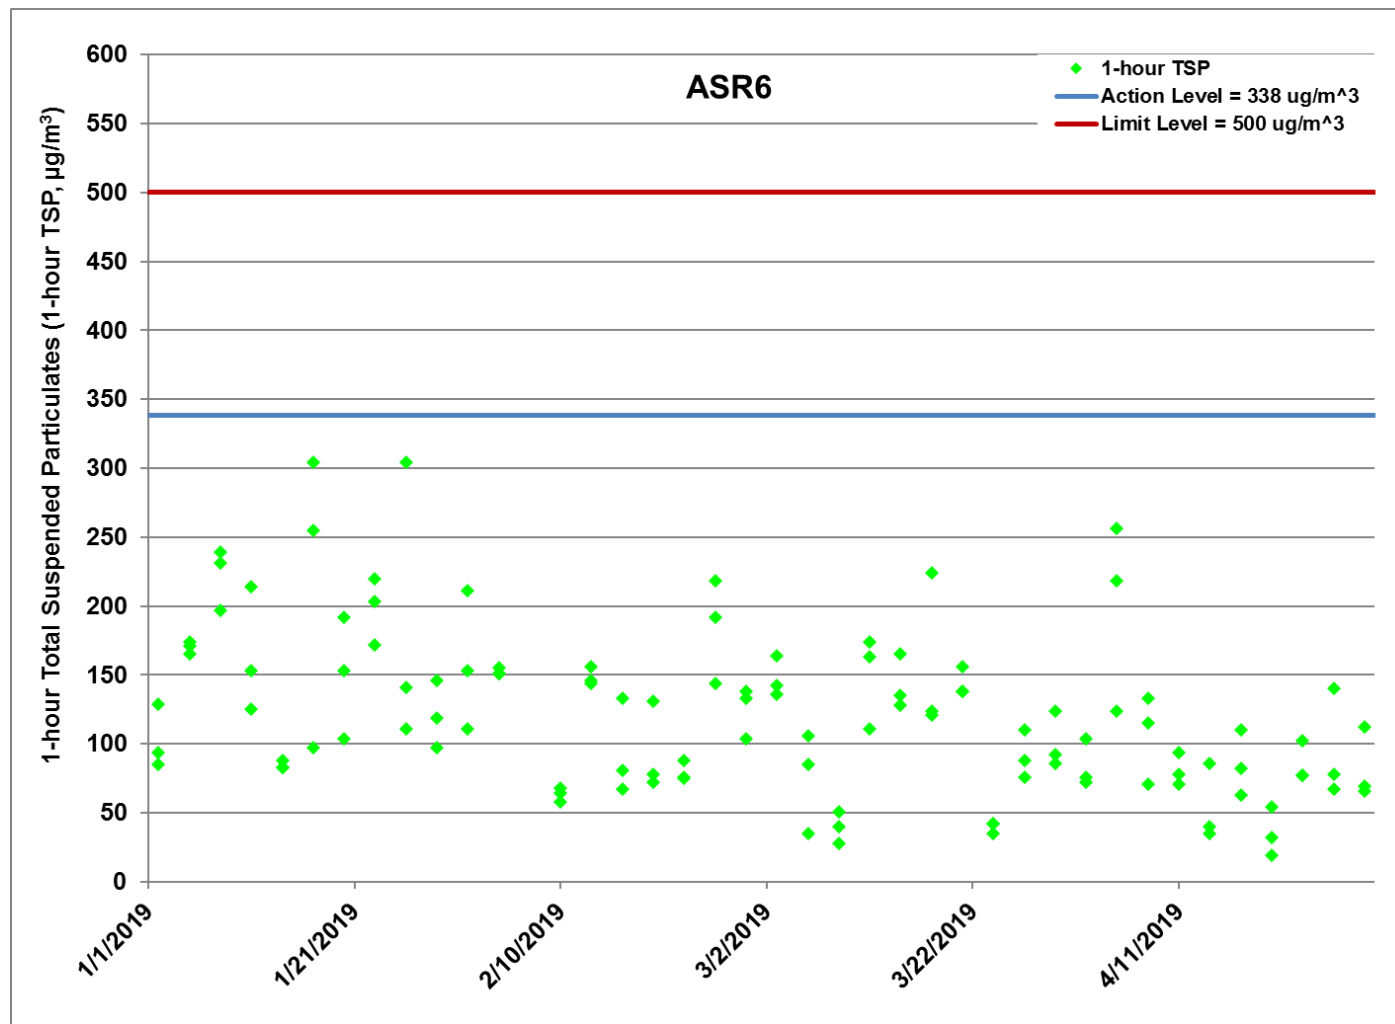
**Figure G.2 Impact Monitoring – 1-hour Total Suspended Particulates ( $\mu\text{g}/\text{m}^3$ ) at ASR6 between 1 January 2019 and 30 April 2019 during impact monitoring period. The weather conditions during the monitoring period varied from sunny to cloudy. Major land-based construction activities included: RC structure, D-wall Construction, TBM Tunnel Works (1/1/2019 – 30/4/2019)**

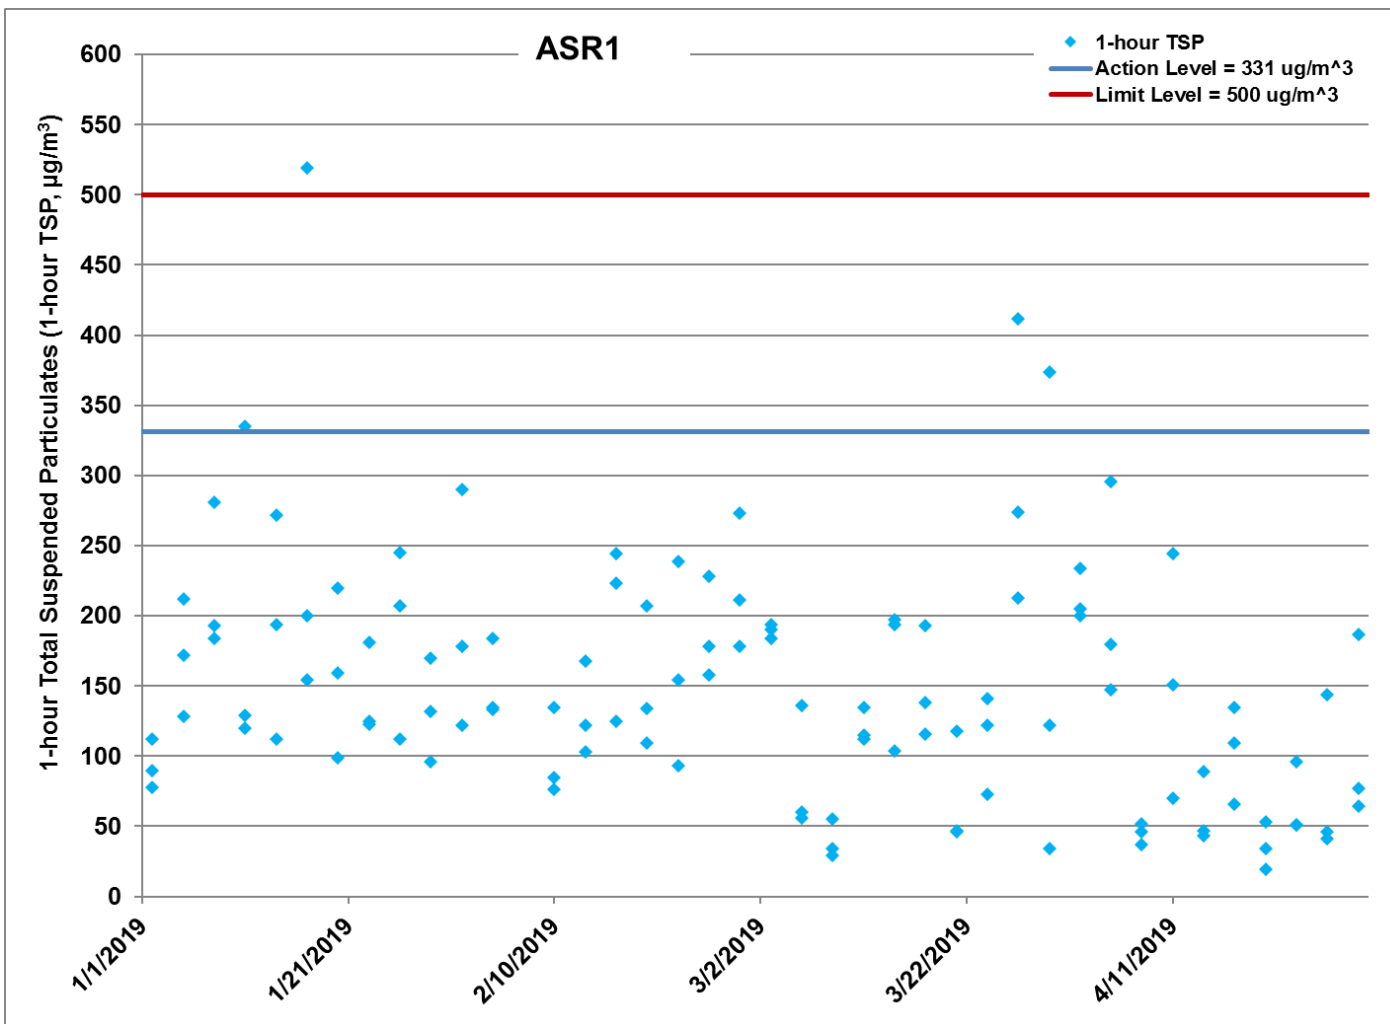
**Figure G.3 Impact Monitoring – 1-hour Total Suspended Particulates ( $\mu\text{g}/\text{m}^3$ ) at ASR1 between 1 January 2019 and 30 April 2019 during impact monitoring period. The weather conditions during the monitoring period varied from sunny to cloudy. Major land-based construction activities included: RC structure, D-wall Construction, TBM Tunnel Works (1/1/2019 – 30/4/2019)**

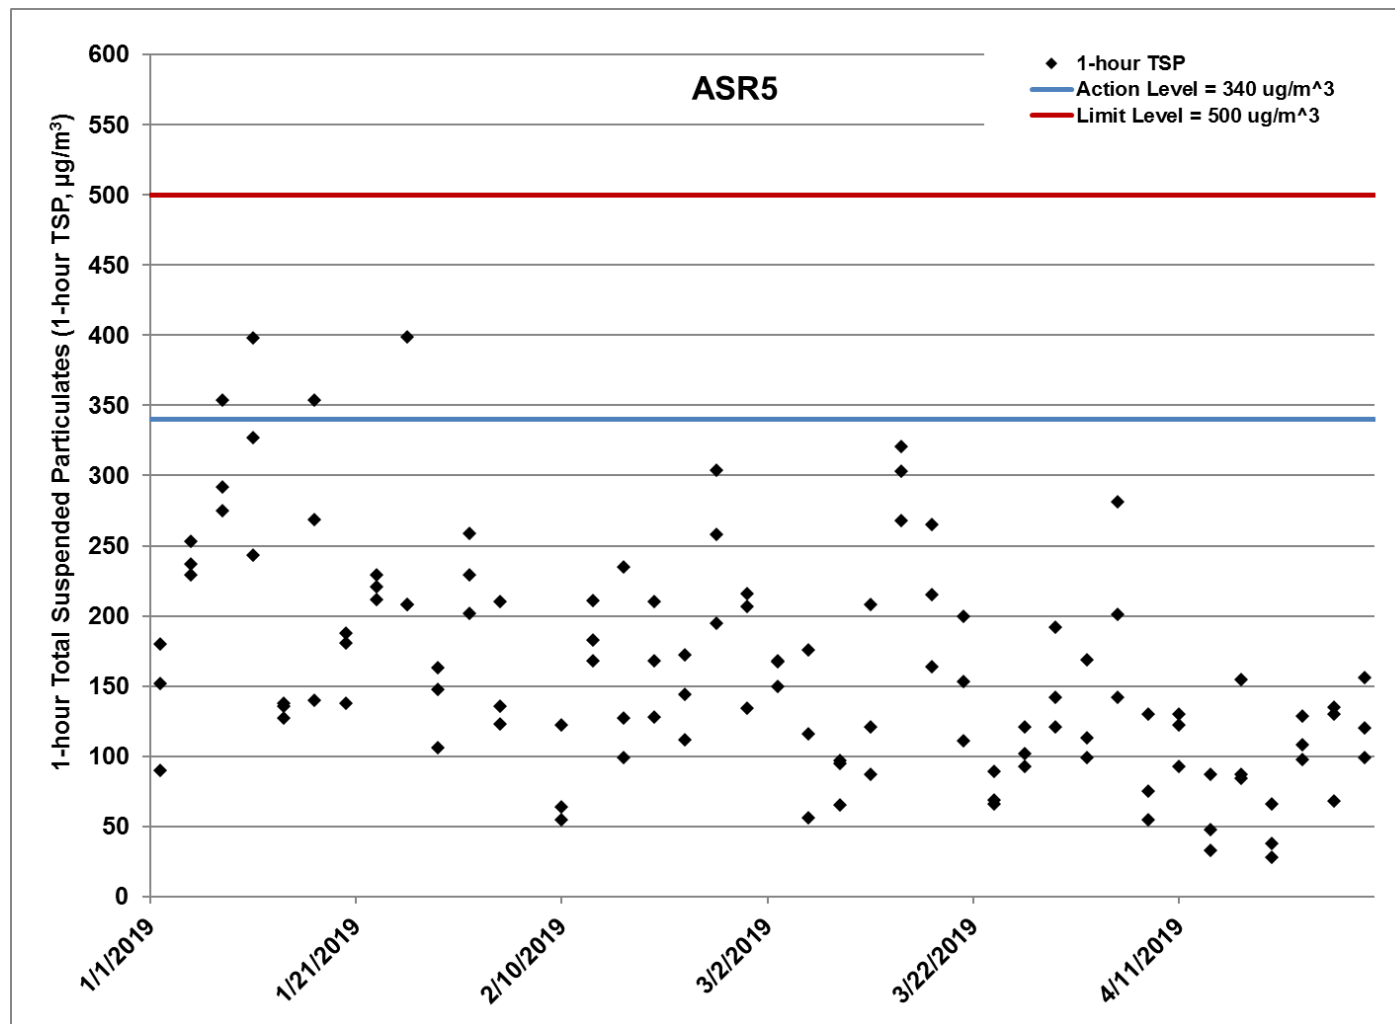
**Figure G.4 Impact Monitoring – 1-hour Total Suspended Particulates (µg/m<sup>3</sup>) at ASR5 between 1 January 2019 and 30 April 2019 during impact monitoring period. The weather conditions during the monitoring period varied from sunny to cloudy. Major land-based construction activities included: RC structure, D-wall Construction, TBM Tunnel Works (1/1/2019 – 30/4/2019)**

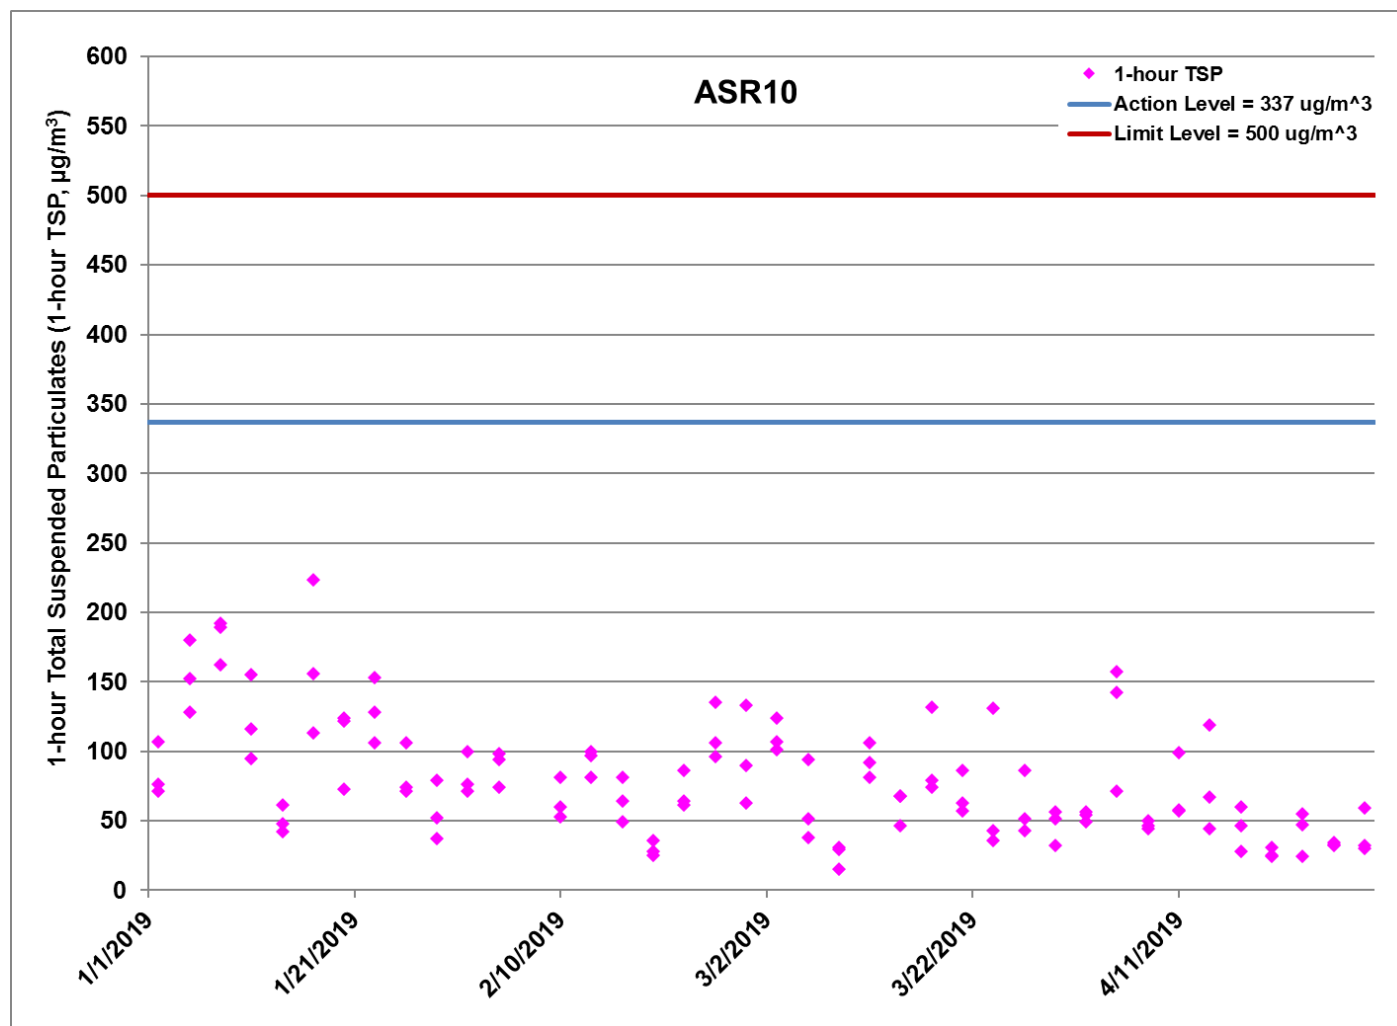
**Figure G.5 Impact Monitoring – 1-hour Total Suspended Particulates ( $\mu\text{g}/\text{m}^3$ ) at ASR10 between 1 January 2019 and 30 April 2019 during impact monitoring period. The weather conditions during the monitoring period varied from sunny to cloudy. Major land-based construction activities included: RC structure, D-wall Construction, TBM Tunnel Works (1/1/2019 – 30/4/2019)**

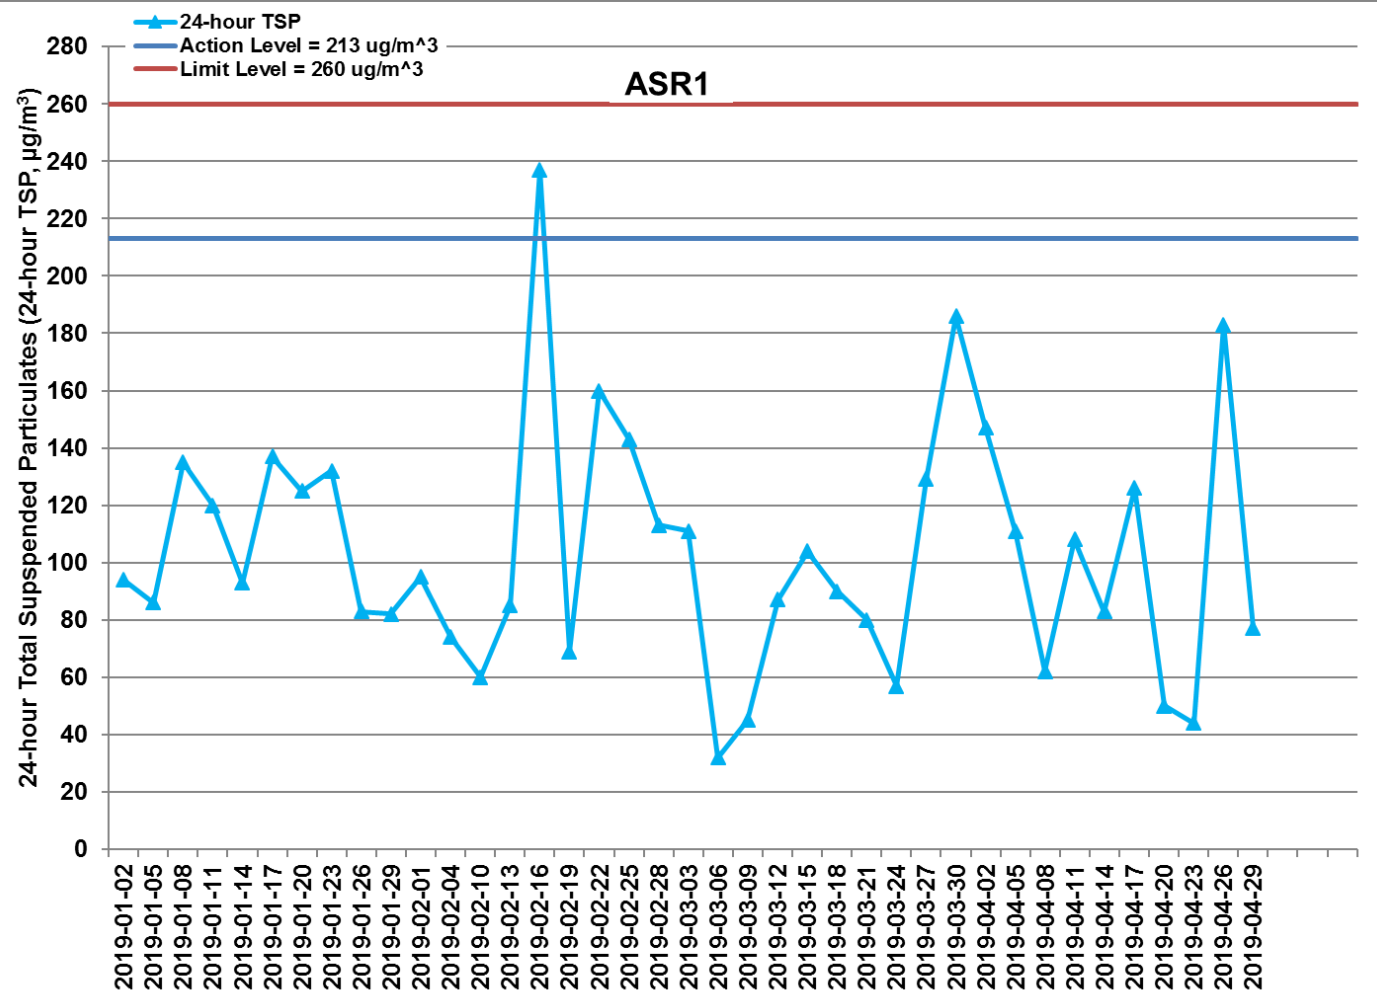
**Figure G.6 Impact Monitoring - 24-hour Total Suspended Particulates (µg/m<sup>3</sup>) at ASR1 between 1 January 2019 and 30 April 2019 during impact monitoring period. The weather conditions during the monitoring period varied from sunny to cloudy. Major land-based construction activities included: RC structure, D-wall Construction, TBM Tunnel Works (1/1/2019 - 30/4/2019)**

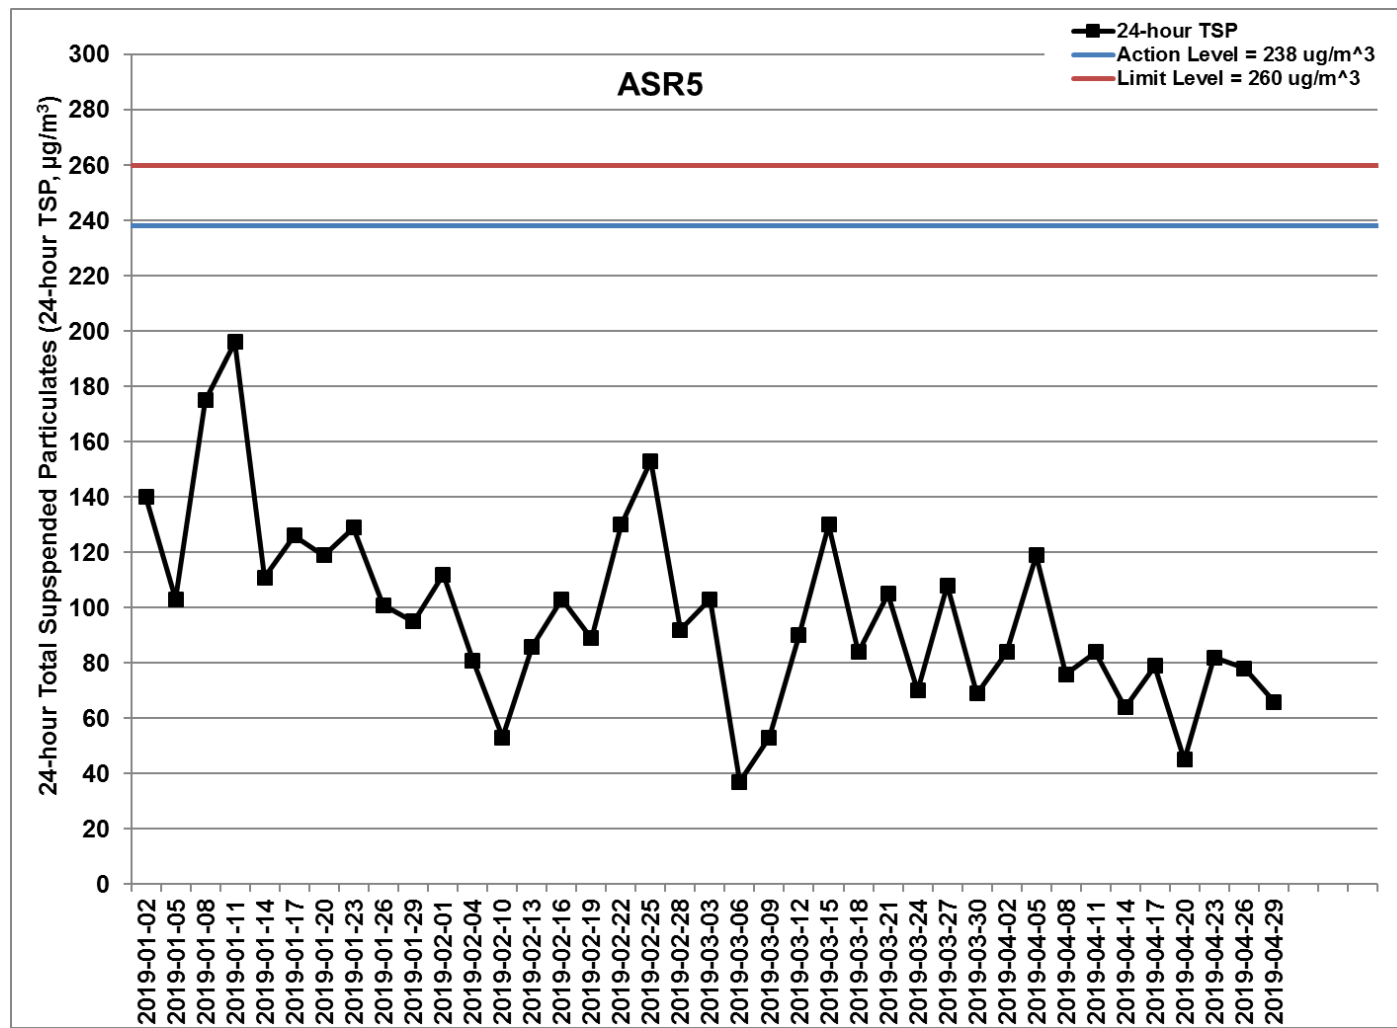
Figure G.7 Impact Monitoring - 24-hour Total Suspended Particulates ( $\mu\text{g}/\text{m}^3$ ) at ASR5 between 1 January 2019 and 30 April 2019 during impact monitoring period. The weather conditions during the monitoring period varied from sunny to cloudy. Major land-based construction activities included: RC structure, D-wall Construction, TBM Tunnel Works (1/1/2019 - 30/4/2019)

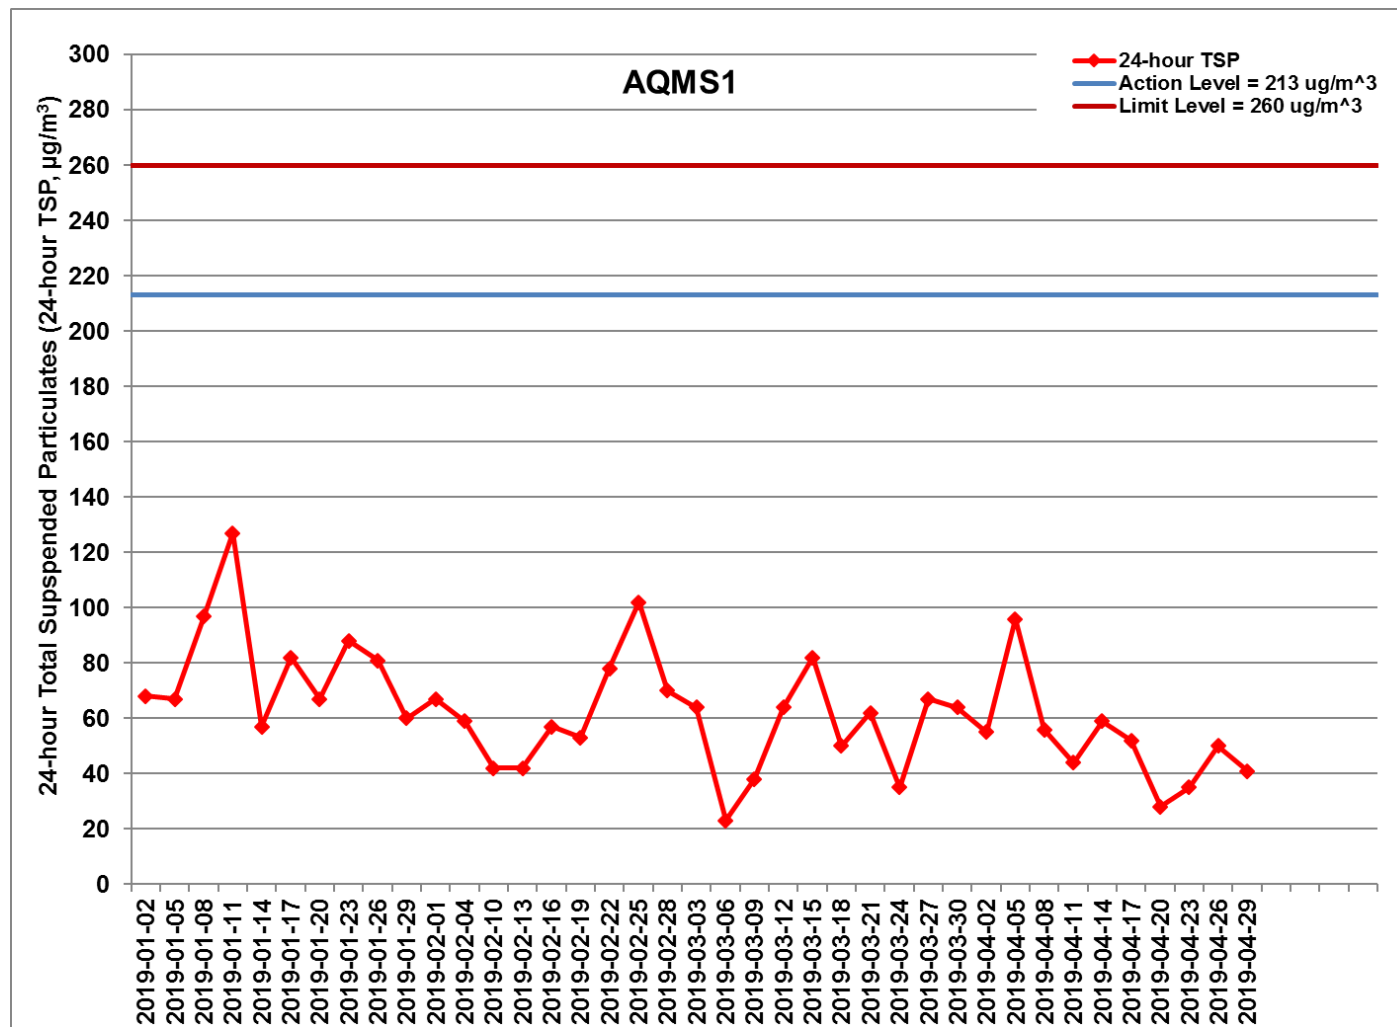
**Figure G.8 Impact Monitoring - 24-hour Total Suspended Particulates ( $\mu\text{g}/\text{m}^3$ ) at AQMS1 between 1 January 2019 and 30 April 2019 during impact monitoring period. The weather conditions during the monitoring period varied from sunny to cloudy. Major land-based construction activities included: RC structure, D-wall Construction, TBM Tunnel Works (1/1/2019 - 30/4/2019)**

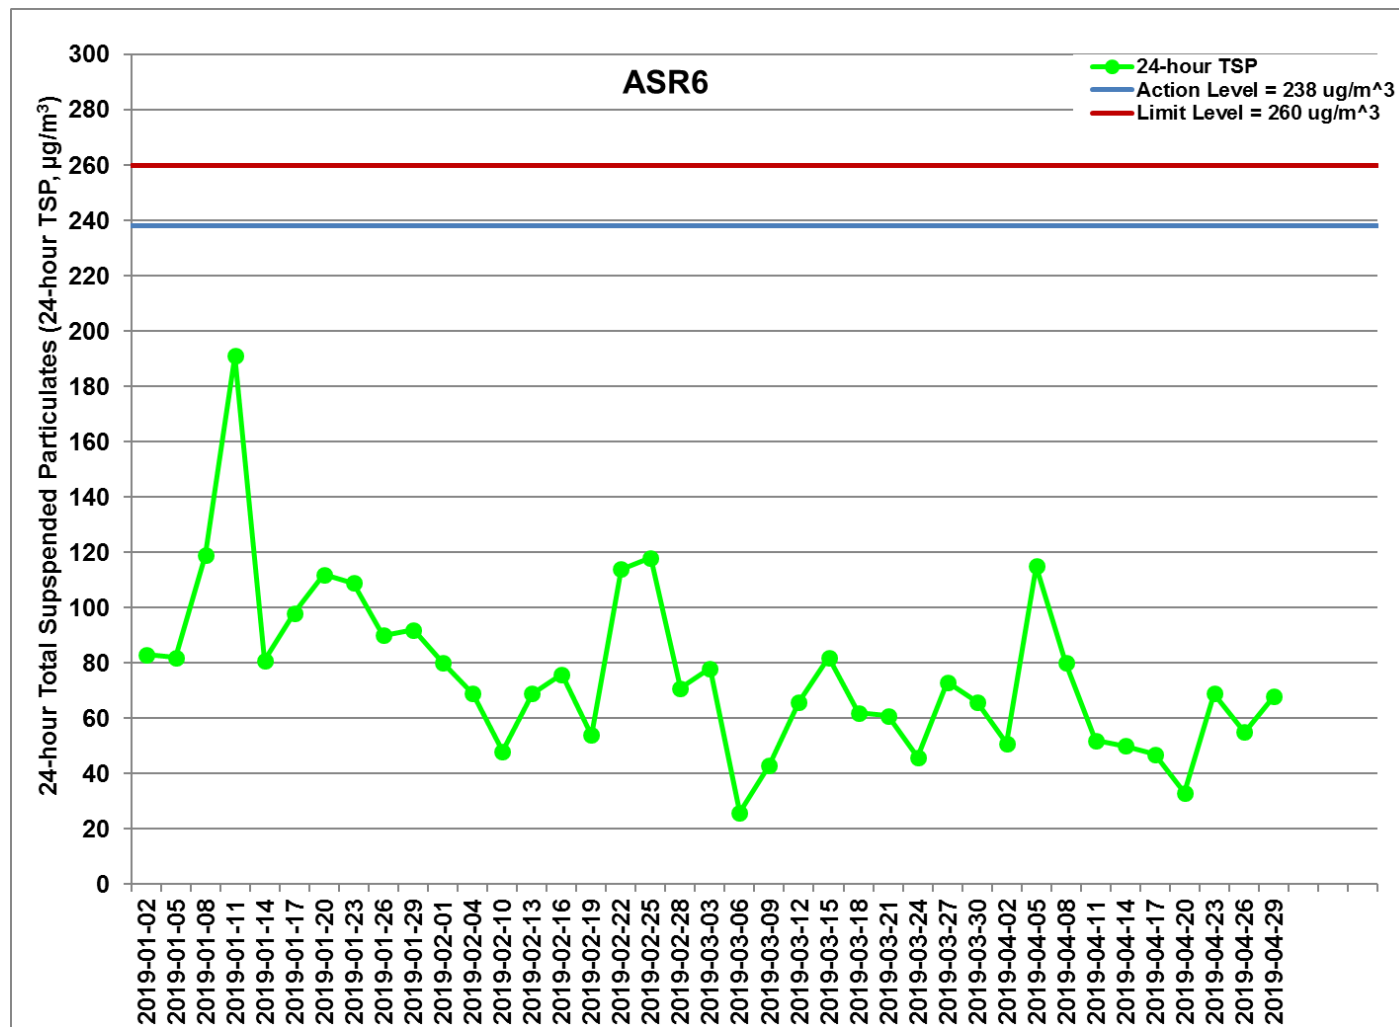
**Figure G.9 Impact Monitoring - 24-hour Total Suspended Particulates ( $\mu\text{g}/\text{m}^3$ ) at ASR6 between 1 January 2019 and 30 April 2019 during impact monitoring period. The weather conditions during the monitoring period varied from sunny to cloudy. Major land-based construction activities included: RC structure, D-wall Construction, TBM Tunnel Works (1/1/2019 - 30/4/2019)**

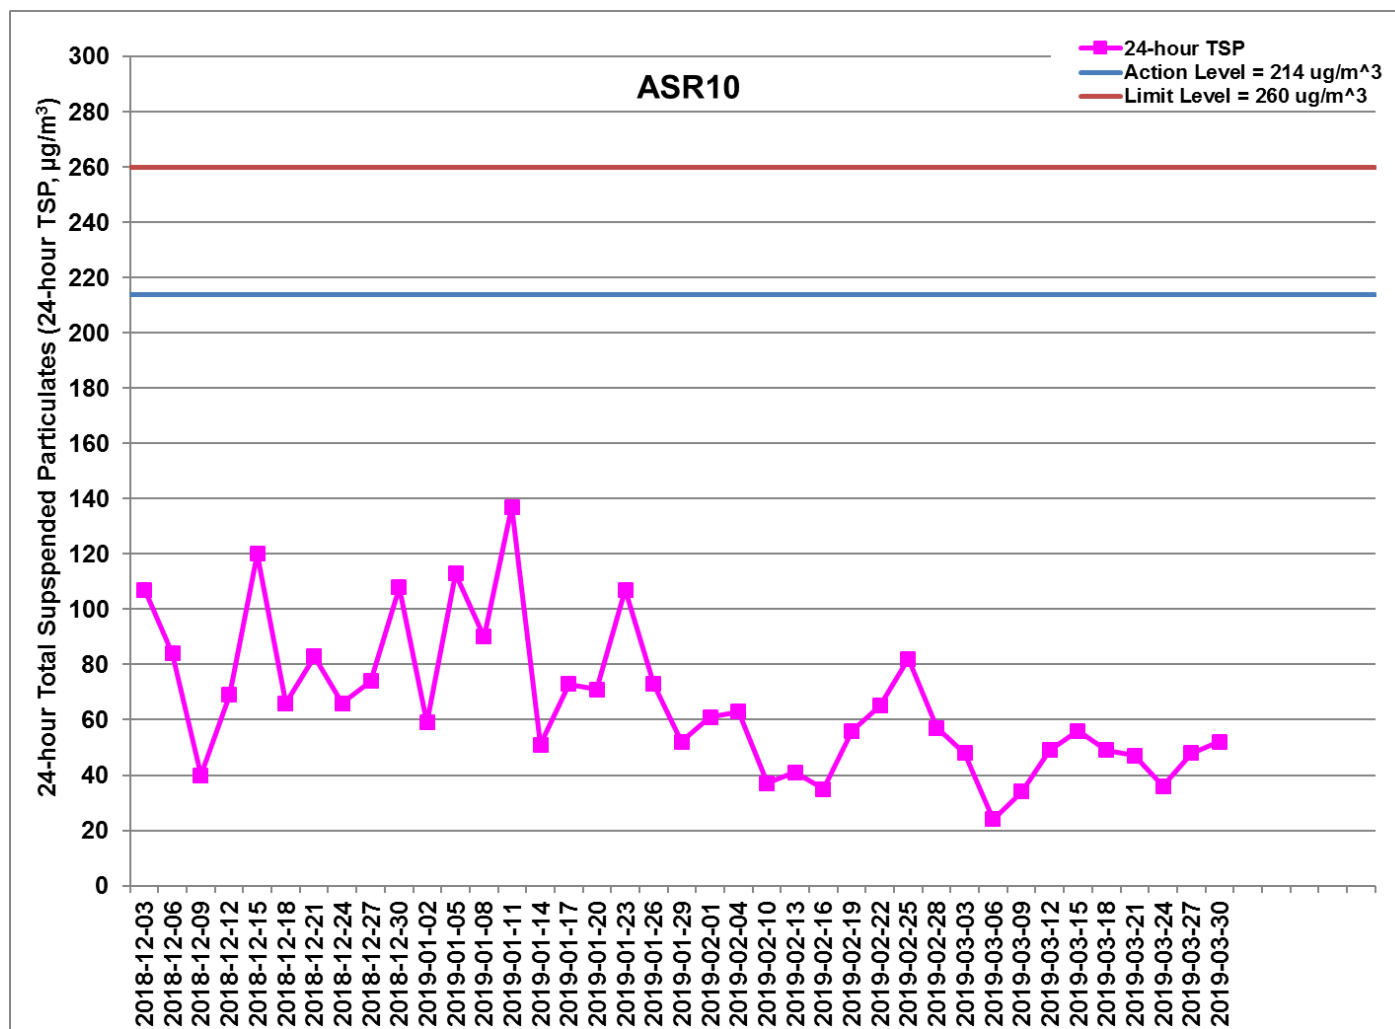
Figure G.10 Impact Monitoring - 24-hour Total Suspended Particulates ( $\mu\text{g}/\text{m}^3$ ) at ASR10 between 1 January 2019 and 30 April 2019 during impact monitoring period. The weather conditions during the monitoring period varied from sunny to cloudy. Major land-based construction activities included: RC structure, D-wall Construction, TBM Tunnel Works (1/1/2019 - 30/4/2019)

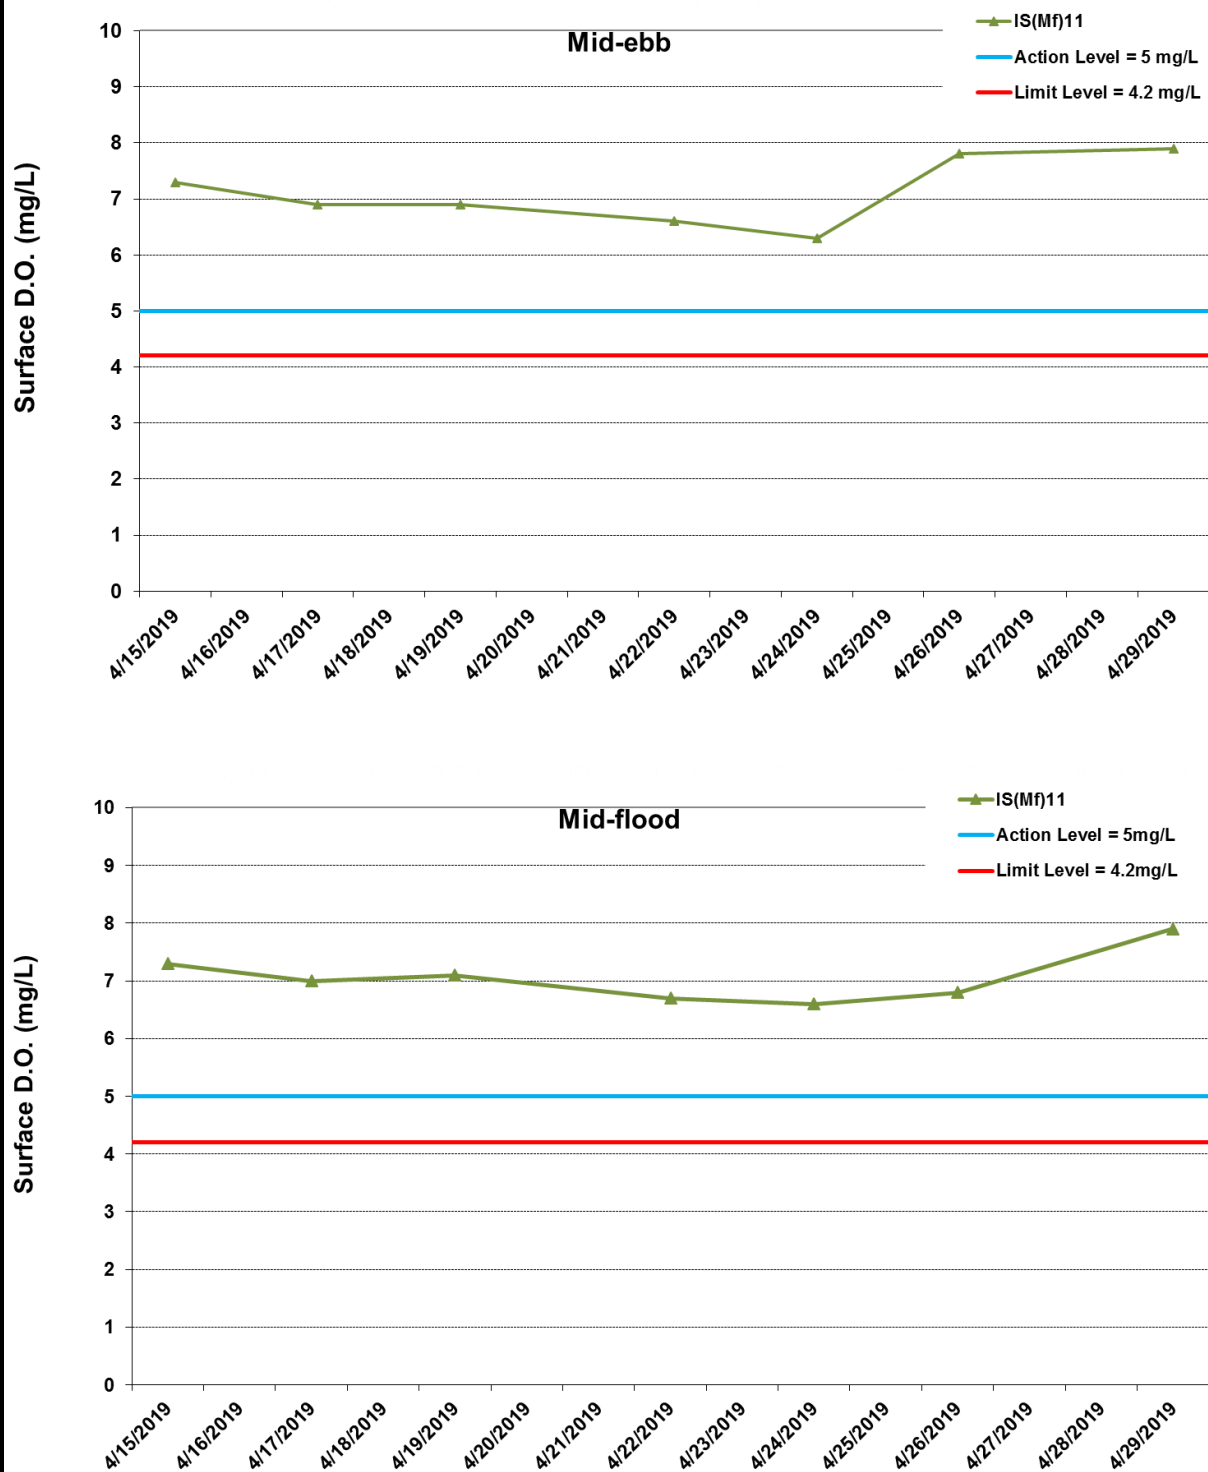
**Figure J1 Impact Monitoring - Mean Level of Dissolved Oxygen (mg/L) in surface waters between 15 April 2019 and 30 April 2019 at IS(Mf)11. The weather conditions during the monitoring period varied mostly from sunny to cloudy. Major marine works included: Seawall Modification works at Southern Landfall (15/4/2019 - 30/4/2019).**
