**Contract No. HY/2012/08  
Tuen Mun – Chek Lap Kok Link –  
Northern Connection Sub-sea Tunnel  
Section**

***Sixty-sixth Monthly Environmental Monitoring &  
Audit (EM&A) Report***

14 May 2019

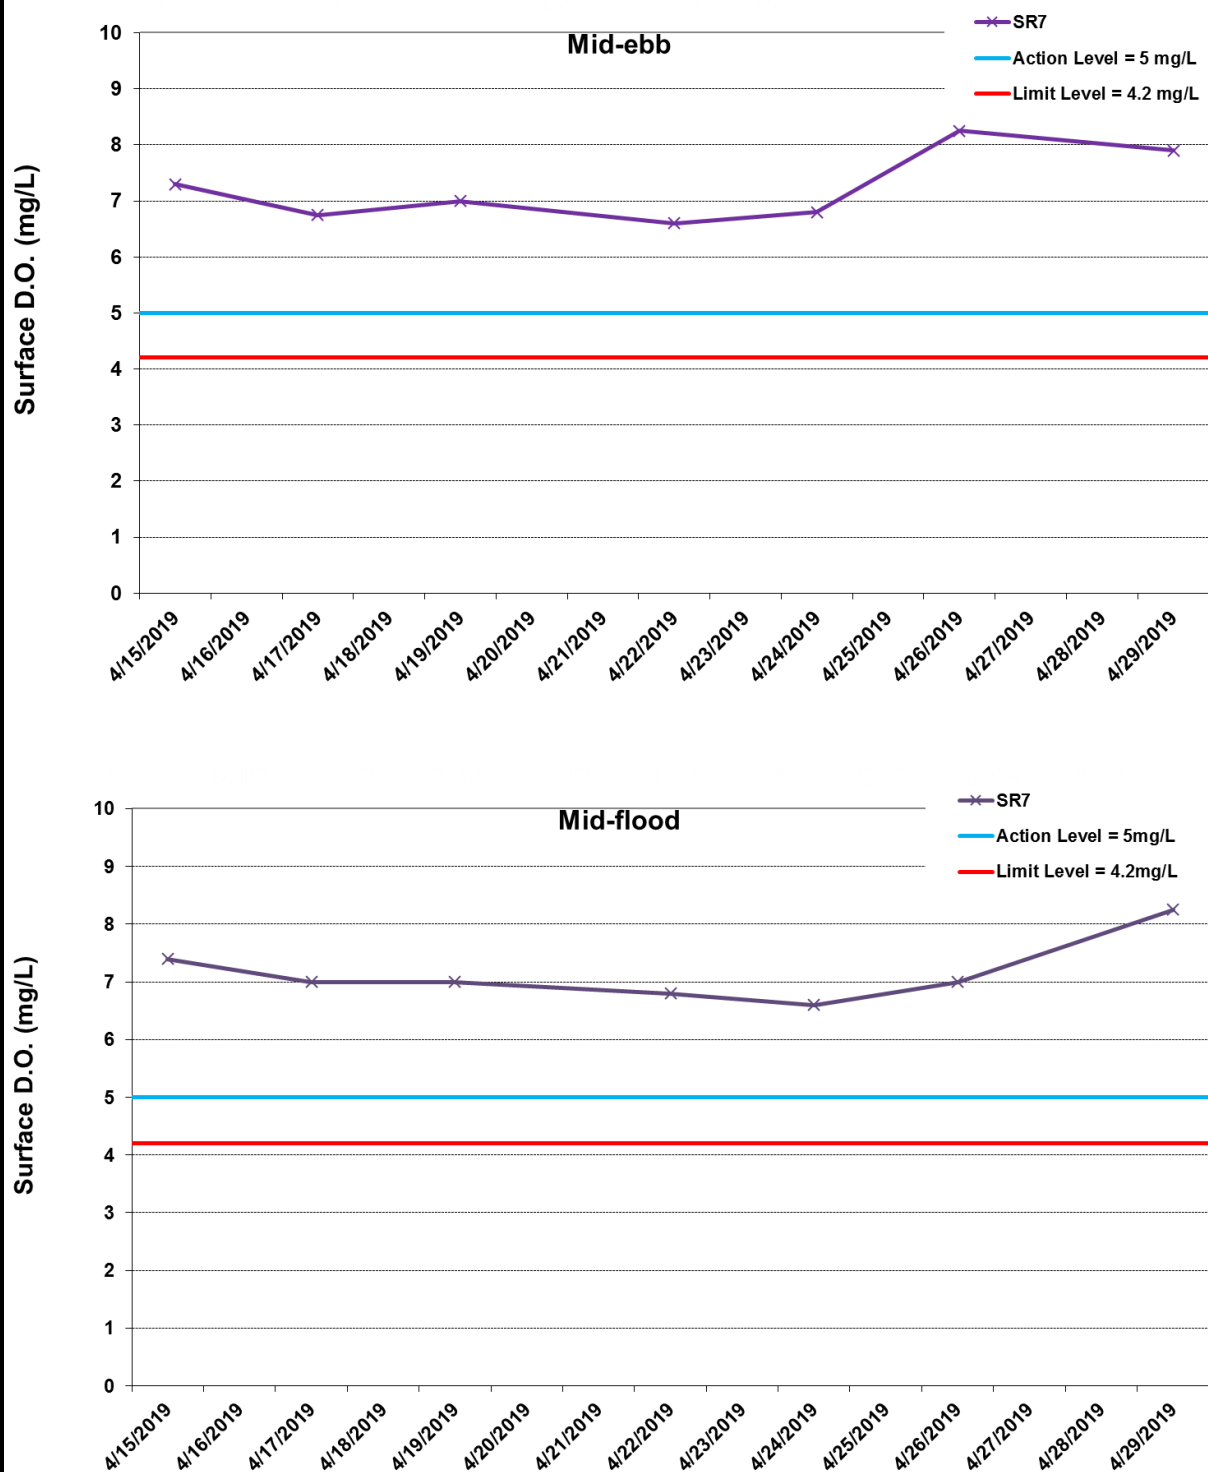
**Figure J2 Impact Monitoring - Mean Level of Dissolved Oxygen (mg/L) in surface waters between 15 April 2019 and 30 April 2019 at SR7. The weather conditions during the monitoring period varied mostly from sunny to cloudy. Major marine works included: Seawall Modification works at Southern Landfall (15/4/2019 - 30/4/2019).**

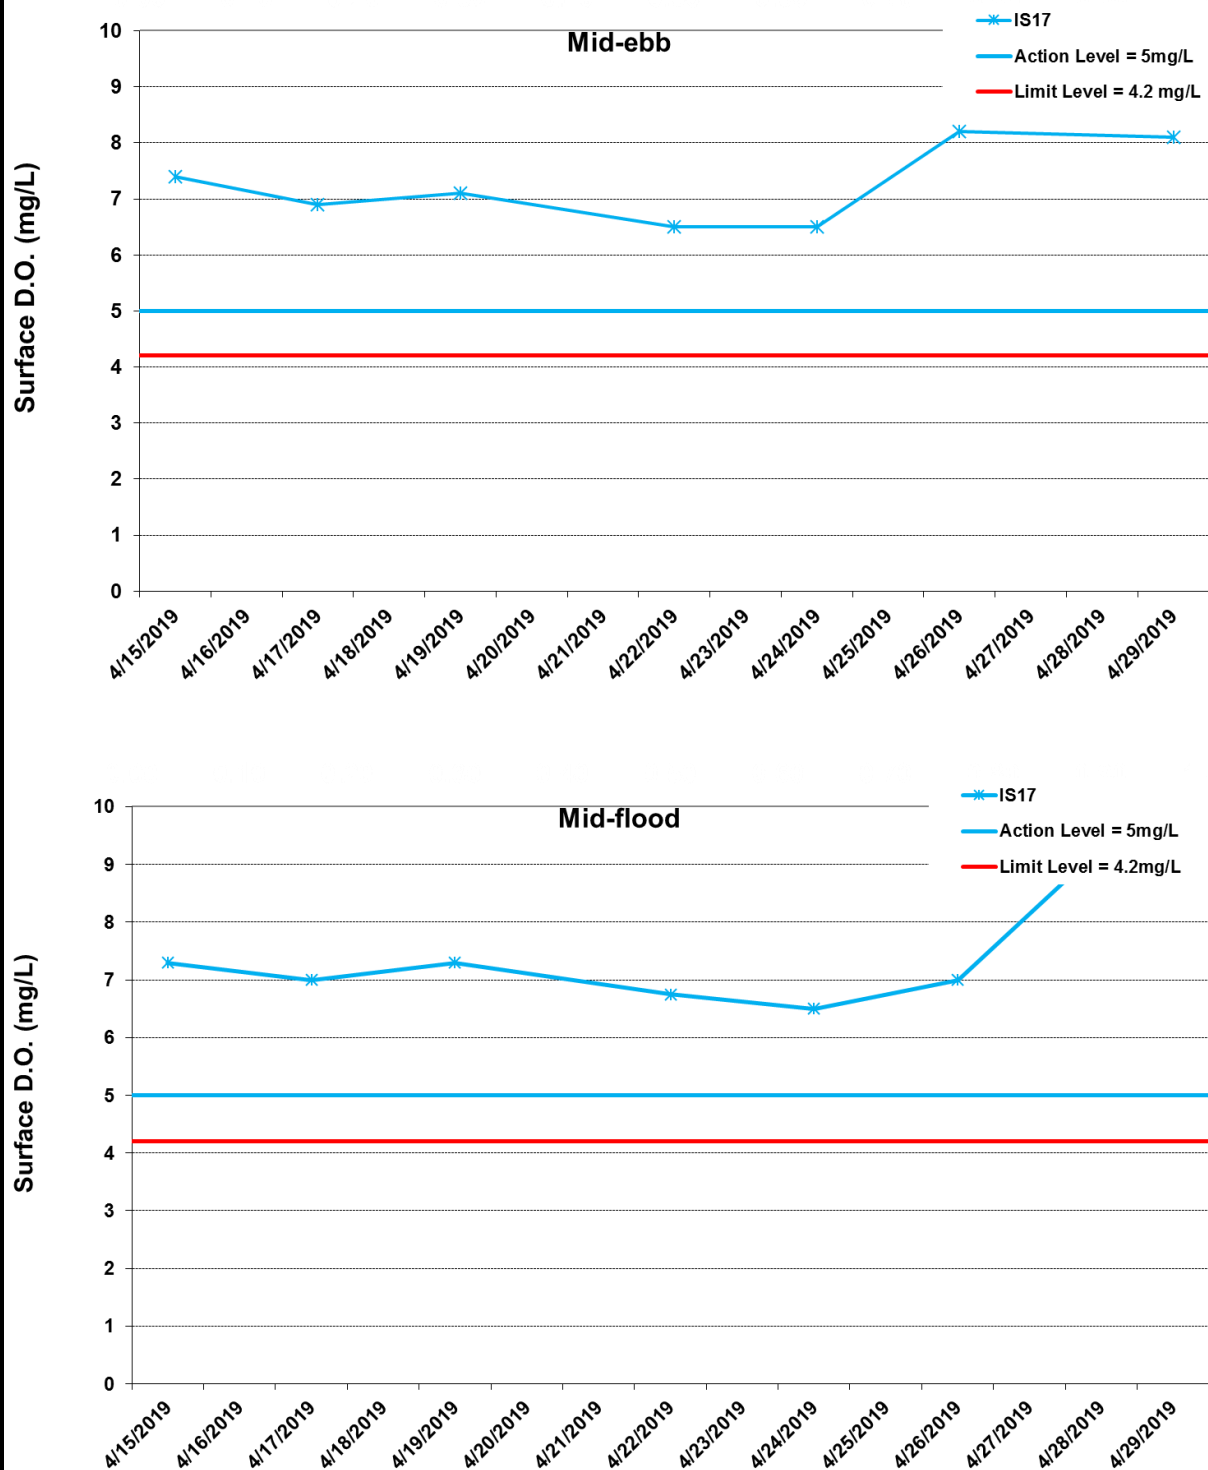
**Figure J3 Impact Monitoring - Mean Level of Dissolved Oxygen (mg/L) in surface waters between 15 April 2019 and 30 April 2019 at IS17.** The weather conditions during the monitoring period varied mostly from sunny to cloudy. Major marine works included: Seawall Modification works at Southern Landfall (15/4/2019 - 30/4/2019).

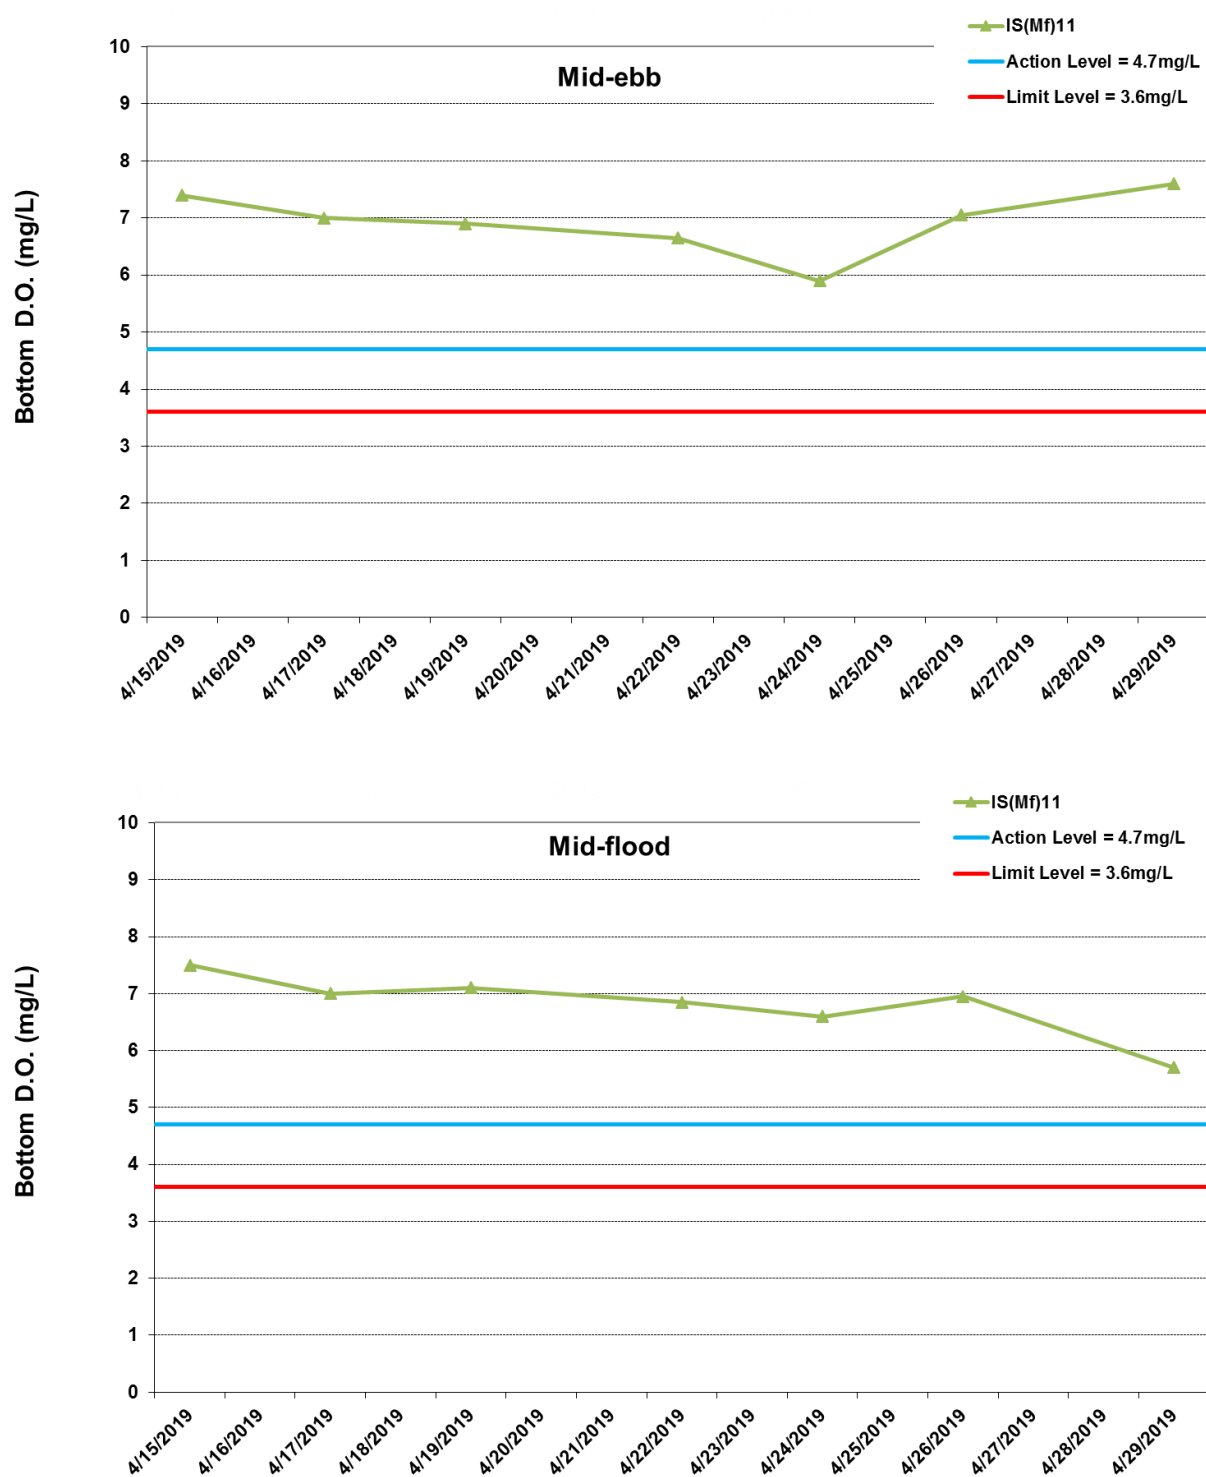
**Figure J6 Impact Monitoring - Mean Level of Dissolved Oxygen (mg/L) in bottom water between 15 April 2019 and 30 April 2019 at IS(Mf)11. The weather conditions during the monitoring period varied mostly from sunny to cloudy. Major marine works included: Seawall Modification works at Southern Landfall (15/4/2019 - 30/4/2019).**

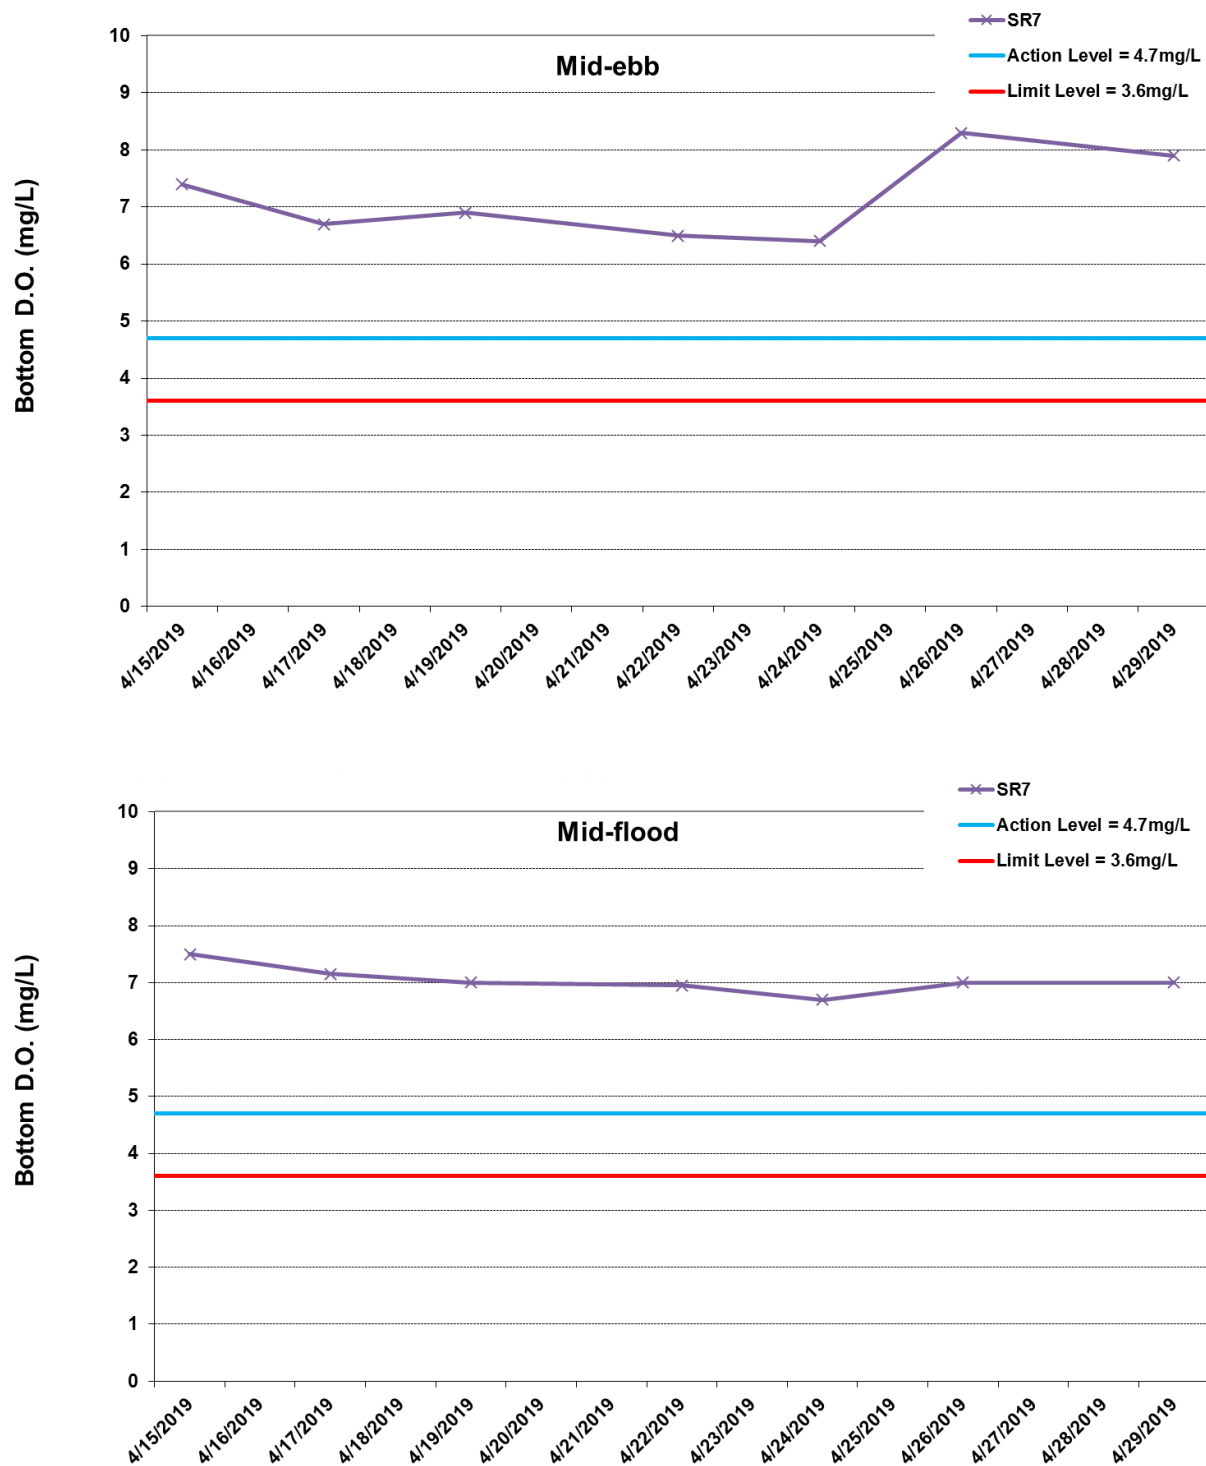
**Figure J7 Impact Monitoring - Mean Level of Dissolved Oxygen (mg/L) in bottom water between 15 April 2019 and 30 April 2019 at SR7.** The weather conditions during the monitoring period varied mostly from sunny to cloudy. Major marine works included: Seawall Modification works at Southern Landfall (15/4/2019 - 30/4/2019).

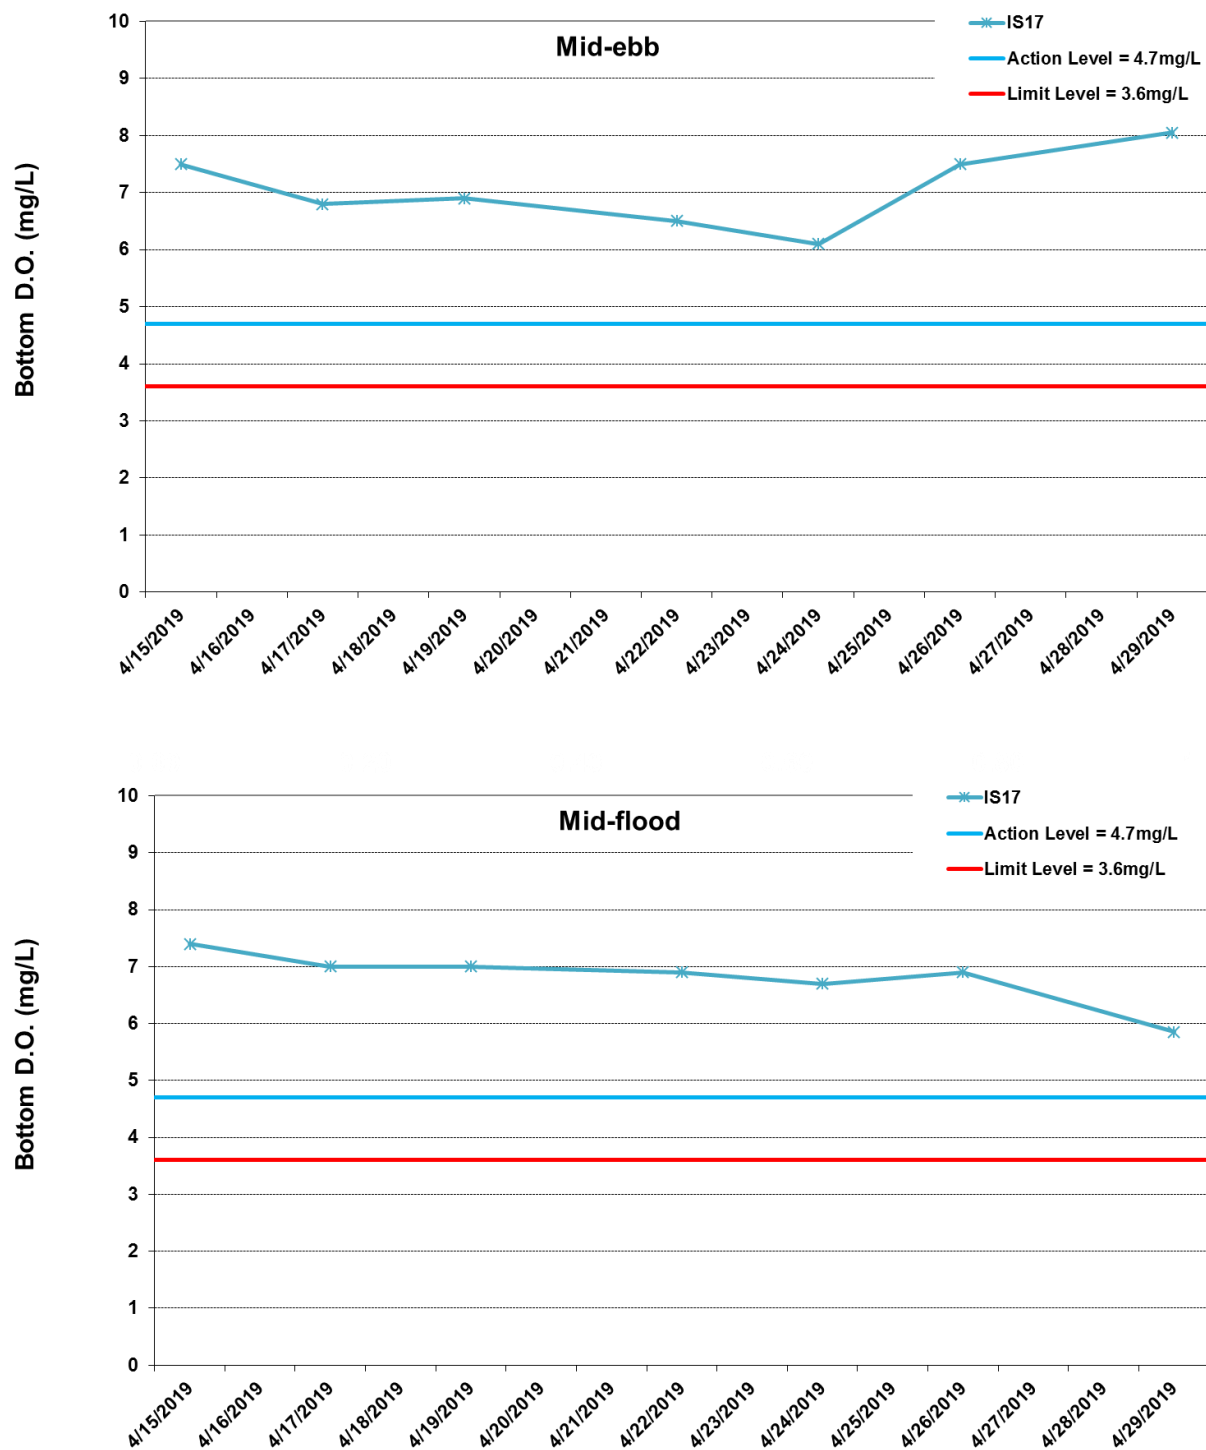
**Figure J8 Impact Monitoring - Mean Level of Dissolved Oxygen (mg/L) in bottom water between 15 April 2019 and 30 April 2019 at IS17.** The weather conditions during the monitoring period varied mostly from sunny to cloudy. Major marine works included: Seawall Modification works at Southern Landfall (15/4/2019 - 30/4/2019).

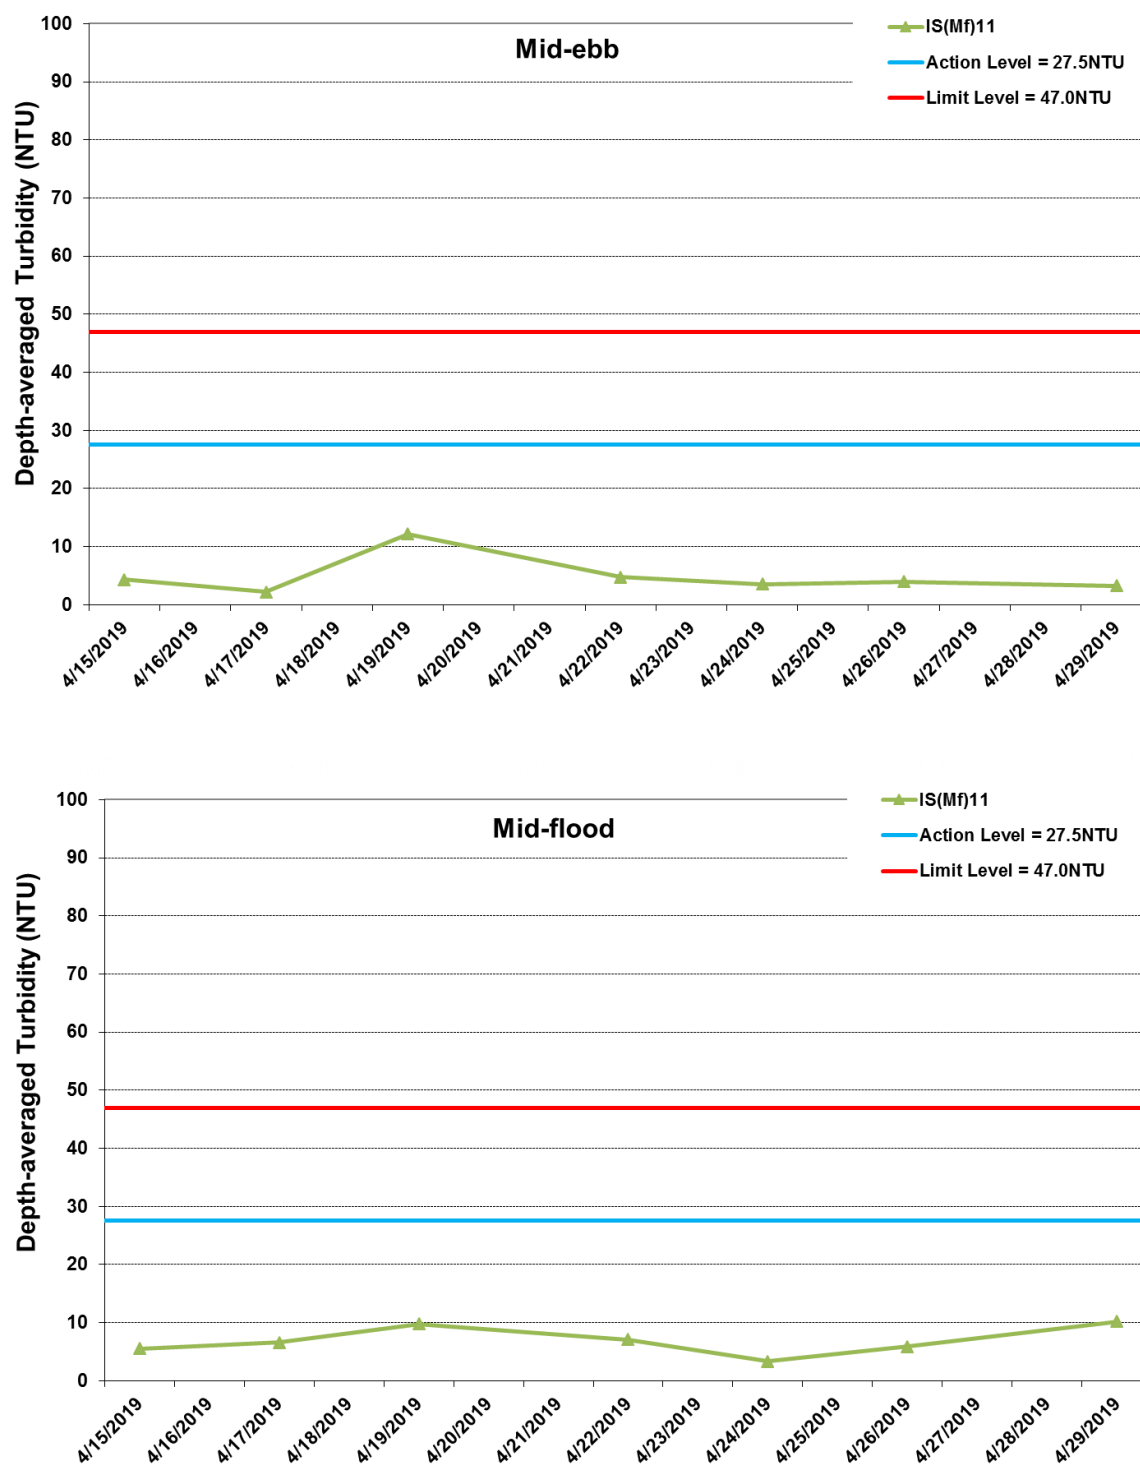
**Figure J9 Impact Monitoring - Mean Depth-averaged Level of Turbidity (NTU) between 15 April 2019 and 30 April 2019 at IS(Mf)11.** The weather conditions during the monitoring period varied mostly from sunny to cloudy. Major marine works included: Seawall Modification works at Southern Landfall (15/4/2019 - 30/4/2019).

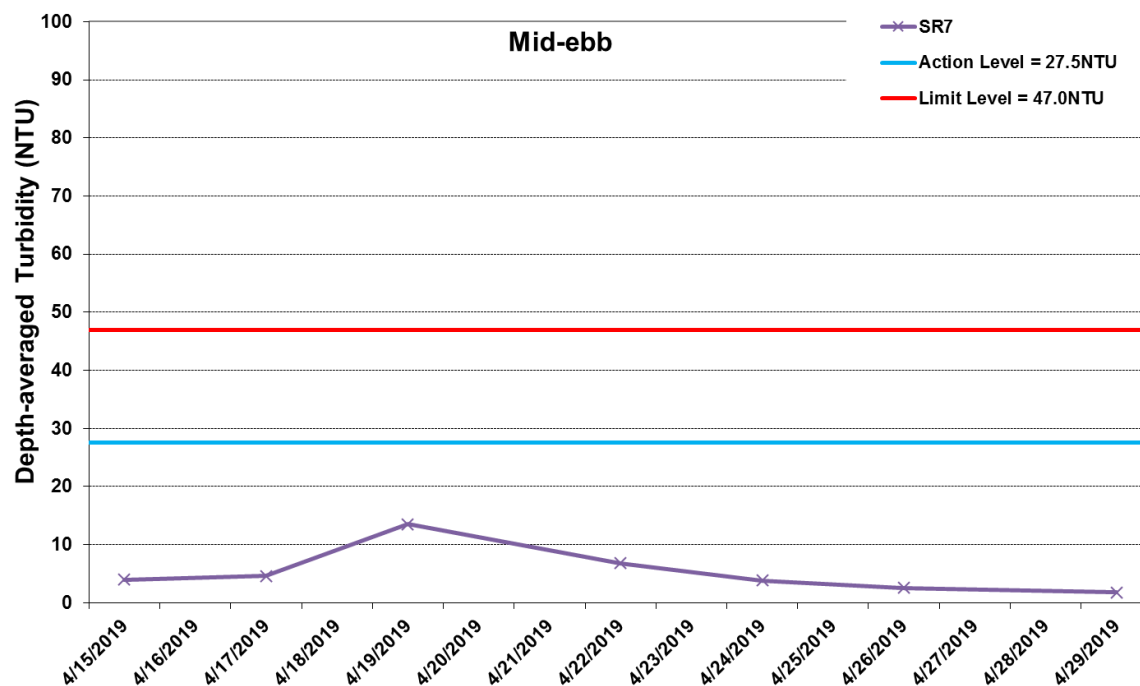
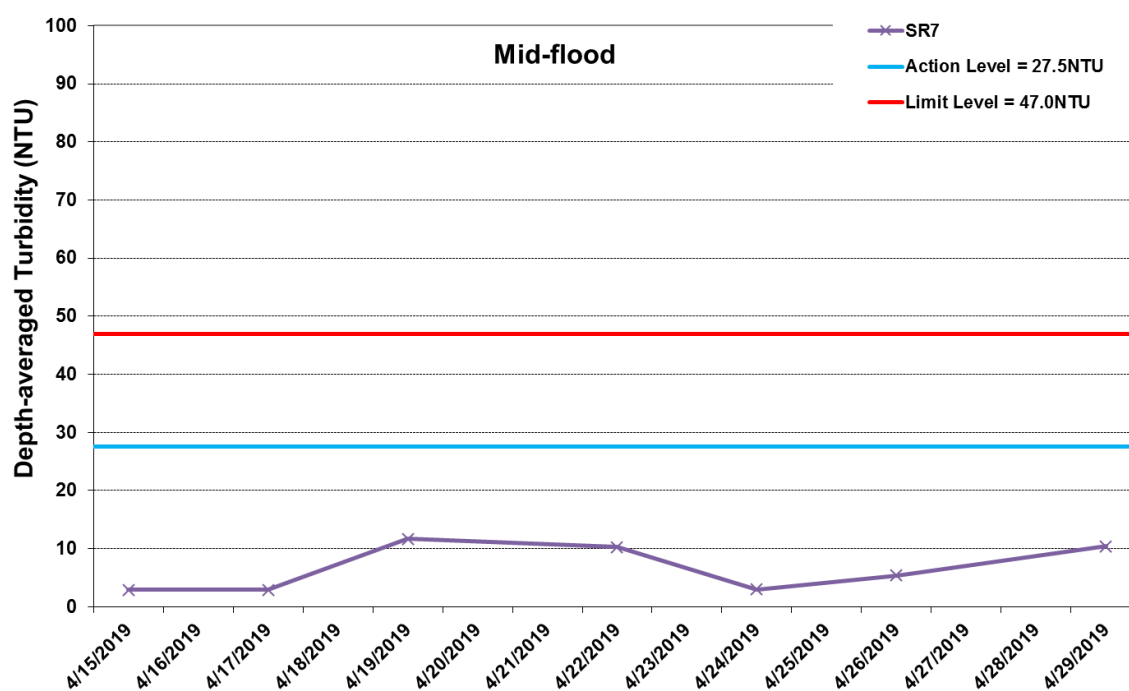
**Figure J10 Impact Monitoring - Mean Depth-averaged Level of Turbidity (NTU) between 15 April 2019 and 30 April 2019 at SR7.** The weather conditions during the monitoring period varied mostly from sunny to cloudy. Major marine works included: Seawall Modification works at Southern Landfall (15/4/2019 - 30/4/2019).

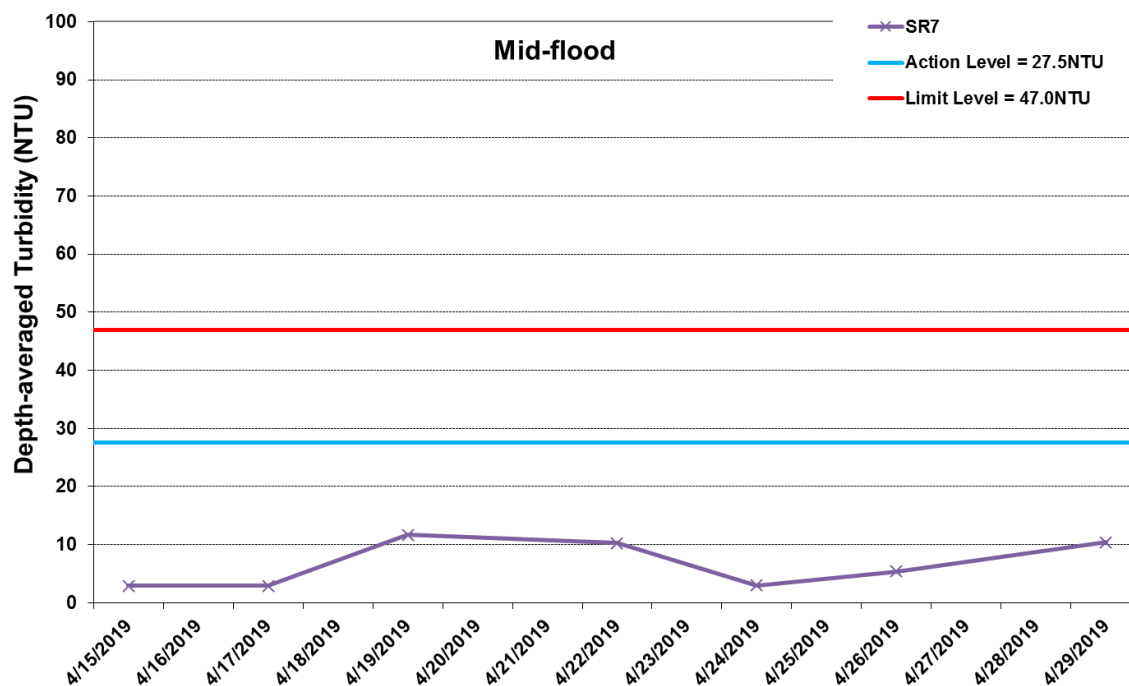
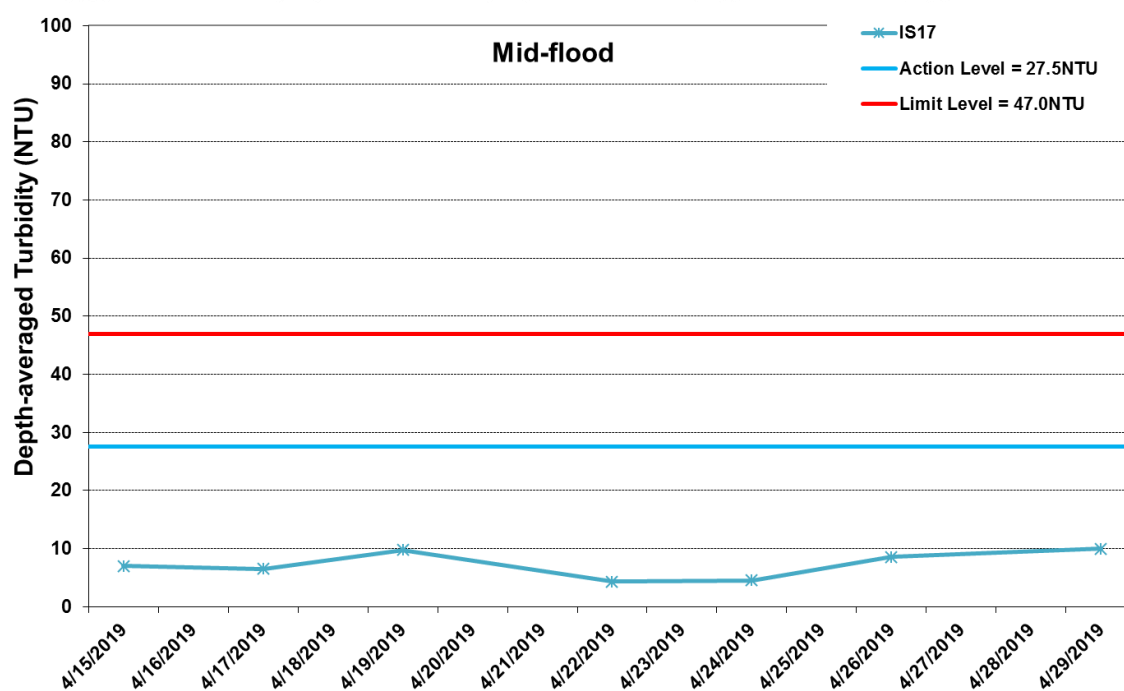
**Figure J11 Impact Monitoring - Mean Depth-averaged Level of Turbidity (NTU) between 15 April 2019 and 30 April 2019 at IS17.** The weather conditions during the monitoring period varied mostly from sunny to cloudy. Major marine works included: Seawall Modification works at Southern Landfall (15/4/2019 - 30/4/2019).
